**House Bill 1418 Report:
Tidegates and Intertidal Salmon Habitat in the Skagit Basin**

**By
Carol J. Smith, Ph.D. and Ed Manary
Washington State Conservation Commission**

2005

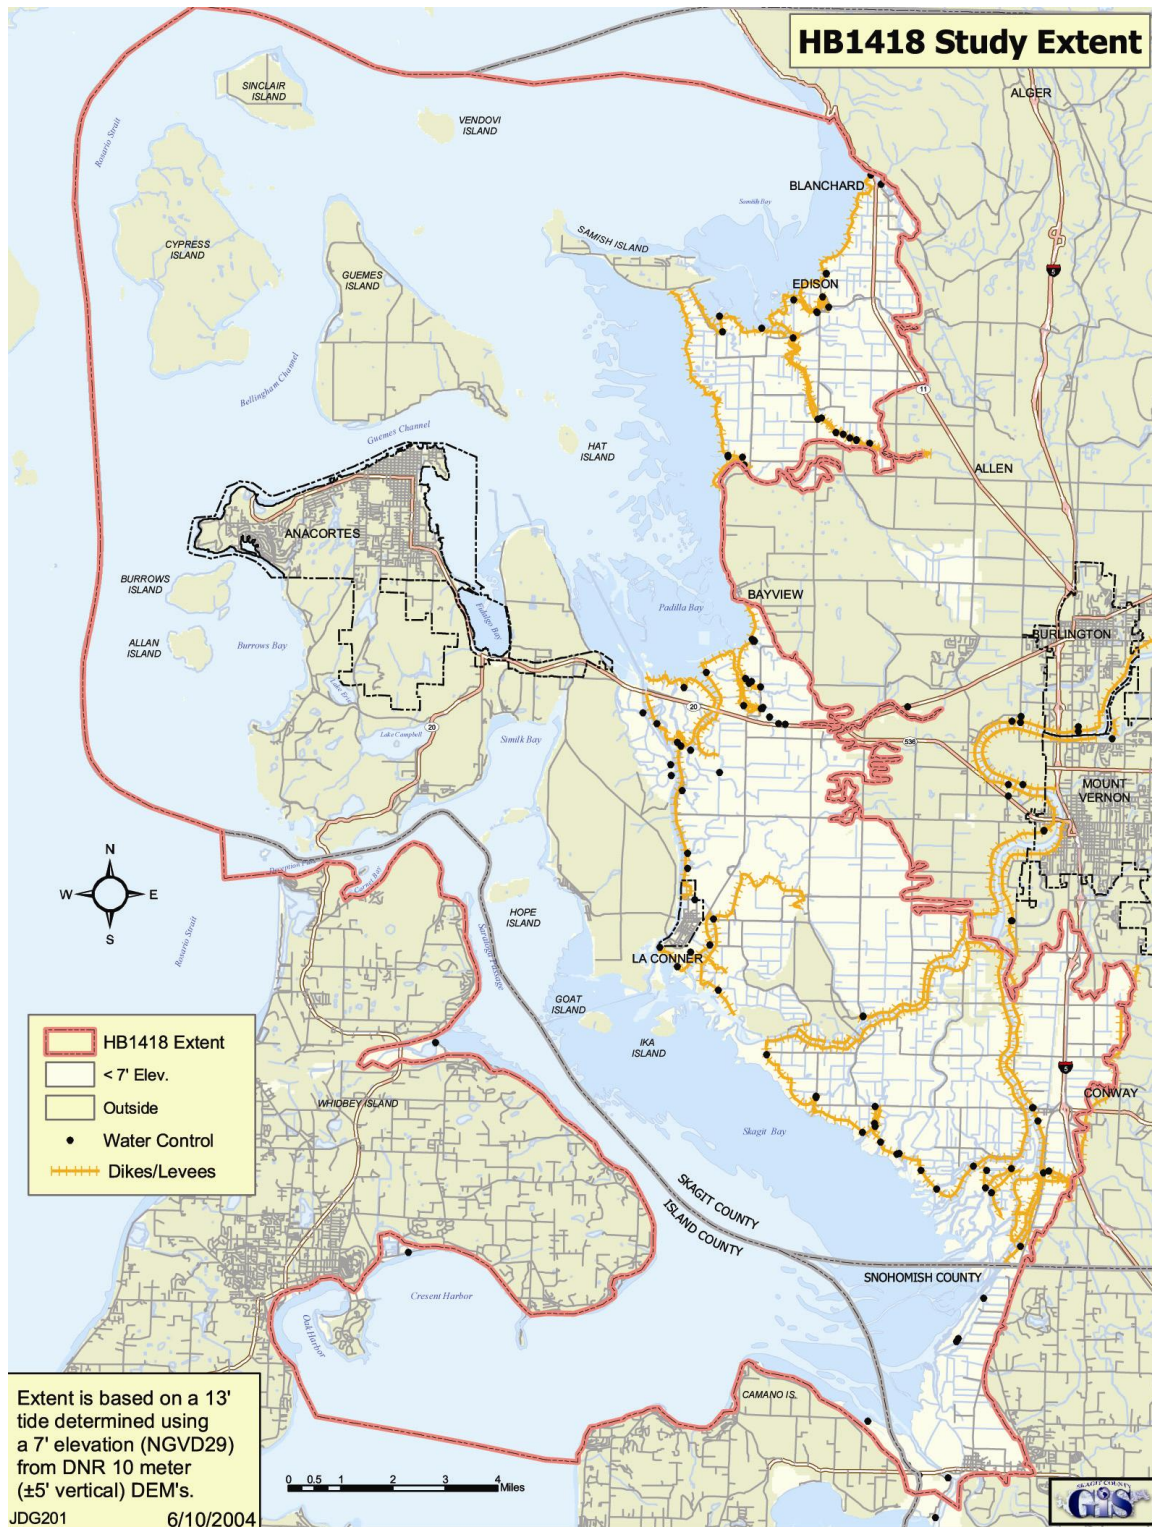
Figure 1. The 1418 project area is bordered by red, and includes the 13-foot tidal range.

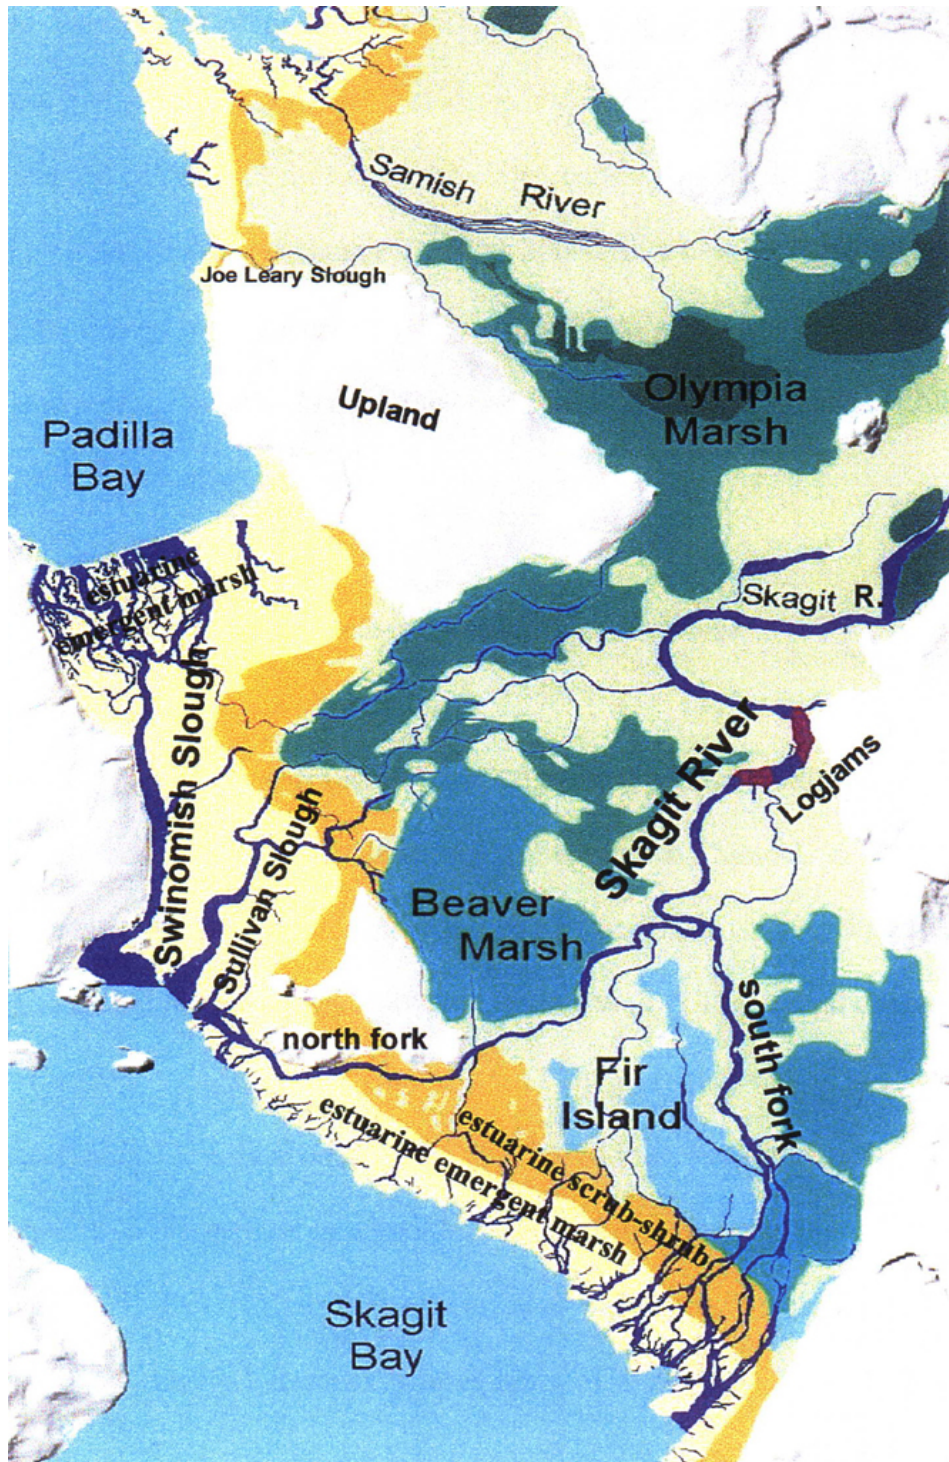
Figure 4. Historic estuarine habitat and channels in WRIA 3 (from Brian Collins, in prep. and in Yates 2001).

Several sloughs drain into east Skagit Bay including Sullivan, Hall, Browns, Dry, Freshwater, Deepwater, Steamboat, Tom Moore, and Douglas Sloughs. As discussed in the Skagit delta section, dikes have isolated and transformed much of the historic salmonid distribution with a considerable loss of blind and open channels (Figure 4).

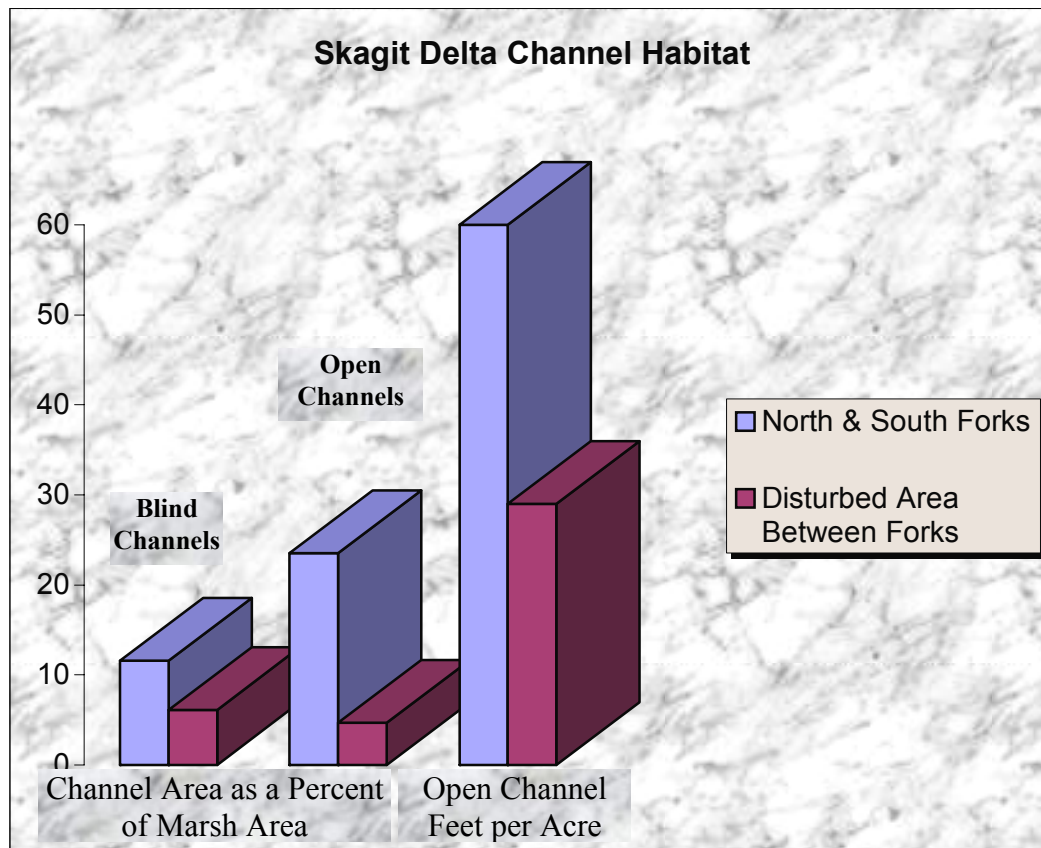
Figure 7. Changes in the Skagit Delta Channel Habitat (data from Beamer et al. 2002a)

The reduction in estuarine habitat has great impact to chinook salmon. Historically, this habitat included an extensive network of blind and open channels. These types of channels are essential to juvenile chinook salmon, and up to 7,800 chinook per acre of blind channel have been recorded in the Skagit estuary (Beamer et al. 2002b). Currently, the North and South Fork Skagit Rivers still have numerous blind channels, while the area between the Forks has been greatly altered and has an average of 6% blind channel habitat per marsh area compared to nearly 12% in the North and South Fork areas (Figure 7). The disturbed area (between the Forks) also has much less open channel area; about 1/5 the area and 1/2 the length compared to the North and South Fork Skagit (Figure 7) (Beamer et al. 2002b).

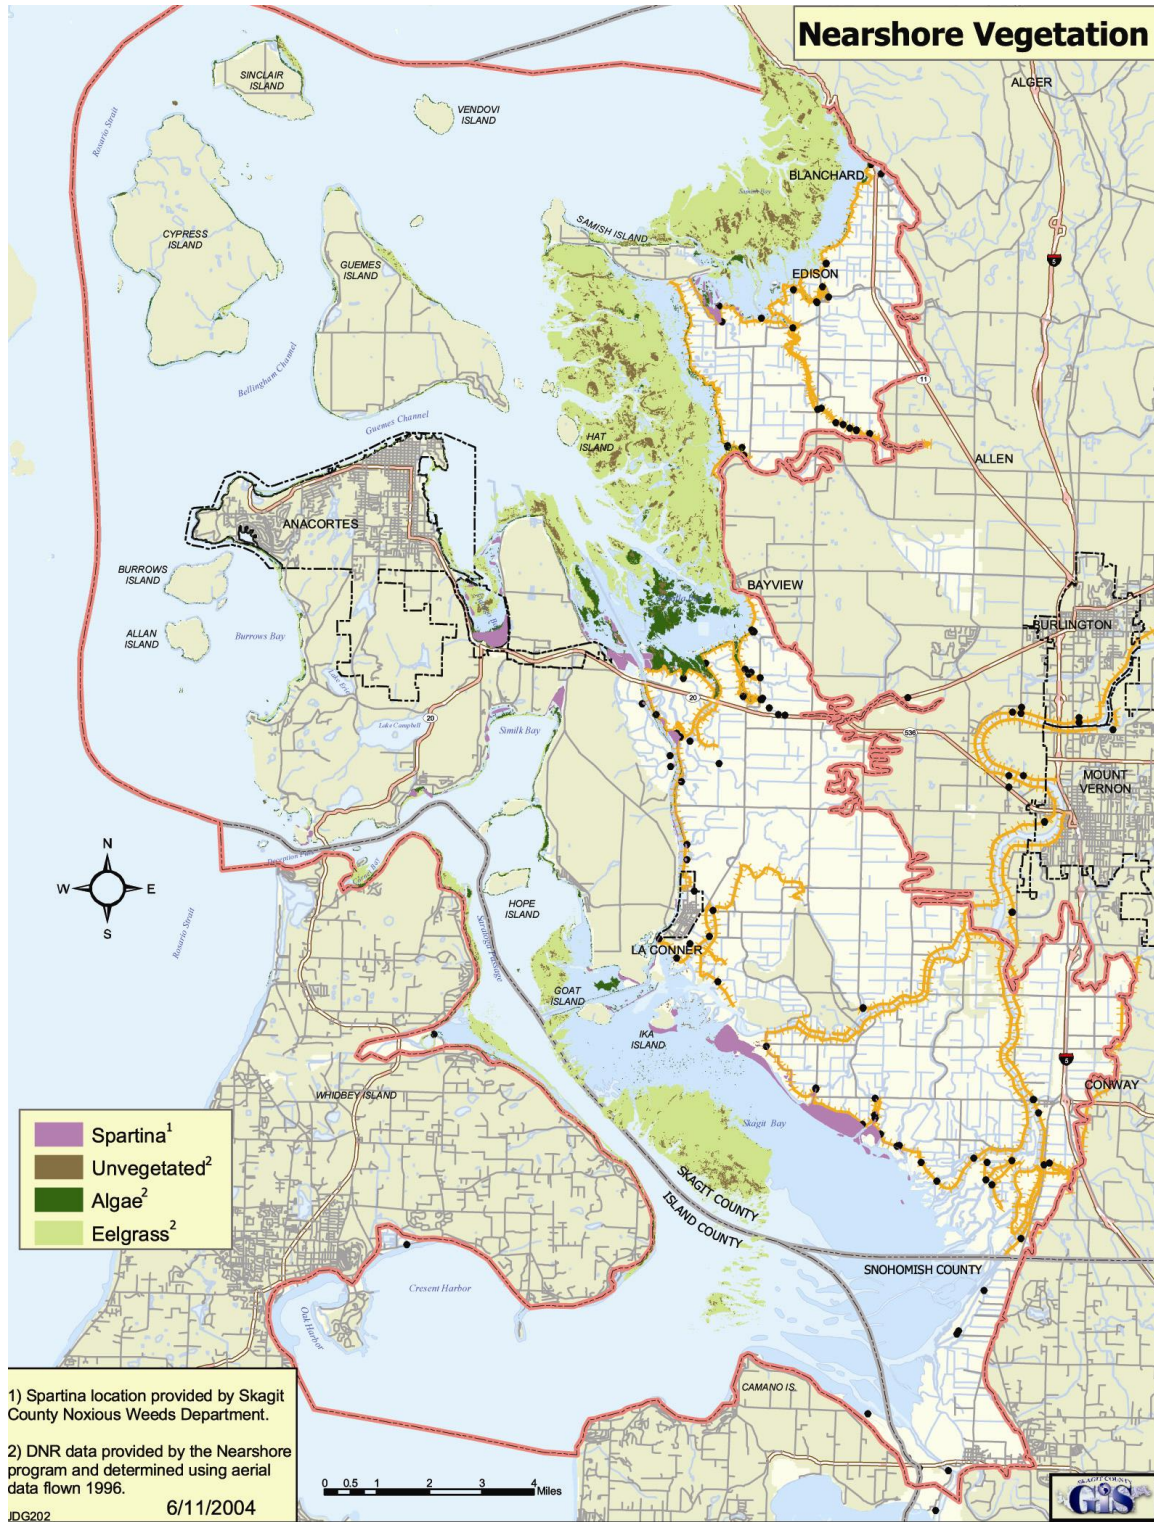
Figure 9. Known *Spartina* sitings in WRIA 3.

Spartina has also been documented in Skagit Bay (Berry et al. 2001; Noffke and Beamer 2001). *Spartina* grows on mudflats and traps sediment from the water column, causing increased elevation of the mudflat. The change in elevation and vegetation can alter the animal assemblages that live in the mud and the loss of open mudflats can reduce foraging habitat for fish. The impact of *Spartina* on salmon production is unknown, but the extent of *Spartina* coverage within the project area is as follows. Skagit County applied for a permit to treat 30 acres within Skagit County, and Snohomish County applied for a permit to treat 65 acres in south Skagit Bay, north Port Susan, and other unnamed Snohomish County shorelines in 2002 (DOE 2002). Sites in or near Skagit Bay that have had past infestations are near Hall and Browns Sloughs and Kiket Island. The northern Camano Island shoreline has documented *Spartina* invasion, especially near Davis Slough, West Pass, Livingston Bay, and Triangle Cove (Wilkosz 2000). *Spartina* has decreased by 42% from 1997 to 1999 in Skagit County, but has increased in south Skagit Bay in Snohomish County (PSWQAT 2000). Figure 9 shows where *Spartina* has been found within Skagit County, but the location and extent of infestation changes with time.

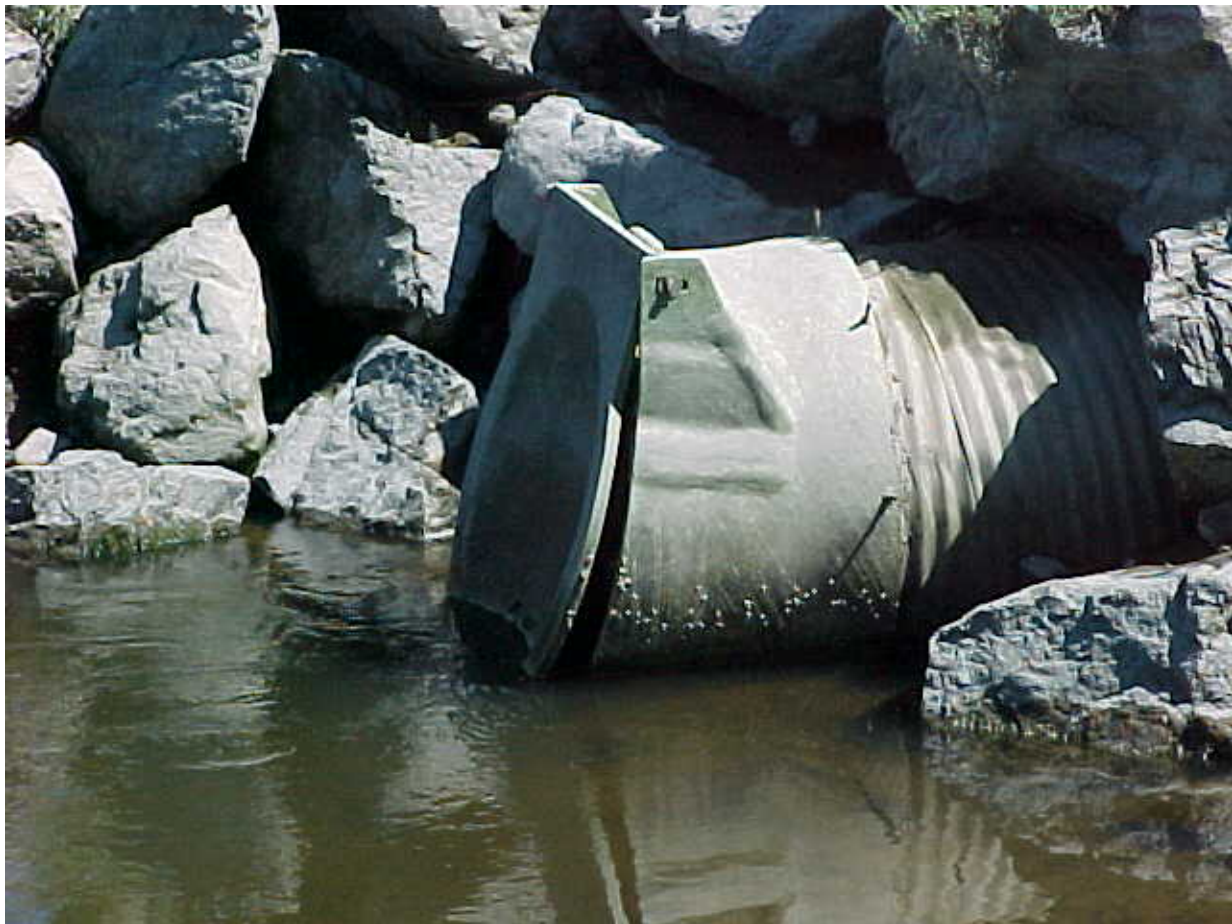
Figure 10. Conventional tidegate located in Skagit County.

A typical conventional tidegate fulfills the three vital functions listed above, all of which are necessary for economically viable agriculture.

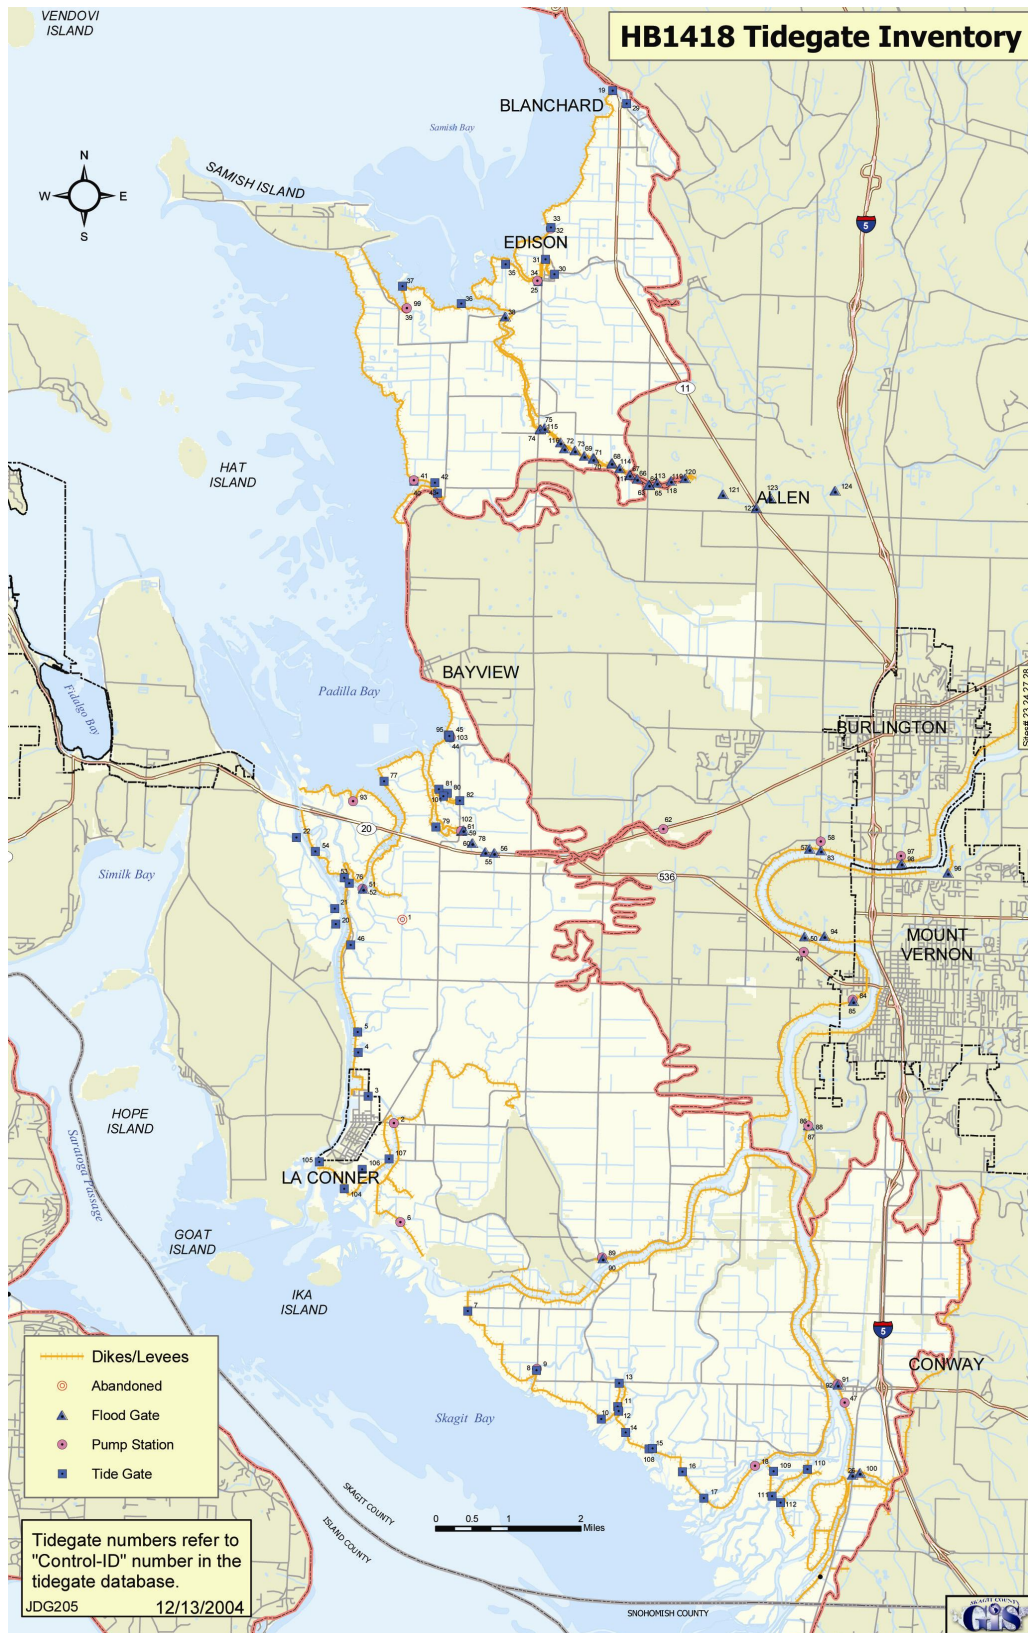
Figure 11. Tidegates, floodgates, and pump stations in WRIA 3 with a focus on those in the 1418 study area as outlined in red.

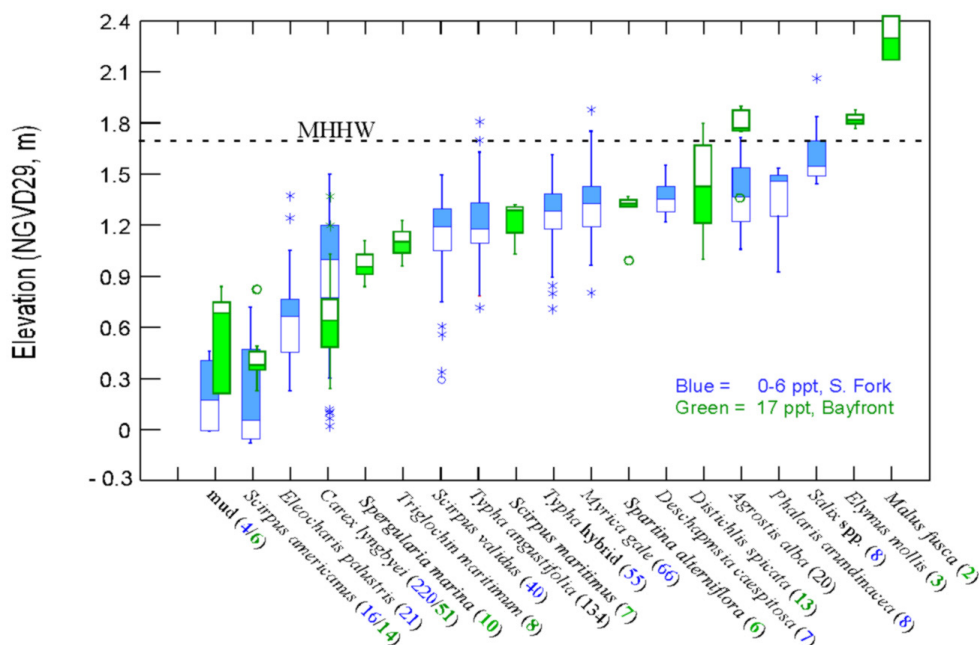
Figure 13. Elevation ranges of dominant vegetation in the South Fork Skagit River tidal marshes (blue) and bayfront marshes near Rawlins Road (green). Sample size for each species is indicated in parentheses. MHHW = mean higher high water.

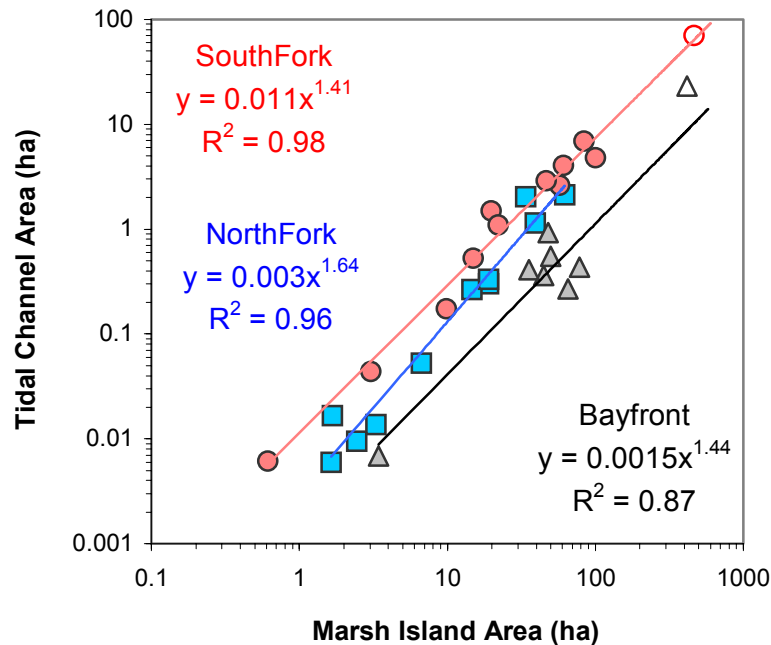
Figure 14. Scaling of tidal channel surface area with marsh island area.

The model reveals several important patterns. First, tidal channel density varies by location. Density is highest in the South Fork tidal marshes and lowest in the bayfront tidal marshes. In fact channel density is 7 times higher in the South Fork tidal marshes as in the bayfront marshes. North Fork channel density is more than twice as high as bayfront channel density. The low density of tidal channels in the bayfront area is consistent with the observation of historical impacts to tidal channels seaward of dikes, caused by conversion of marsh lands to diked and drained uplands (Hood 2004). The lower channel density in the North Fork marshes compared to the South Fork marshes is probably related to the high rates of sediment accretion and channel filling in the North Fork area (Hood, in review). Perhaps the most important pattern revealed in the data is that as marsh islands increase in size, the total area of tidal channels that drain an island increases even more rapidly (the exponents of the fitted power functions are > 1), i.e., one large island supports more channel area than two or

more smaller islands of equal total size. The data indicate that it is more efficient and effective to restore one large area than several smaller areas of equivalent total area.
