COWLITZ WILDLIFE AREA 2017 MANAGEMENT PLAN UPDATE

Washington Department of Fish and Wildlife

Land Management Summary

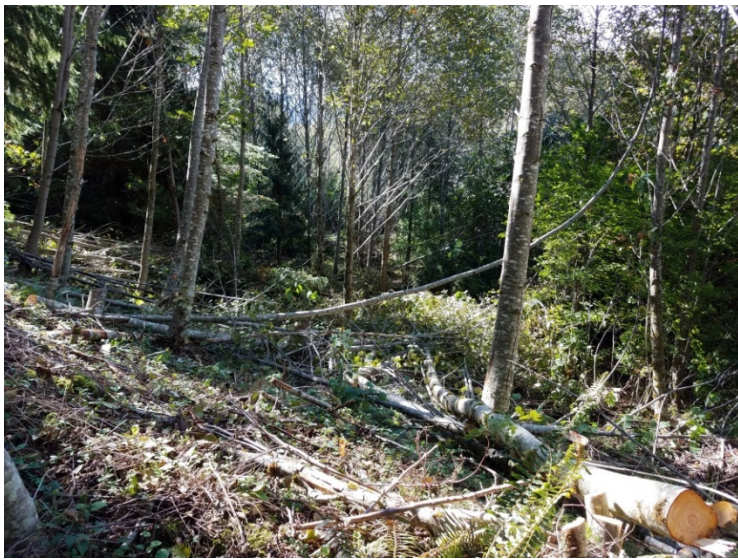
Figure 1 View of pre-commercial thin

Vegetation management activities continued under the CWLA Timber Management Plan (CTMP) on the Peterman Unit. In 2015, wildlife area staff worked closely with Tacoma Power to co-managed the commercial thinning of a 20-acre parcel. Tacoma Power is responsible for funding the projects that occur under the CTMP, staff prepared a thinning plan identifying units and the recommended prescriptions to better facilitate Tacoma's funding requests. In 2016, the wildlife area in cooperation with Tacoma Power co-managed the thinning of 11 management units (Figure 1) totaling 362 acres that were identified in the CTMP for pre-commercial thinning. Photo plots were established within some of these units to track the vegetation and habitat changes over time.

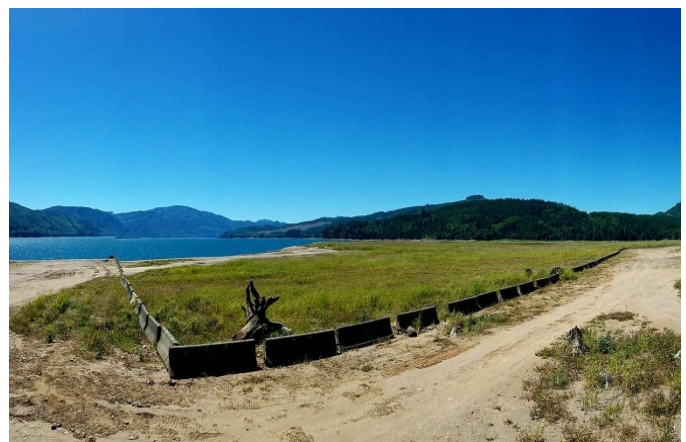
Figure 2 View of the Kosmos Access Barrier

as well and fire risk in the grass will become more likely as it dries out during the summer months. The CWLA staff installed a permanent barrier on the Kosmos Unit isolating vehicular traffic to the established dispersed camping site near the foot of Dog Mountain. This will mitigate some of the issues identified above. Due to the possibility of the exposure of previously unknown cultural resource sites and the need to protect these resources under State and Federal law, staff has taken training to better facilitate those responsibilities and help Tacoma Power meet their FERC requirements.

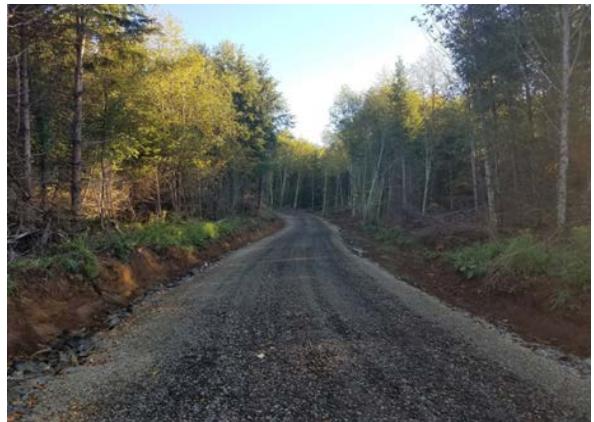
Figure 3 Peterman Mainline after reconstruction

The project to repair and upgrade the 1000 line (6.5 miles) on Peterman Unit began in 2015 with the daylighting or removal of trees from the edges of the road. In addition, two new road alignments were cleared of trees and the roads roughed-in. The new alignments will facilitate the abandonment of about one mile of stream-adjacent road to improve stream integrity by eliminating sediment delivery, and improving fish habitat.

The 1000 Mainline project was completed in 2016 with upgrades and reconstruction efforts focusing on restoring ditches, upgrading and installing additional cross drains, and grading the roadway. The road was resurfaced (graded and compacted) with ~12,000 cubic yards of crushed rock. Management costs in the future will be reduced as a result of the improved roadway. The abandonment of approximately one mile of stream-adjacent road was completed and approximately 10 acres of timber was removed.

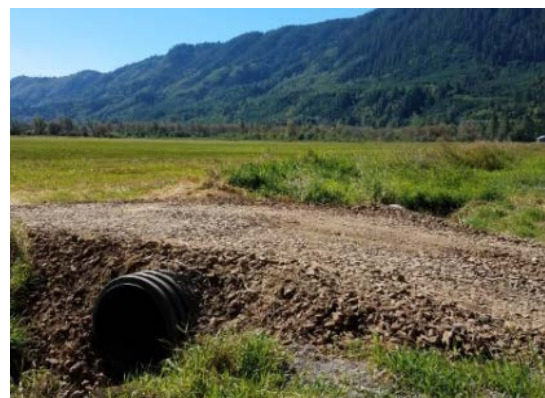
Figure 20 Davis Lake Unit culvert

Two culverts were installed to facilitate access for summer hay cutting on an additional 20 acres (Figure 10). The grass was cut and removed by a landowner as compensation for losses due to elk foraging. This benefits the wildlife area by providing nutritious forage for wildlife and wintering waterfowl. It also provides the added benefit of reducing the chance of wildfires (these fields are near private residences).

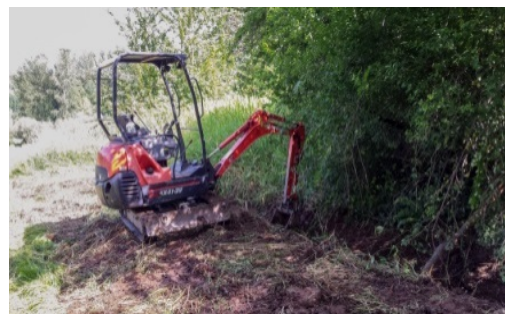
Figure 3 Mossyrock ditch cleaning

The ditches were cleaned throughout this unit using a mini-excavator to remove channel blocking vegetation and debris (Figure 11). Additionally, the banks and pond bottoms were mowed. All activity was done while the ponds and ditches were dry. An animal had excavated a sizeable burrow in the berm separating pond #2 from the ditch that flows into pond #3. The burrow was excavated using the mini-excavator, collapsed, and then the material was reincorporated back into the bank. The reincorporated material was compacted using the bucket on the excavator.

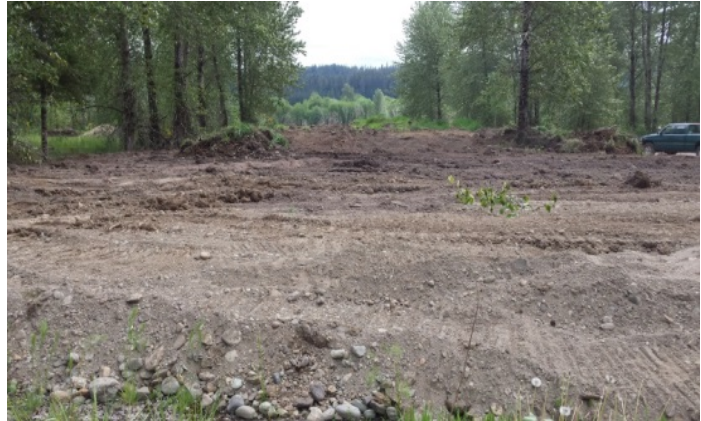
Figure 42 Old foundations now under fill

This project’s main purpose was to correct the safety issue that the old exposed foundations and footings, left over from when the area was an operating plywood mill. An additional objective of this project was to provide plantable soils in areas where soil compaction is high and limiting diversity in the vegetation community. Wildlife area staff worked with local agencies (City of Morton, Washington State Department of Transportatin, and Lewis County) to acquire the necessary fill materials. Approximately 8,000 yards of fill material has been deposited to date (Figure 12). The partners have done a great job of keeping the dirt graded out and aesthetically appealing. Wildlife area staff have seeded the fill dirt to prevent erosion and cottonwoods will colonize the new soils.
