**Sunset Falls Fish Transfer Site at Money Creek Bridge  
Vegetation Report**

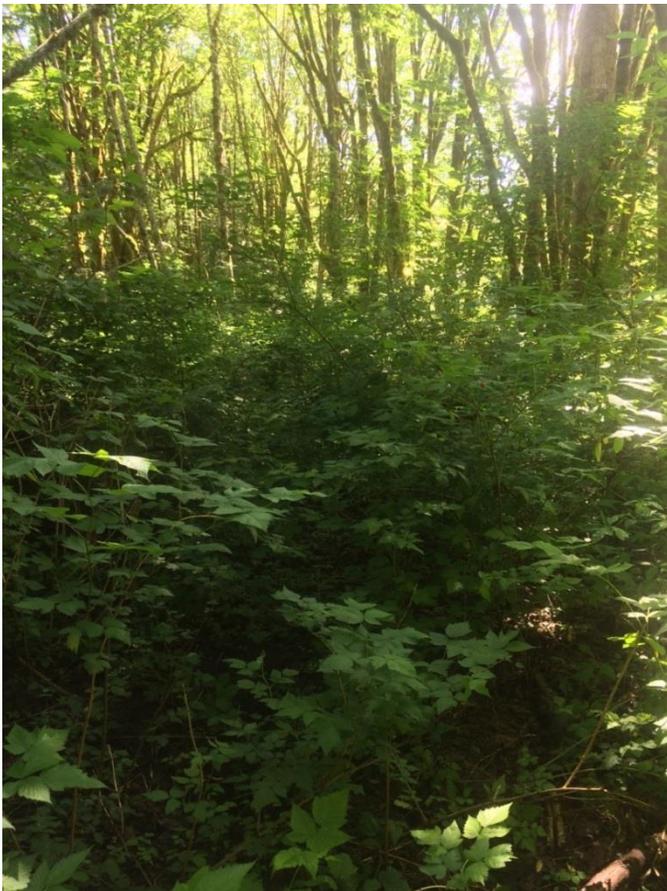
The access roads are in various states of disrepair. The eastern access has not been in use for over a decade with encroachment of smaller trees (less than 6" dbh) and would require a minimum amount of pruning to make it passable. This road will only be used as an entrance, given its close proximity to a tunnel just east of its intersection with State Route 2. The western access receives some use annually and remains passable, though in need of maintenance, for about 500 feet to the juncture of the gravel road forming a connection to the east. This connector road is the area where the larger tress would be removed to complete the loop.

**Photo 1** View of access road looking east down the road grade overgrown with shrub species (rubus, var. species).

WDFW proposes to improve the existing site by removing enough brush, limbs, the three bigleaf maple trees and three to five red alder trees to gain access for the planting truck, add gravel to the access roads, construct a

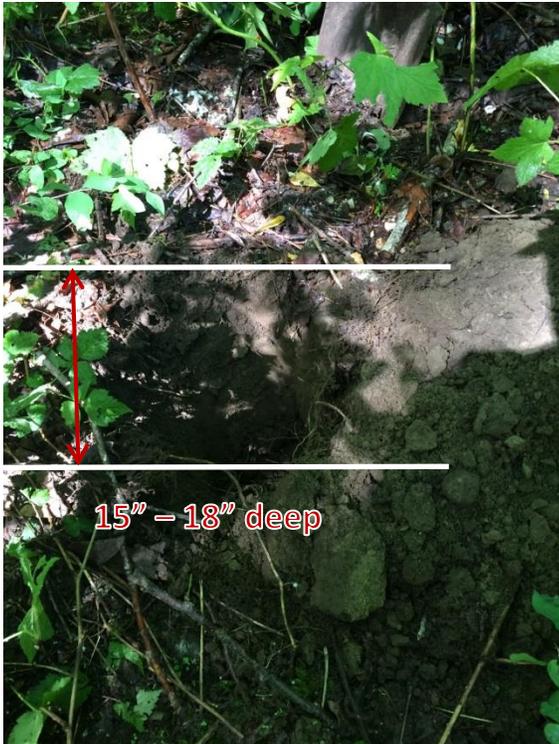
Photo 5 – Soils Test Pit

A test pit was dug within the proposed access roadway following a rain event. The soils showed no evidence of hydric soils and no ground water was found in the 18” pit.

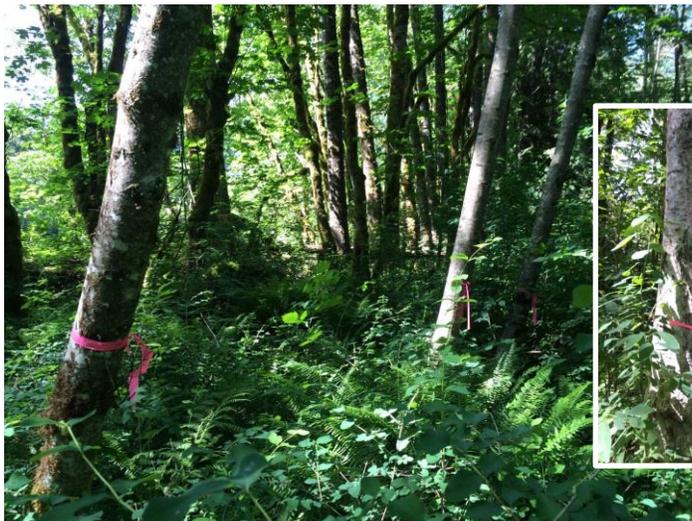
Between six and eight trees will be removed to complete the repair and maintenance of the loop access road. The project's Planting Plan is to assure no net loss of ecological function within shoreline zone/ riparian zone. Tree removal includes three bigleaf maples (*Acer macrophyllum*) and between three and five red alder (*Alnus rubra*). The maples average 12.5 dbh. The alders include a 17" (dbh) and the average 8" (dbh).

**Photo 6 – Red alder: 9", 8", and 7" (dbh)**

3 - 5 red alder : 6 - 15 red alders per above

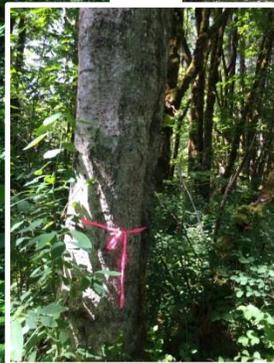
**Photo 8 – Red alder 17" (dbh)**

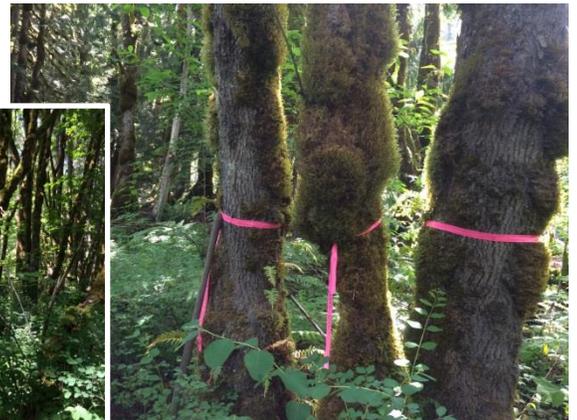
**Photo 7 - Big leaf maples: 12" 9" 17" (dbh)**

3 bigleaf maples : 6 - 9 bigleaf maples per above
