United States Department of Agriculture Forest Service

# Chewuch River Restoration River Miles 15.5-20

# **Environmental Assessment**

Methow Valley Ranger District, Okanogan-Wenatchee National Forest, Okanogan County, Washington

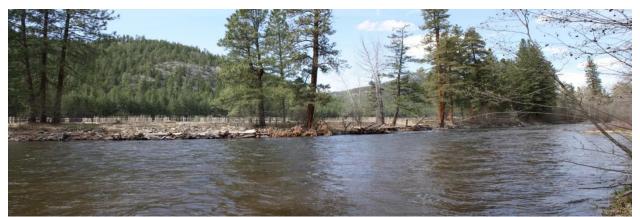
Figure 40. Photograph looking upstream at the constructed log structures on the south end of Eightmile Ranch riverfront.

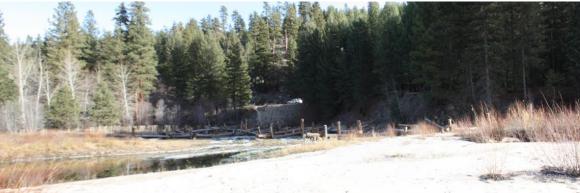
Figure 41: View of Structure 13B from the Chewuch River

This structure has a scenic integrity objective of Very Low because the size of the structure is out of scale, the lines in the structure (both horizontal and vertical) are strongly parallel, and the pattern is very angular and geometric.

The uniform, geometric pattern of the structure is easily reached from the banks of the river, and creates a tempting climbing structure. The structure has no elements to reduce hazards to people – such as flattened tops on the logs, railings, or abutments.

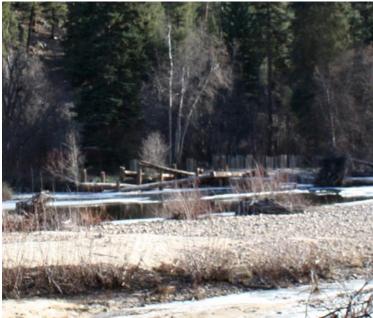
Figure 44. View of Structure 13C from the river

The vertical pillars in the structure are dominating due to consistent height and even row appearance. The blunt ends of the logs are perpendicular to the flow of the river and extend into the waterway. Since much of this structure extends into the water, future vegetation growth would not substantially reduce the visual impact. The structure would likely blend into the surroundings more over time as the logs weather, and the structure catches debris and logs, somewhat hiding the parallel pattern of the upright piers.

Structure 13C (Figure 44) is also having a direct and negative impact on the scenic value of the river, however since it is only viewed by people passing by in a boat, the overall impact is diminished. The following photo shows the structure from the river side.

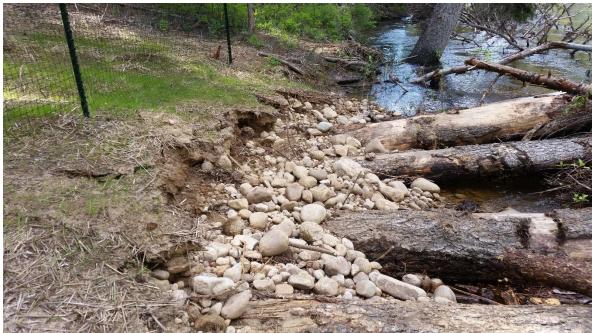
Figure 57: Example of previous in-stream wood placement along the Chewuch River. The bare soil was seeded and the riparian planting were on the other side of the mesh fencing. Rock armoring along the stream bank would help reduce erosion.

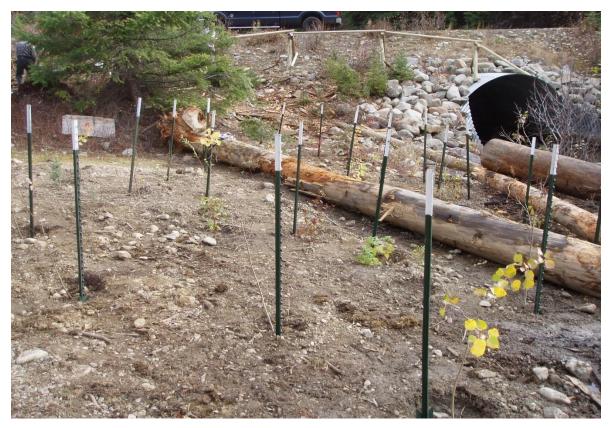
Figure 58. Example of riparian planting that would be done with this project. This adds soil stability, biodiversity, and long-term soil health and productivity.
