CROSS SECTION VIEW 1 - Site 2

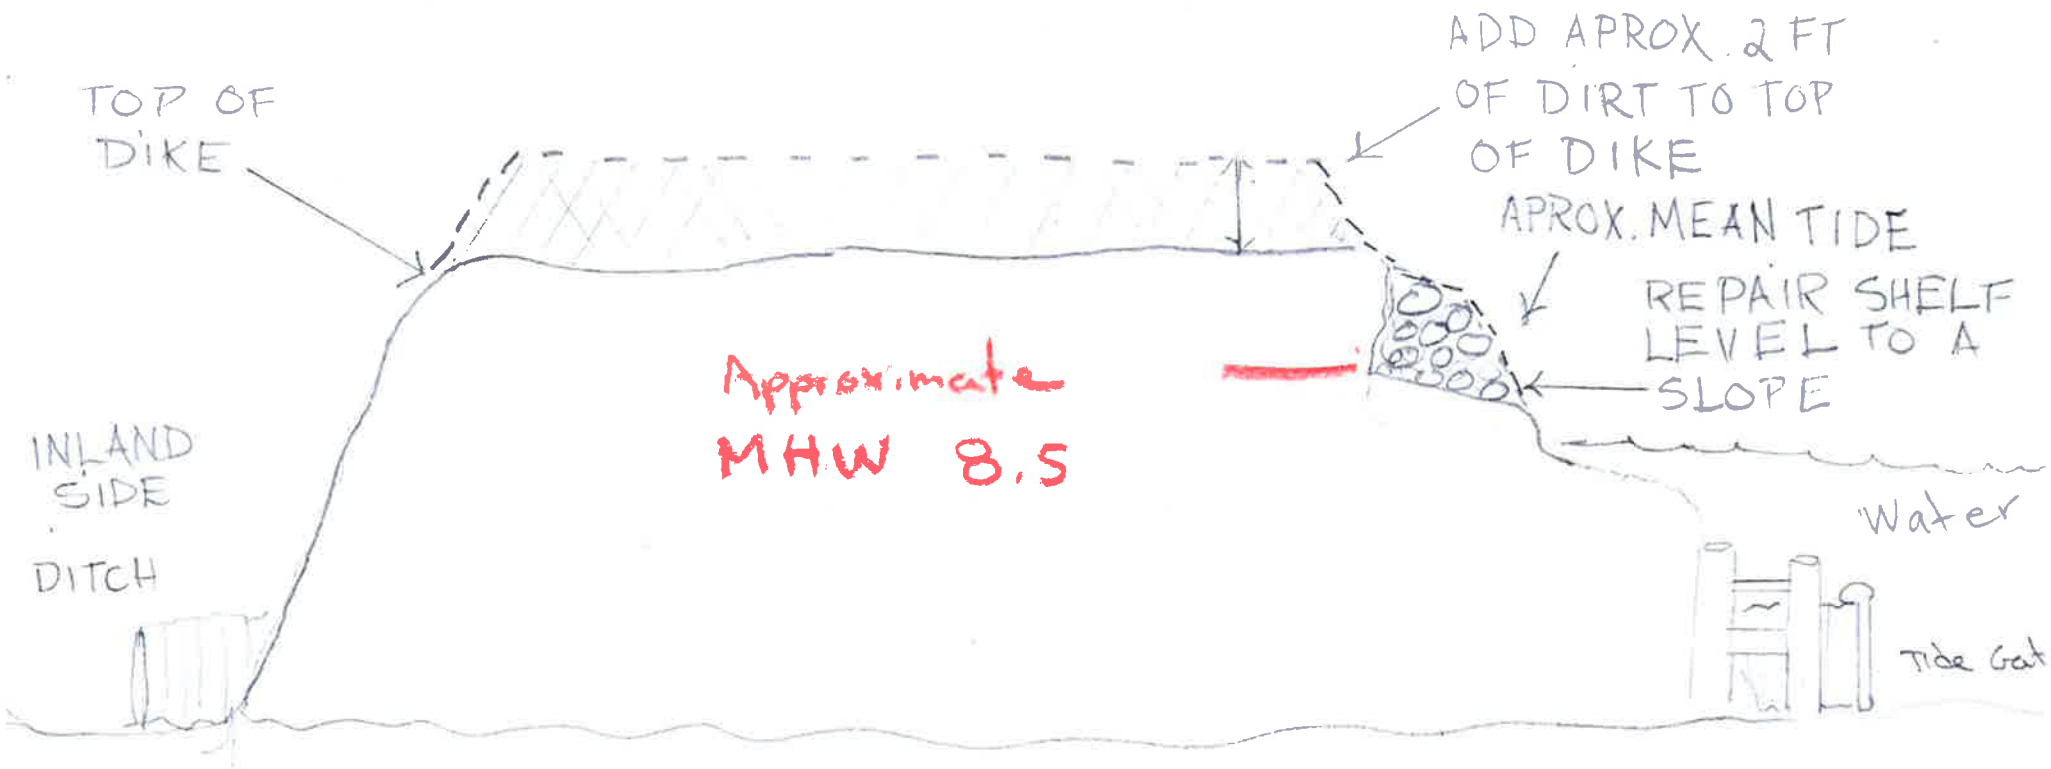
Fill Replaced on top of Levee and about 1 Foot Below Levee at Eroded at north and south side of tide gate.

materials = Dirt - 100 yds
Some Rock - 2 yds

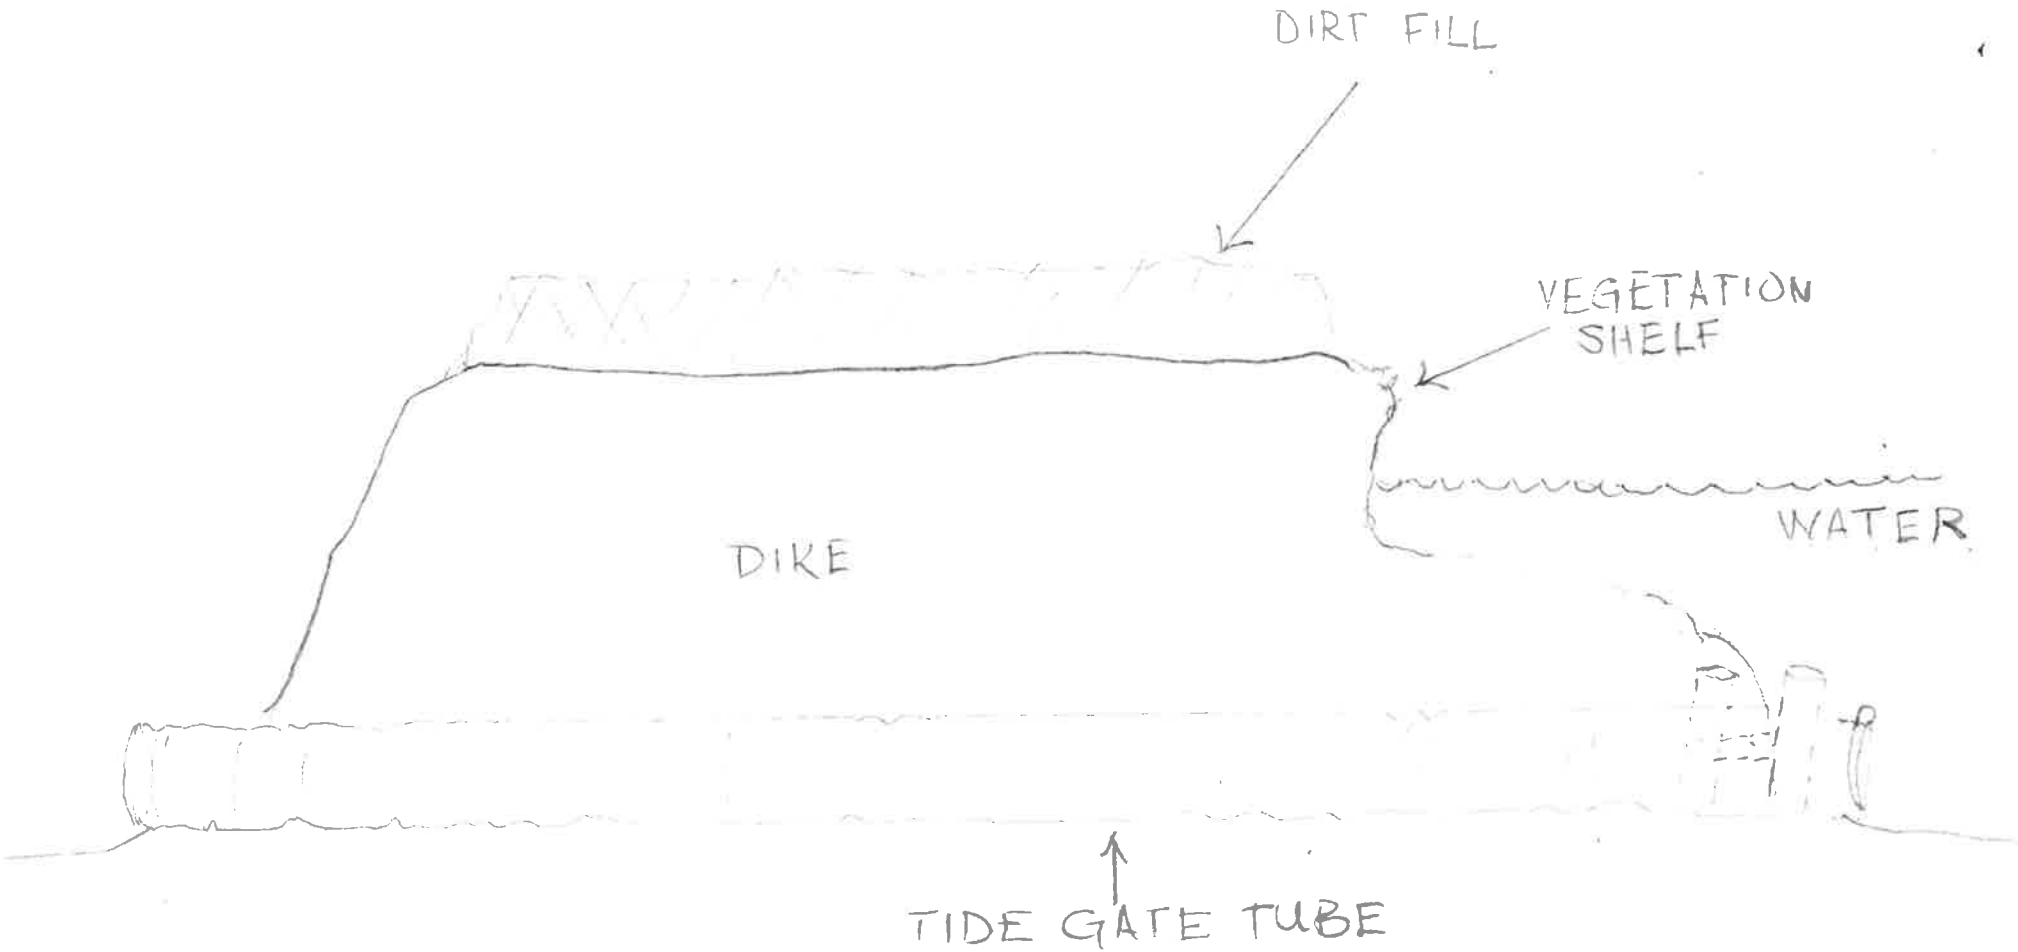
SLICE - CROSS SECTION - Site 2
VIEW #2

BASE OF DIKE INTACT
