SITE INFORMATION

Site Identifier : WN3LB9
Site Name :
WRIA : 03.0227X
Region : NS
Trib to : Lake McMurray
River Mile : 15.30
River System : W. F. Nookachamps
Legal Description : NW1/4S31T33NR5E
County : Skagit
Habitat Type : lower valley wall tributary

Field Survey Information

Date : 02/08/1999 **Observer :** Olis **Survey Type :** initial

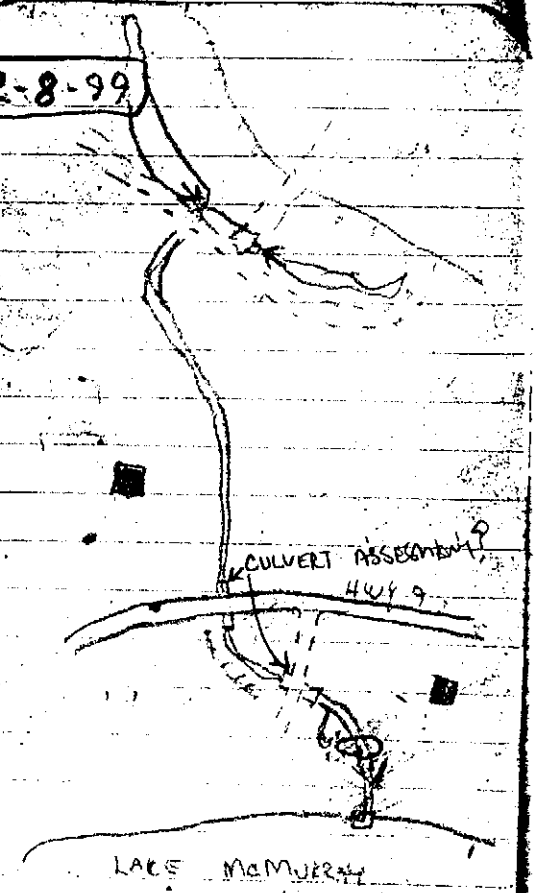
WN3 LB 9

0.0 ENTRY
FLOW - 0.25 CFS
W.T. - 40°
RWT. - 38°
ACCESS - INTO LAKE

37m ALL 3' CULVERT UNDER LAWN
- 3' CMP DOWNSTR.
- 3' ST. ROUND UPSTR.
- SAND BAGS IN UPSTR. END OF CULV.
- MATERIAL THRU PIPE
49m WW 10 m POOL EXC.? 1m DEEP IN PLACES

19m WATER CROSS
SAND & GR., SETTLING P.
- @ 18" CULVERT CMP

60m UPSTR END
OF CULVERT DRAIN
INTO CULVERT
136m WW 1m
MOSTLY RIFF - FAIR
BLUGH - 6m² SP. HAB -
1"-4" GR., SHALLOW
THROUGH. @ 2' CMP
SOME - SLOPE - NO DROP - GOES
UNDER DRIVEWAY
GRAVEL SUBSTR.
TRIB ON LB.

176m WW 1m
- MOSTLY RIFF - COBBLE
- @ 18" CONC. PIPE -
12" DROP - 7-1% SLOPE
W/ 2m x 2m PLUNGE
POOL

196m UPSTR END OF CULV.
TRICKLE ON RB

256m WW 1.5m
- SPREAD OUT IN PLACES
- 15% POOLED - COBBLE
GOOD BRUSH -
ADJ. TO HOUSE

256m OLD STRINGER
CR. PARELLEL (CLGR)
289m, WW 2m
60% POOL. - SM. AM
WTR PARS. - 15 OMC
BAND & GR.
353m WW 1m
50% POOLED - MIXED
FOREST - GOOD BRUSH
@ 1' DROP PASS.

476m WW 5m
POOL - SLOW MOVING -
BRAIDED IN FEW PLACES.
MUD BOTTOMED & LOTS
OF WTR PARSLEY
