The WRIA 9 Marine Shoreline Monitoring and Compliance Pilot Project

April 2014

King County

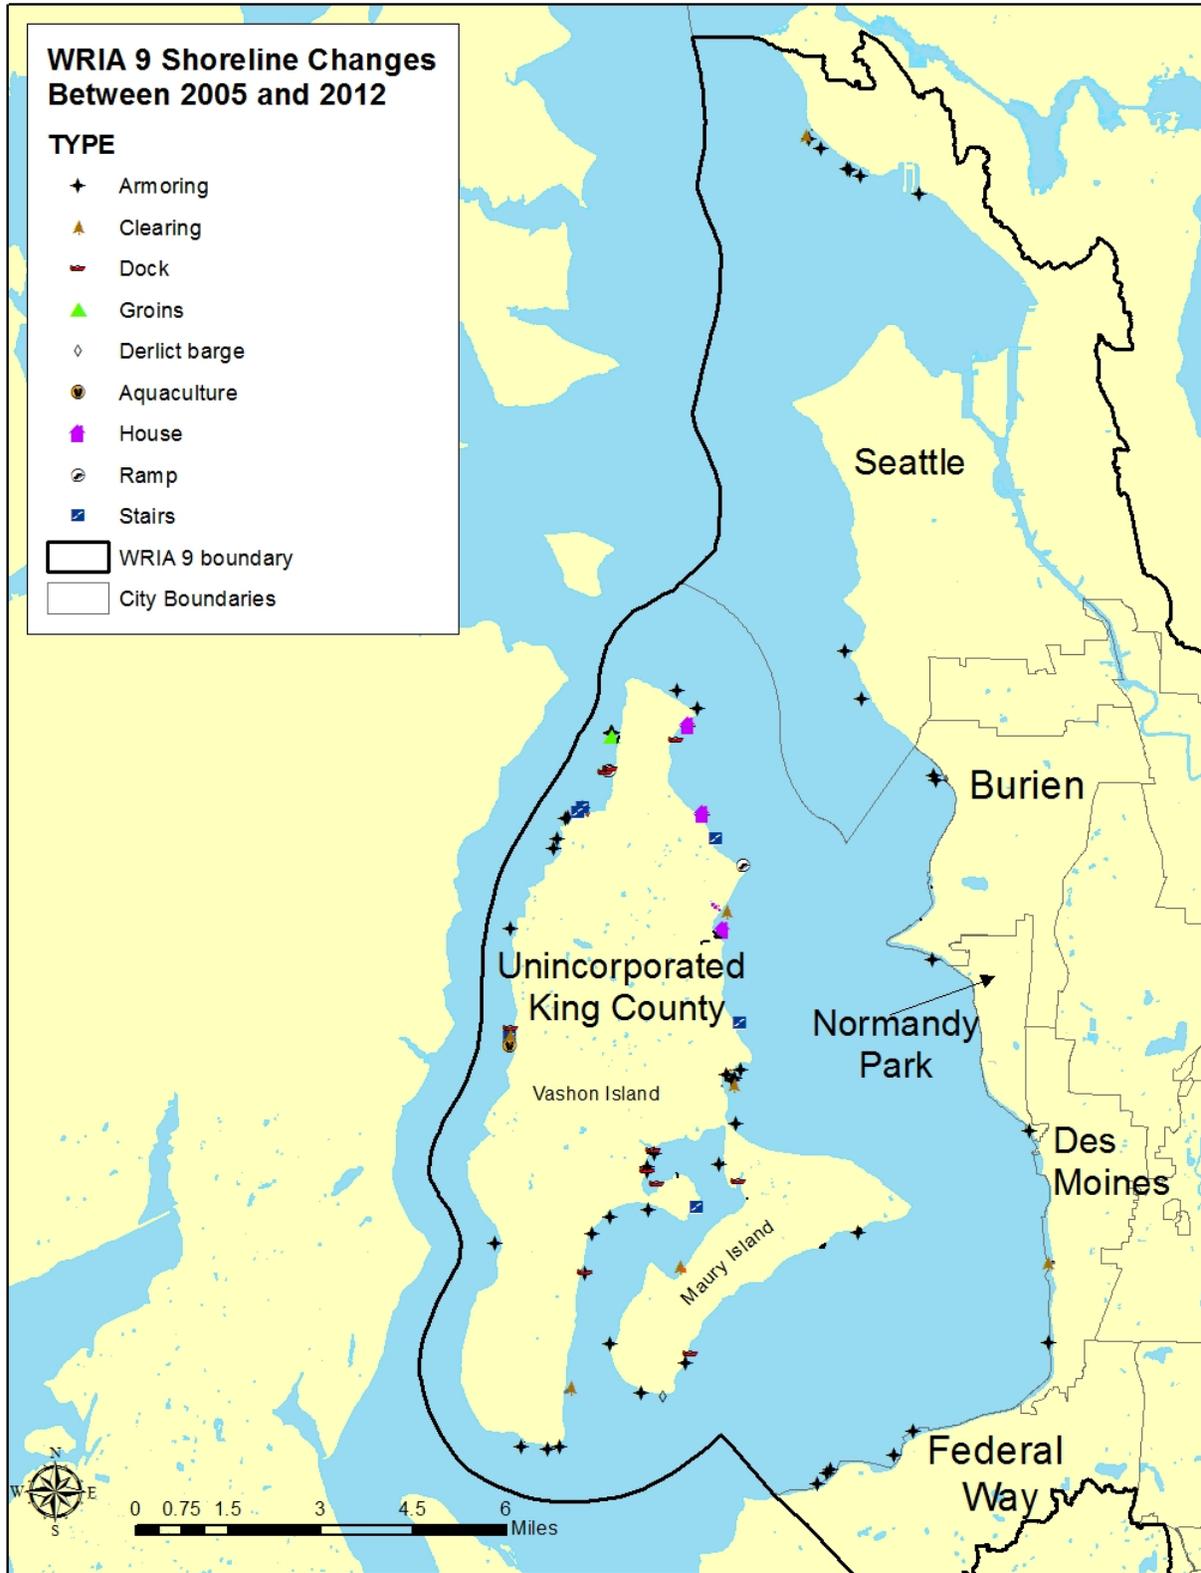
Figure 2. Locations of changes in shoreline condition in 2012.

Surveys of the entire WRIA 9 shoreline took place on Sept 10 and 12 of 2012. Over 900 photographs were taken of various shoreline changes. There were 85 distinct changes noted in shoreline condition (Figure 2 and Table 3). Photographs of example changes can be found in Appendix B. Seventy percent of the changes found were repairs or complete rebuilds to existing infrastructure. Changes associated with shoreline armoring accounted for 63% of the changes noted, with most changes associated with repairs to existing shoreline armoring infrastructure. Only 4 of the 53 changes in shoreline armoring were new bulkheads which didn't exist in 2004 or where it was no longer functioning. Almost 12% of the changes noted were associated with docks and other overwater structures, while another 10% were associated with the clearing of vegetation along the shoreline. Most of clearing changes occurred in unincorporated King County. The remainder of the changes were composed of a mixture of alterations to the shoreline including new or substantially altered buildings, staircases, aquaculture facilities and ramps.

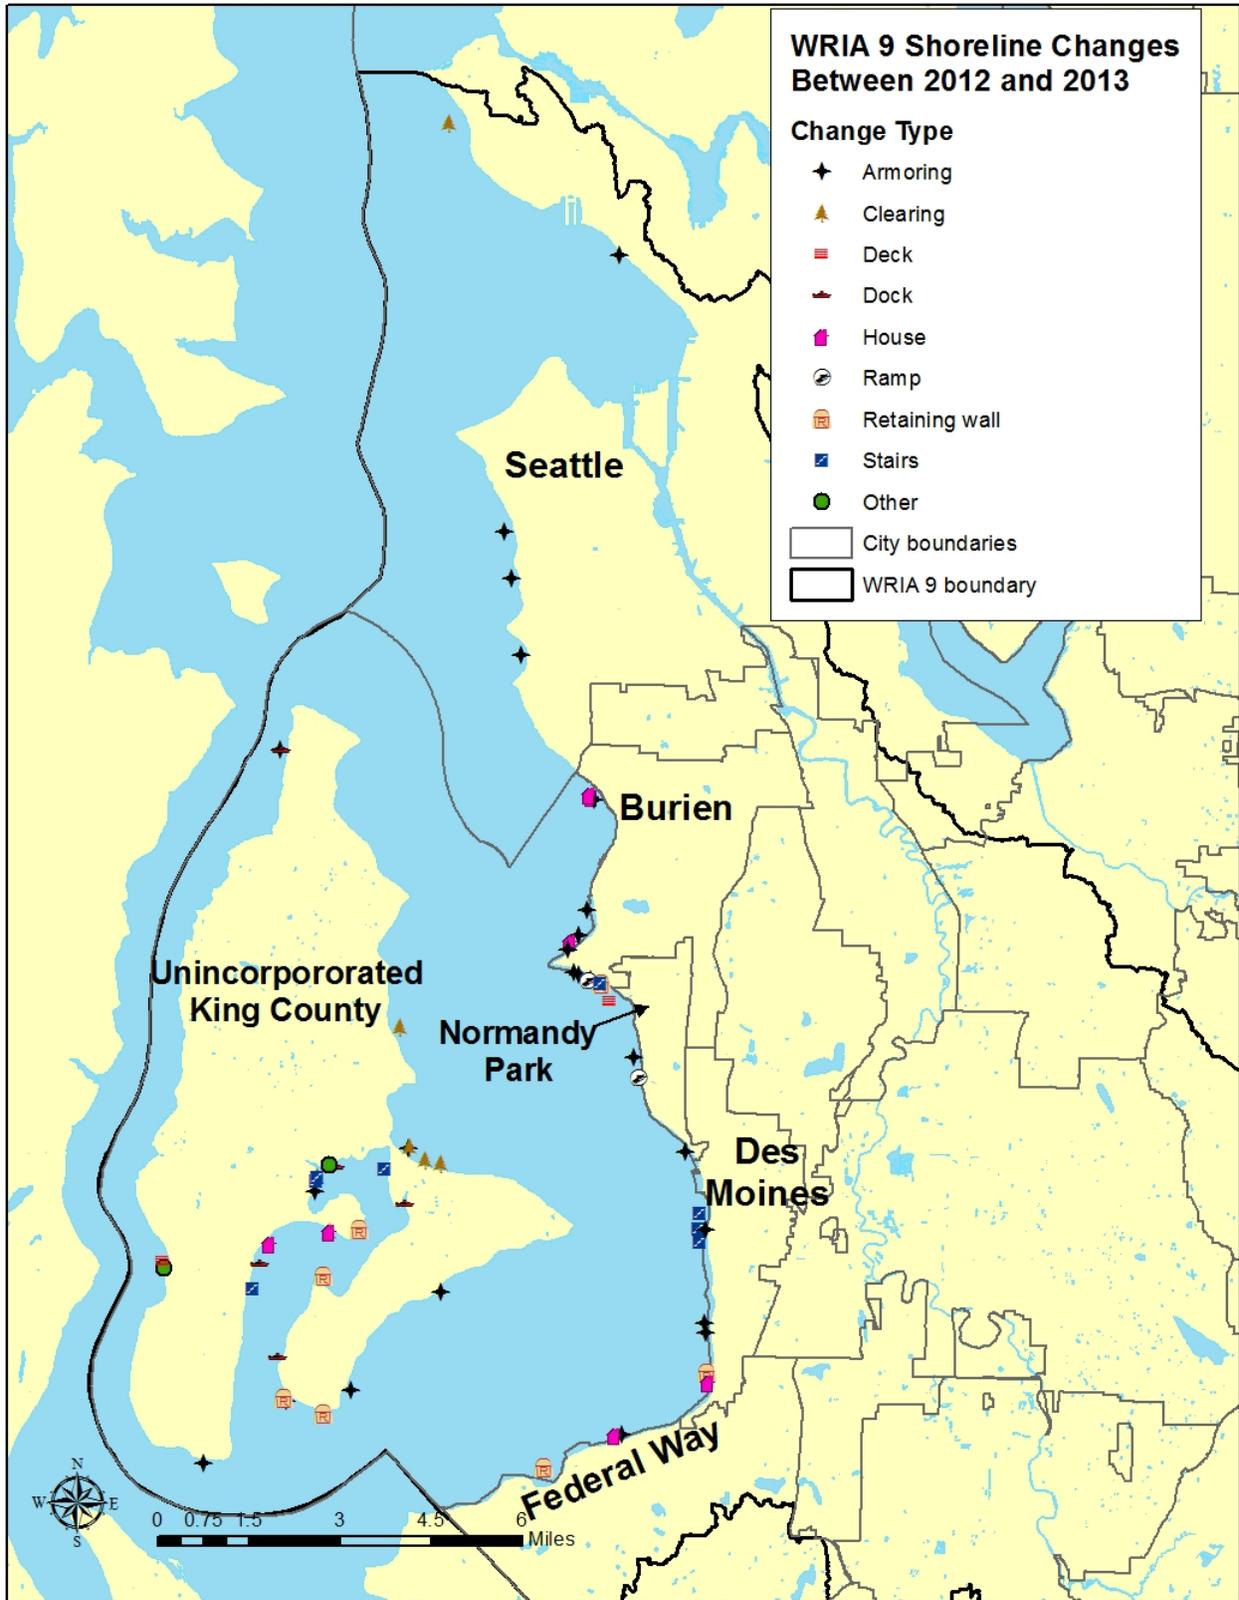
Figure 3. Locations of changes in shoreline condition in 2013.

There were 60 changes noted in shoreline condition in 2013 (see Figure 3 and Table 3). Example photographs of changes can be found in Appendix B. When establishing the approximate date of when the change occurred, it was noted that some of the changes occurred prior to the 2012 survey, but were not noted during that survey. Thirty-three percent of the changes found were associated with shoreline armoring. Increases in the proportions of new houses, clearing, and retaining walls offset the decreases in changes to shoreline armoring. Changes in shoreline armoring accounted for 24 of the changes noted. Only 2 of the 24 changes in shoreline armoring were new bulkheads where one didn't exist previously. All of the changes in overwater structures (e.g. docks and decks) occurred in unincorporated King County. There was one new dock observed in Raab's Lagoon. Two of docks had their creosote pilings replaced with steel pilings along with minor modifications to the dock footprints. As with 2012, the majority of the observations of clearing occurred in unincorporated King County.
