SITE INFORMATION

Site Identifier : AL1LB7 **Landowner Type :** Private
Site Name : **Landowner Name :**
WRIA : 03.0359X **Address :**
Region : NS **Address2 :**
Trib to : Alder Cr **City :**
River Mile : 1.20 **State :**
River System : Alder Cr **Zipcode :**
Legal Description : SE1/4S7T35NR7E **Phone :**
County : Skagit
Habitat Type : terrace tributary

Date : 02/03/1997 **Observer :** Olis **Survey Type :** initial

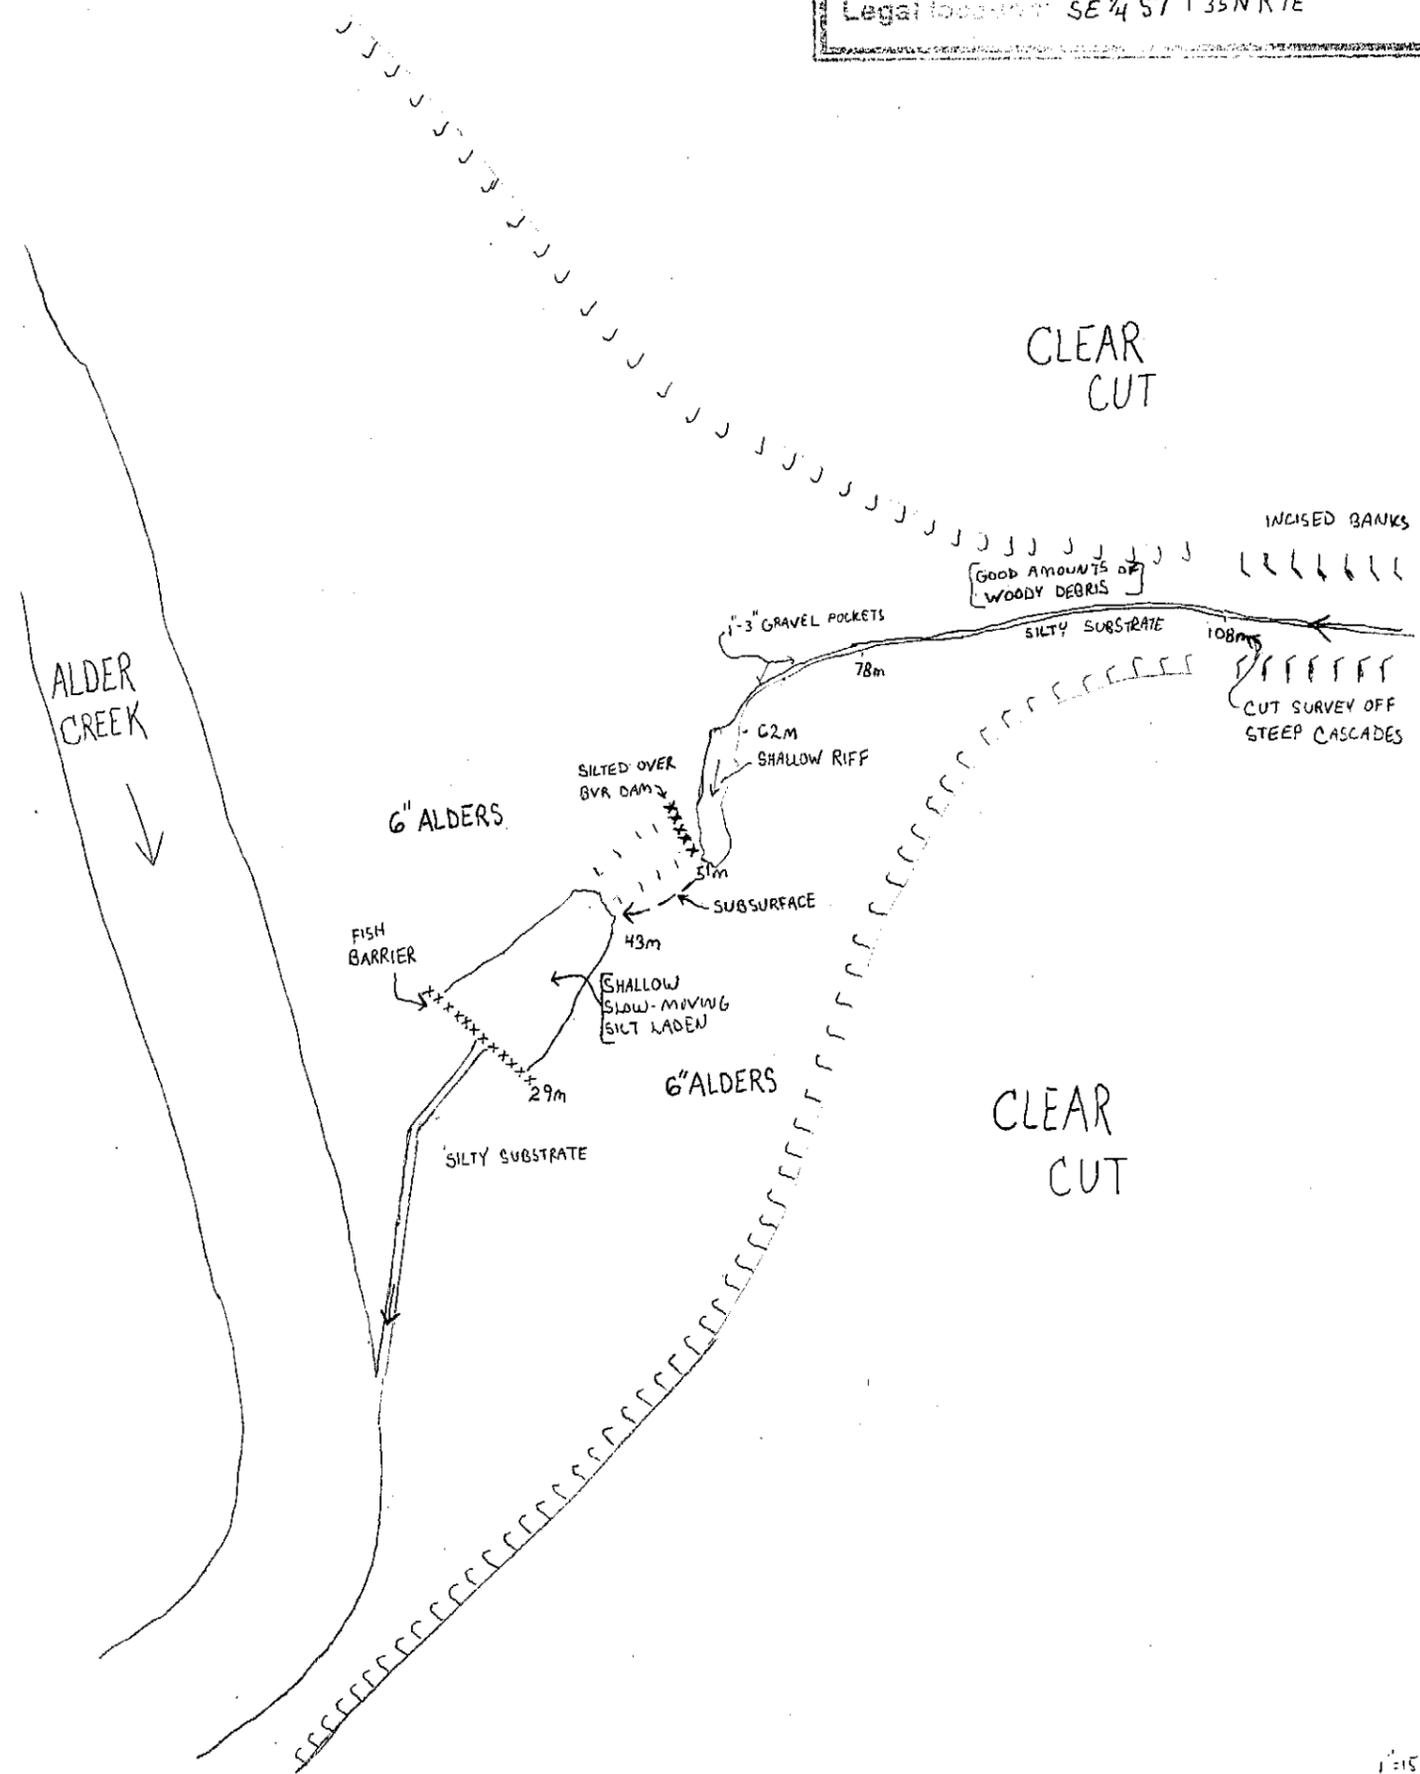
Site ID: AL1LB7
 Site name:
 Scale: 1" = 15m
 Observer: OLS
 Legal location: SE 1/4 S7 T35N R7E

This terrace trib has some beaver activity on it and appears to be surface fed. The beaver dam at 29m appears to be a fish barrier, making upstream habitat unaccessable.
