SITE INFORMATION

Site Identifier : BA1RB2 **Landowner Type :** Federal
Site Name : Zander Cr **Landowner Name :** USFS
WRIA : 03.1774X **Address :**
Region : NS **Address2 :**
Trib to : Bacon Cr **City :**
River Mile : 3.75 **State :**
River System : Bacon Cr **Zipcode :**
Legal Description : SE1/4S6T36NR11E **Phone :**
County : Skagit
Habitat Type : man-made impoundment

Field Survey Information

Date : 10/27/1997 **Observer :** Olis **Survey Type :** initial

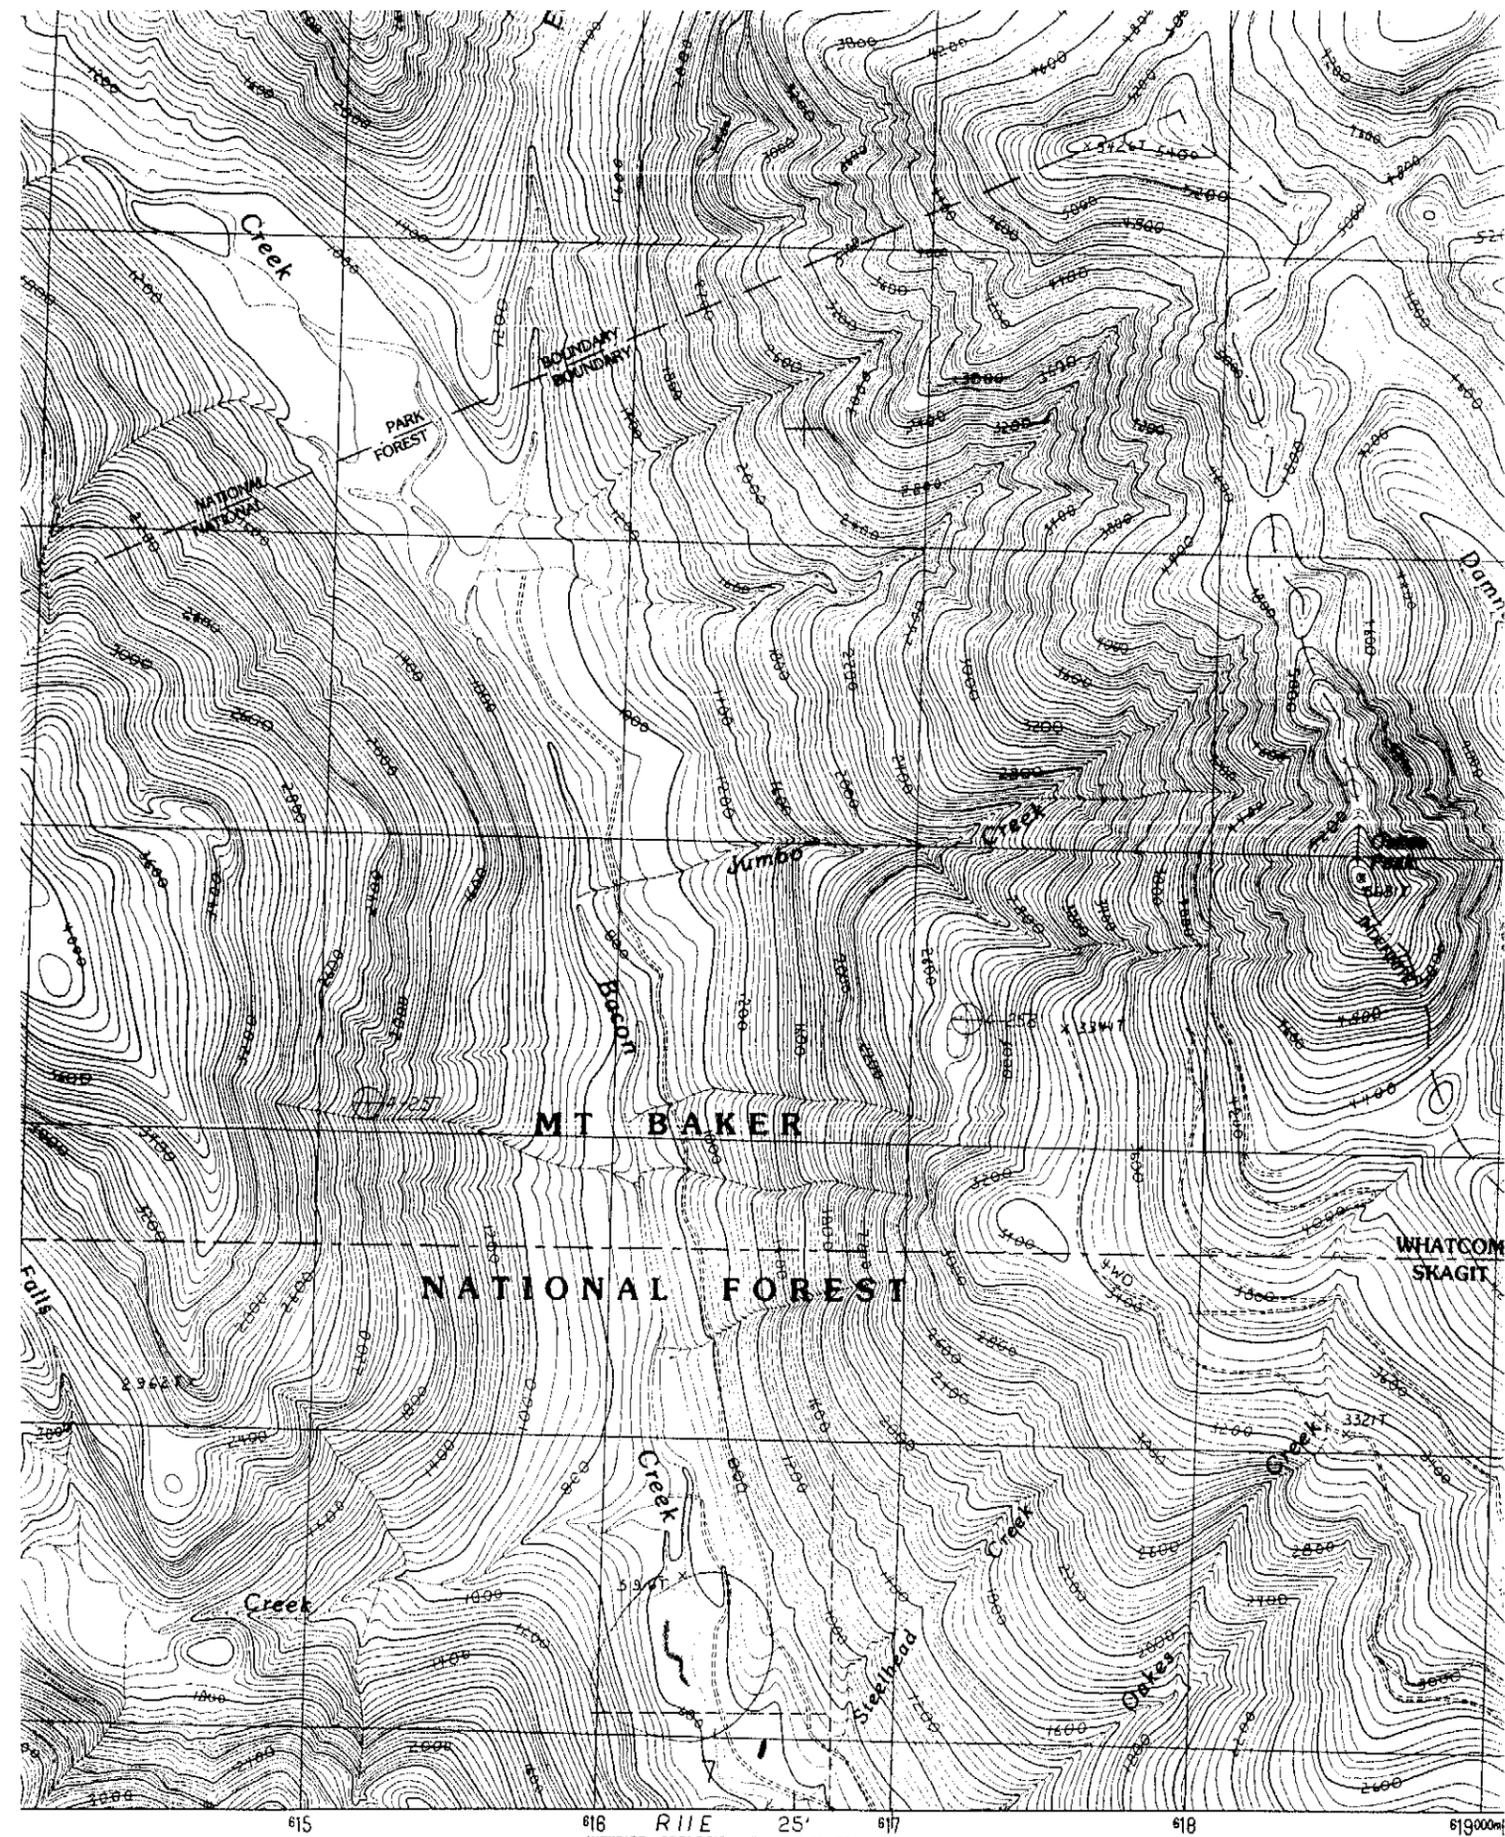
Site id. code: BA1RB2
Site name: ZANDER CREEK
Scale: 1" = 45m
Observer(s): MICHAEL OLIS
Legal location: SE 1/4 S6 T36N R11E

This is a terrace trib that has been enhanced by the Skagit System Co-op. It has two 100m long excavated channels at the head end. It also has some recent beaver activity creating more coho rearing habitat.
