**SITE INFORMATION**

**Site Identifier :** CF1LB5 **Landowner Type :** Private  
**Site Name :** **Landowner Name :**  
**WRIA :** 03.0200X **Address :**  
**Region :** NS **Address2 :**  
**Trib to :** 03.0200 **City :**  
**River Mile :** 1.50 **State :**  
**River System :** Carpenter/Fisher **Zipcode :**  
**Legal Description :** SE1/4S22T33NR4E **Phone :**  
**County :** Skagit  
**Habitat Type :** lower valley wall tributary

**Field Survey Information**

**Date :** 1/2/01 **Observer :** Olis **Survey Type :** initial

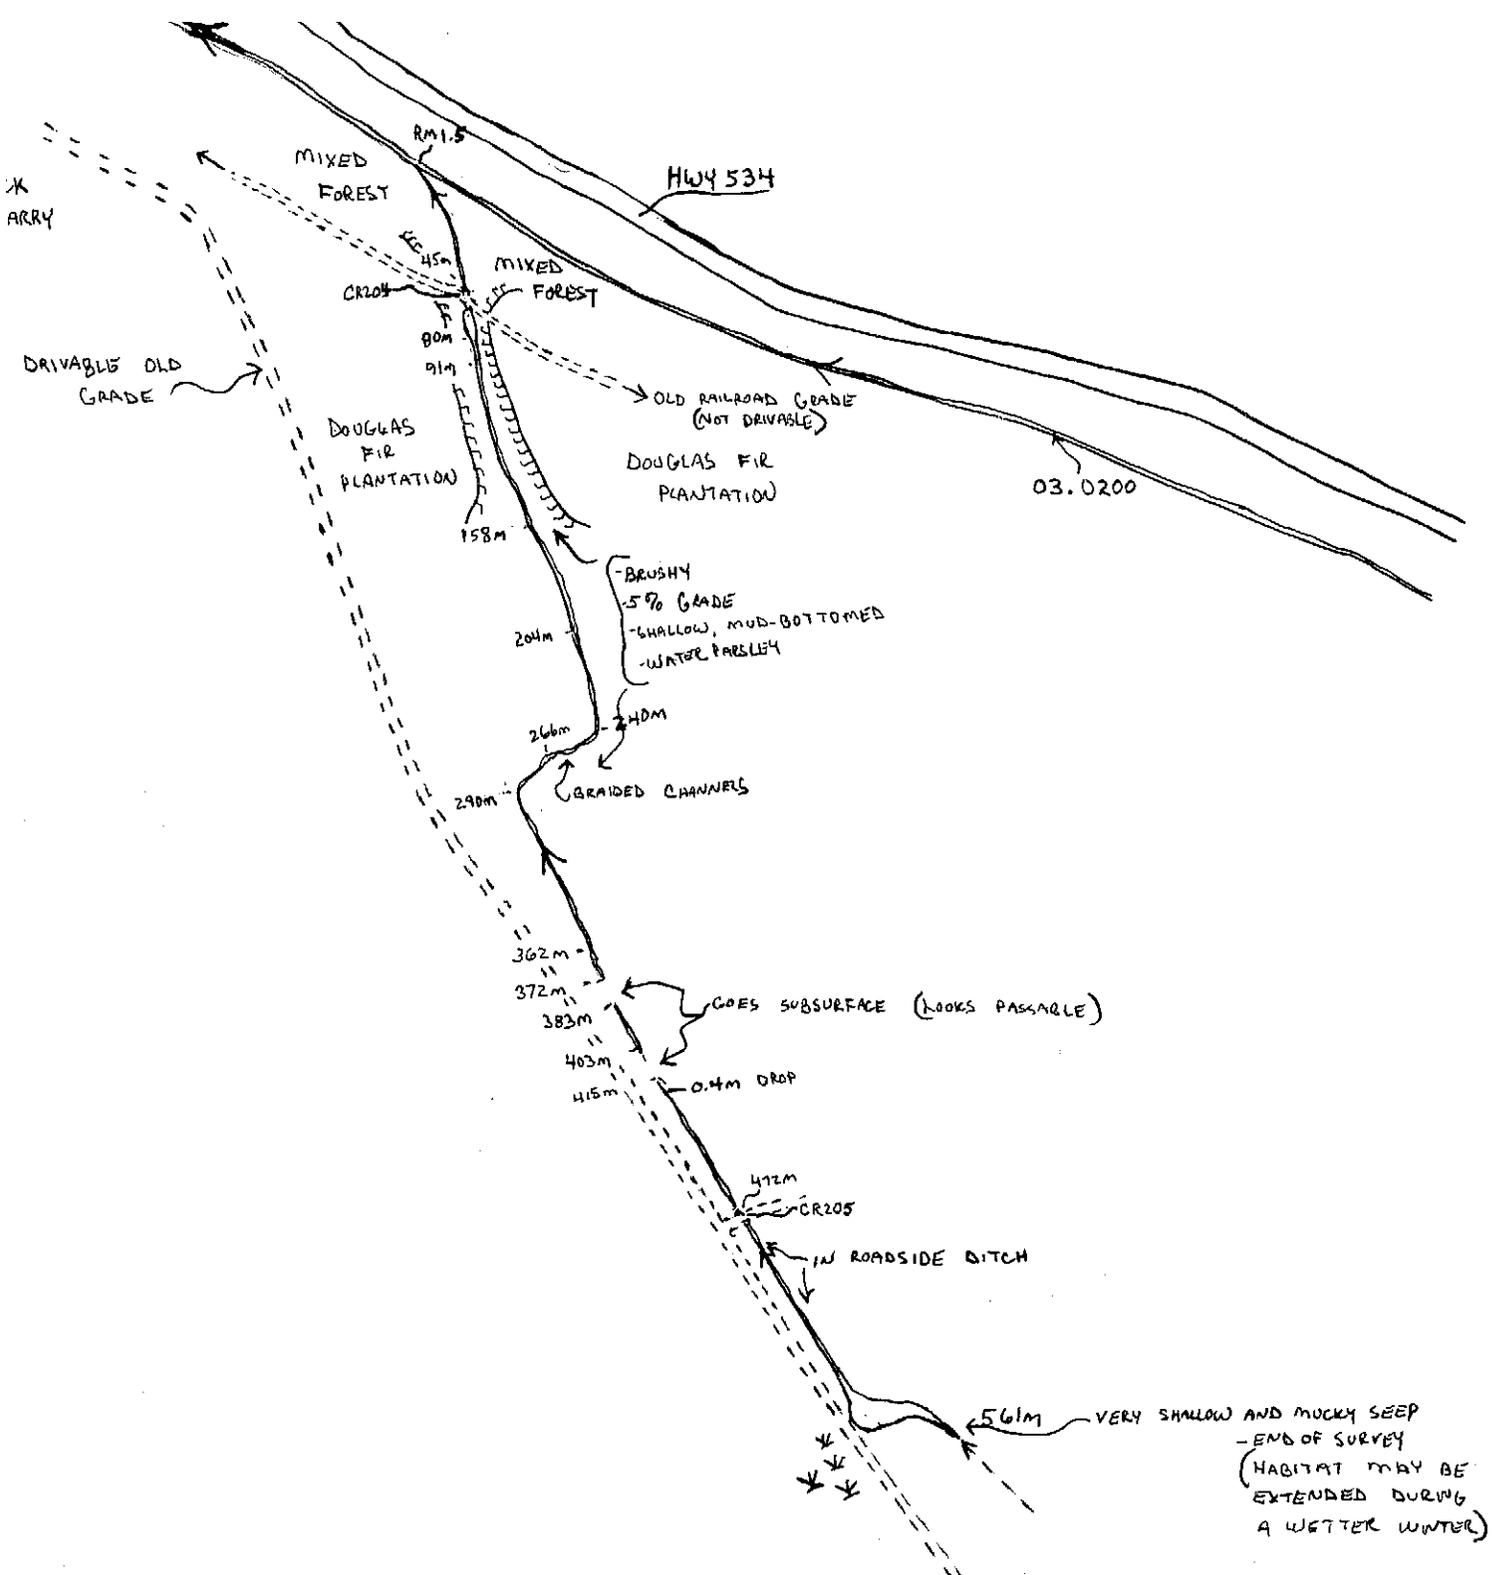
Site id. code: CF12B5  
 Site name:  
 Scale: 1" = 75m  
 Observer(s): OHS  
 Legal location: SE 1/4 S22 T33N R4E

**Area Overview :**  
 This is primarily a surface fed stream that may pick up some ground water flow along the way. It offers 561 square meters of good over-winter rearing that is partially blocked by a culvert at the 45 meter mark.

UPSTR. END RUSTED OUT

DEEP POOLS - 25% RUST

ENHANCEMENT OPPORTUNITIES: The culvert at 45 meters could be replaced to facilitate fish passage. This section of the railroad grade is abandoned and overgrown.
