SITE INFORMATION

Site Identifier : DA1LB2 **Landowner Type :** Private
Site Name : **Landowner Name :**
WRIA : 03.0299X **Address :**
Region : NS **Address2 :**
Trib to : Day Cr **City :**
River Mile : 3.00 **State :**
River System : Day Cr **Zipcode :**
Legal Description : SE1/4S33T35NR6E **Phone :**
County : Skagit
Habitat Type : beaver pond

Area Overview :

A 60m by 60m beaver pond that appears to be passable during high flows, and offers some nice over-winter rearing habitat.

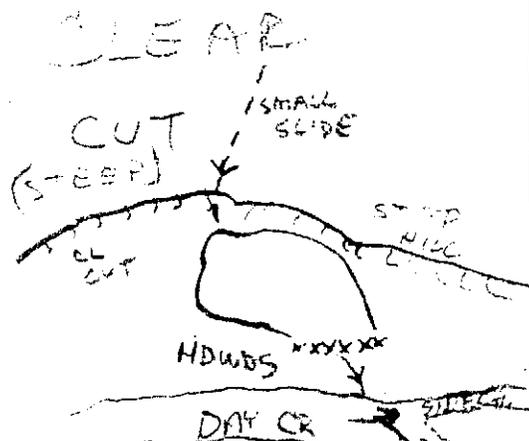
0.0 ENTRY

- FLOW - .1 CFS
- REC WTR TEMP - 41
- STREAM TEMP - 43.5
- ACCESS IS GOOD.
- 15M WW 1.5M (50/50 PH)
- SUBSTR IS MUCKY
- @ 24 M LONG BEAVER DAM - SOME WTR FLOWED AROUND DAM DURING HIGHER FLOWS, SUGGESTING THAT IT WAS PASSABLE
- THE BVA POND CREATED IS 62M X 60M W.
- MOSTLY SHALLOW (1M DEEP @ MOST)
