SITE NUMBER: ED-L4-04
LOCAL NAME: Sandy Creek
WRIA: 20.0120A

NORTH COAST OFF CHANNEL SITE INVENTORY DATA

RIVER SYSTEM: E. F. Dickey **DATE:** 3/26/91 **OBSERVER:** Nettnin

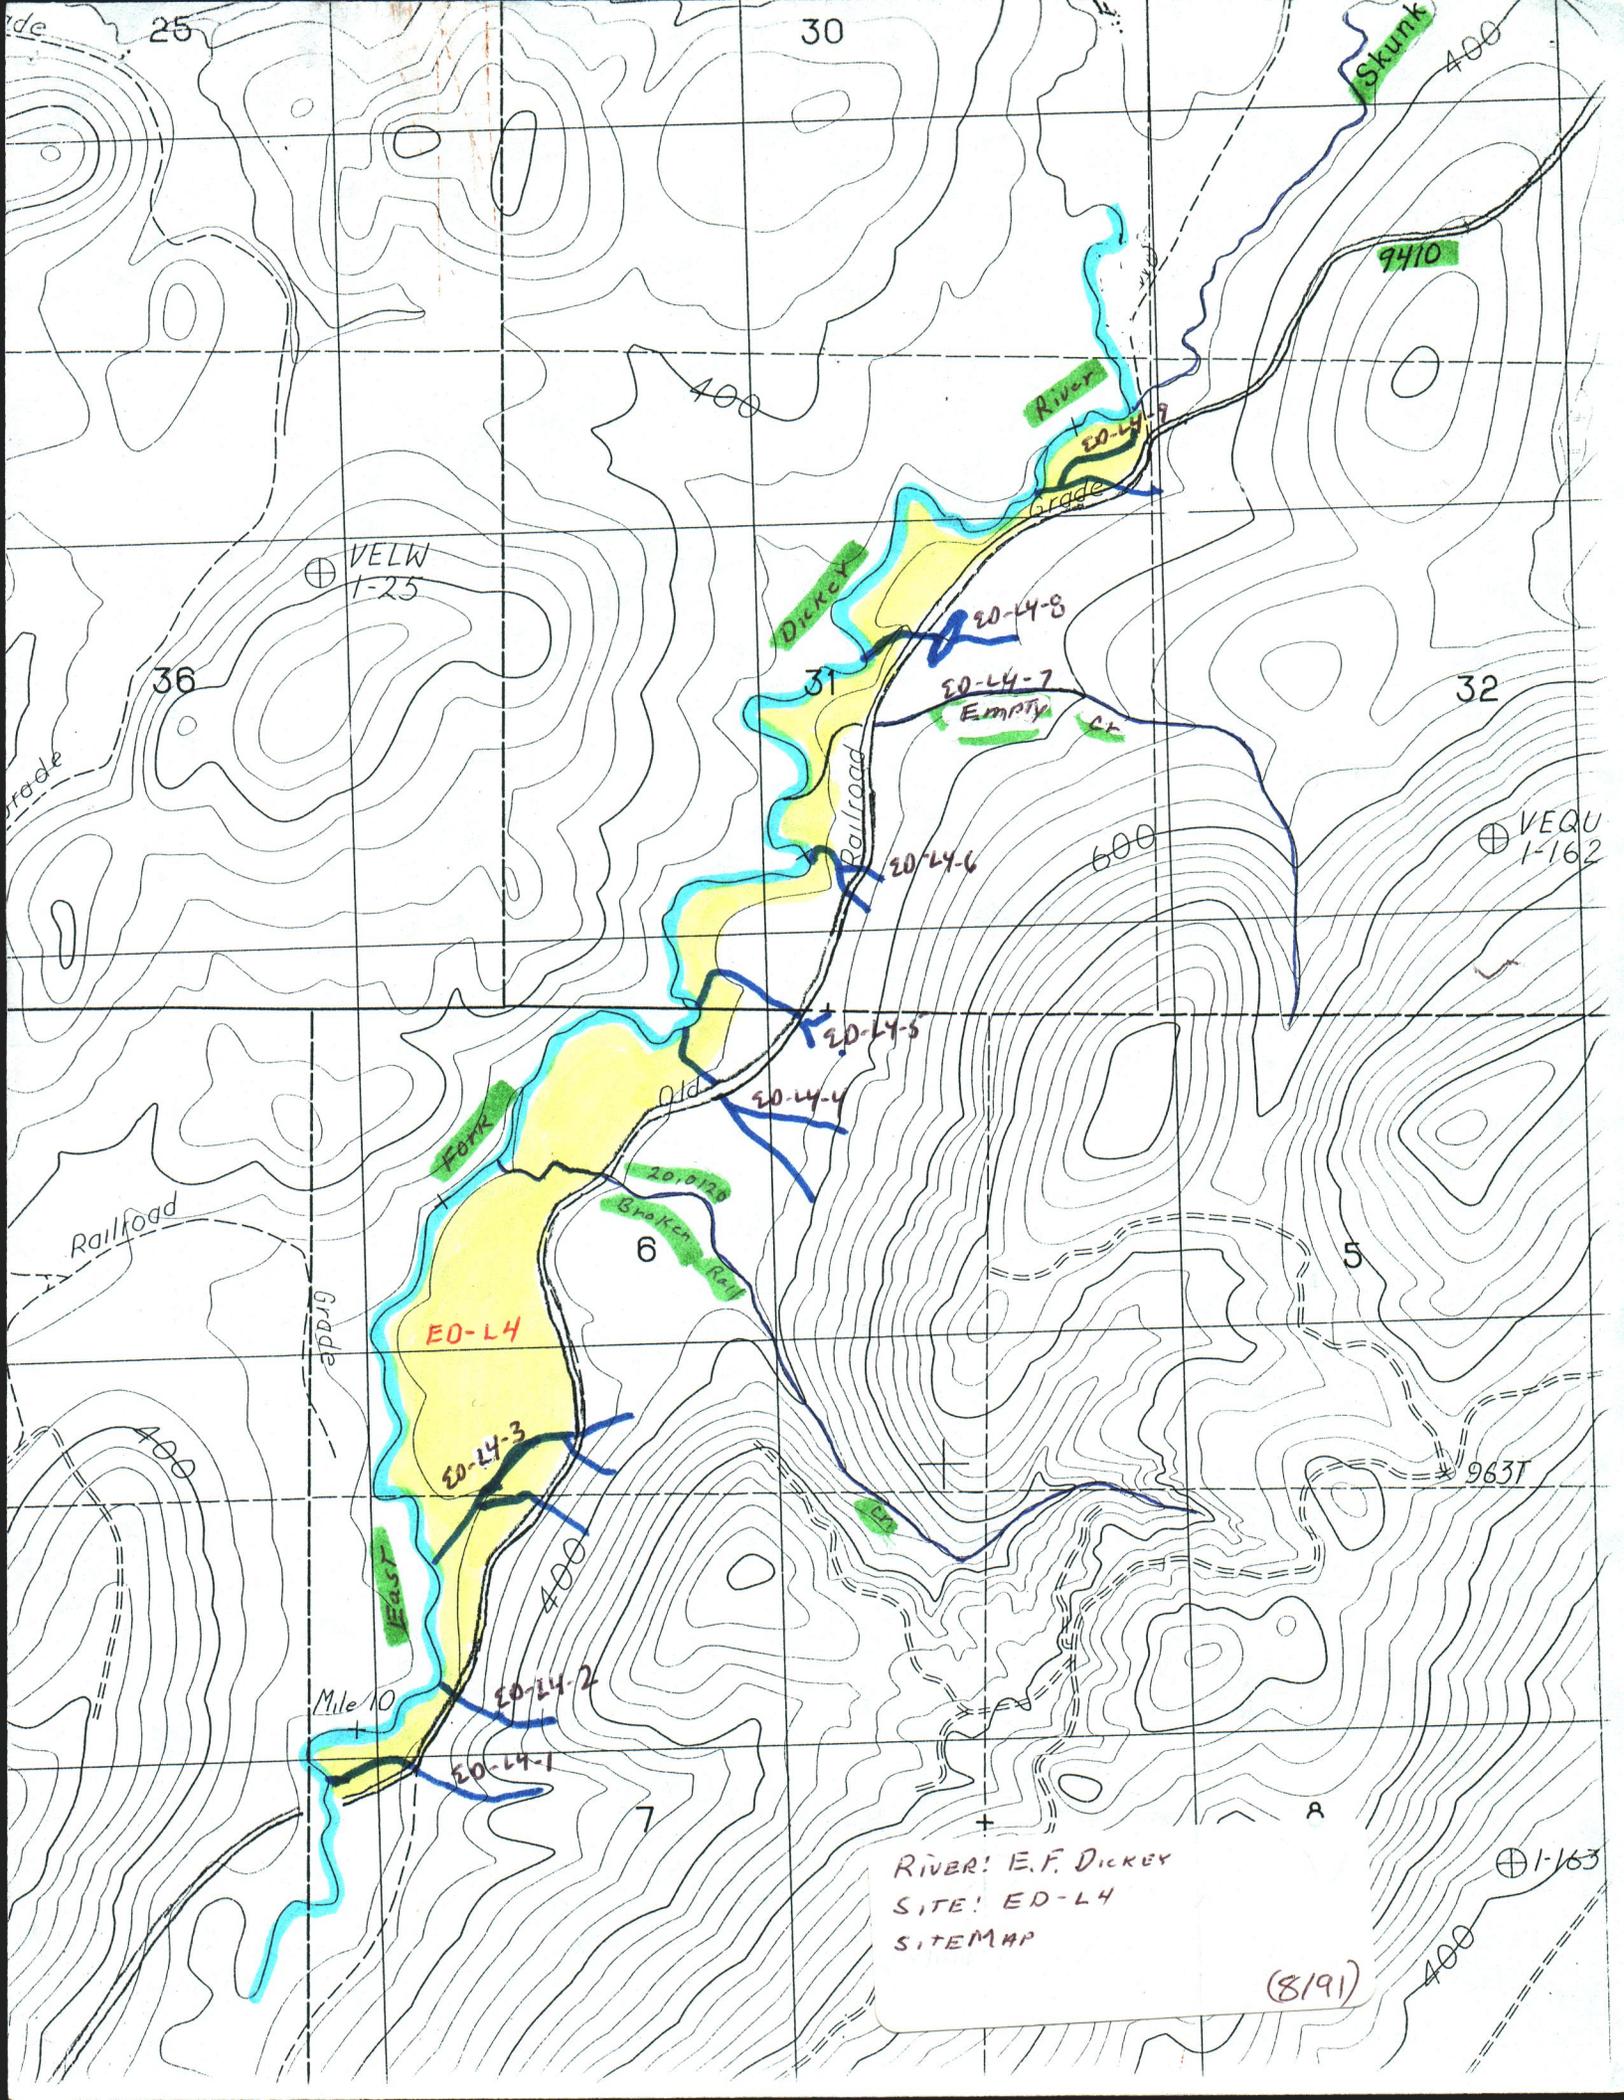
RIVER: E. F. DICKEY
 SITE: ED-14
 CHANNEL: ED-14-4
 LOCAL NAME: Sandy Creek

COMMENTS & RECOMMENDATIONS: ED-L4-04 enters the river on the outside of a hard, sweeping bend. This causes debris and bedload from the river to accumulate at the mouth of the channel. This creates only a minor fish passage problem at present and may even enhance entrance conditions at higher flows. The stream bed of ED-L4-04 appears stable. There is no indication of large bedload movements. The substrate is parent soil (clay) in the faster flowing reaches and gravel in the slower reaches. The channel of ED-L4-04 is incised 2 to 3 meters deep along the entire reach that was surveyed. About 130 m above the mouth of ED-L4-04 there is a nice looking marsh on the right bank, but outflow from this marsh enters the channel over 1.1 m fall.

The 100 m reach of ED-L4-04 above the marsh egress has the best looking rearing habitat. A smolt-sized fingerling was observed near the log jam in this reach. There may be passage problem at this jam.

- Still flowing throughout despite record dry March.
- 18" drop out of 36" CMP blocks 0+ migration above 9410 road.
- Coho fry seen throughout below 9410.
- Smolts seen in pool just below culvert and in channel just above.
- Need to improve passage at culvert by placing riprap at outlet.
- Lower and upper channel could use some controls to improve pool to riffle ratio.
