**Site Identifier :** HN1LB3 **Landowner Type :**  
**Site Name :** **Landowner Name :**  
**WRIA :** 03.0268X **Address :**  
**Region :** NS **Address2 :**  
**Trib to :** Red Cr **City :**  
**River Mile :** 0.40 **State :**  
**River System :** Hansen Cr **Zipcode :**  
**Legal Description :** NE1/4S17T35NR5E **Phone :**  
**County :** Skagit  
**Habitat Type :** man-made impoundment

**Date :** 2/18/98 **Observer :** Barkdull **Survey Type :** initial

Site id. code: HN1LB3

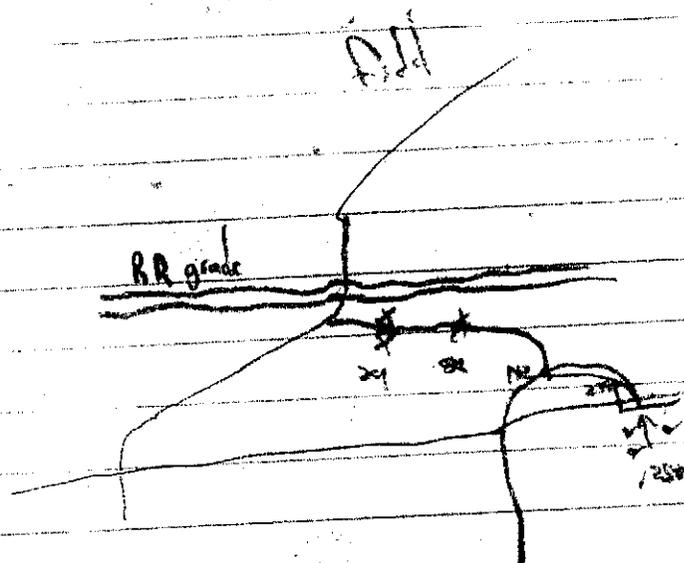
2/10/98 trip to Red cr Catch

0.0	2.5 wide	no obvious flow
209	2.5 wide	Beaver dam
88	2.5	Beaver Dam 1 gal/min flow
142	2	Red culvert
238		trib under Hwy
258		End of ditch
