**SITE INFORMATION**

**Site Identifier :** HN2RB3 **Landowner Type :** Private  
**Site Name :** **Landowner Name :**  
**WRIA :** 03.0267X **Address :**  
**Region :** NS **Address2 :**  
**Trib to :** Hansen Cr **City :**  
**River Mile :** 4.90 **State :**  
**River System :** Hansen Cr **Zipcode :**  
**Legal Description :** NE1/4S7T35NR5E **Phone :**  
**County :** Skagit  
**Habitat Type :** terrace tributary

**Field Survey Information**

**Date :** 02/11/1998 **Observer :** Olis **Survey Type :** initial

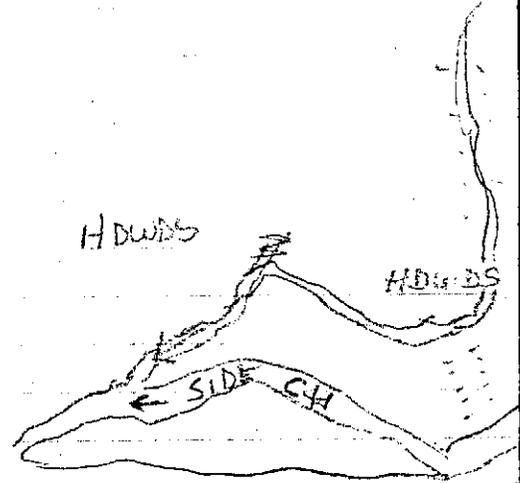
A short terrace trib that has no spawning habitat but does offer a small amount of rearing. It may be usefull as a refuge during high flows.

Describe: No fish were observed at the site. There is no spawning habitat available for adults but site is accessible to juveniles.
