Site id. code: P12RB9
 Site name:
 Scale: 1" = 35m
 Observer(s): OHS
 Legal location: NE 1/4 S8 T33N R5E

P12 RB 9

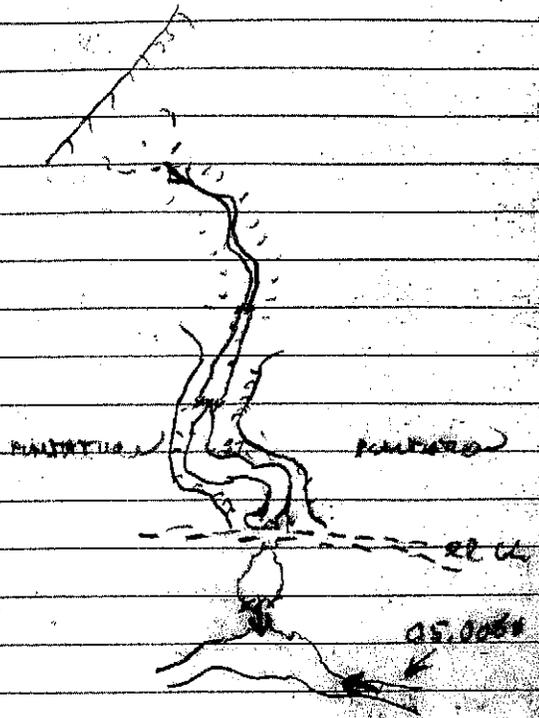
B-6-01

225m W/W 0.25m
TRICKLE
- ORIGINALS MUCKY ALGA
JUST ABOVE. - WT 42°/CO.1
COMMENTS
- GOOD REPAIRS - COLLECTS
BLOCKS ACCESS - BUL ACT.
