SITE IDENTIFIER:SU5RB1
LOCAL NAME:Slo-co channel

NORTH SOUND OFF CHANNEL SITE INVENTORY DATA

RIVER:Suiattle SURVEY DATE:7/30/94 OBSERVER:B.Barkdull

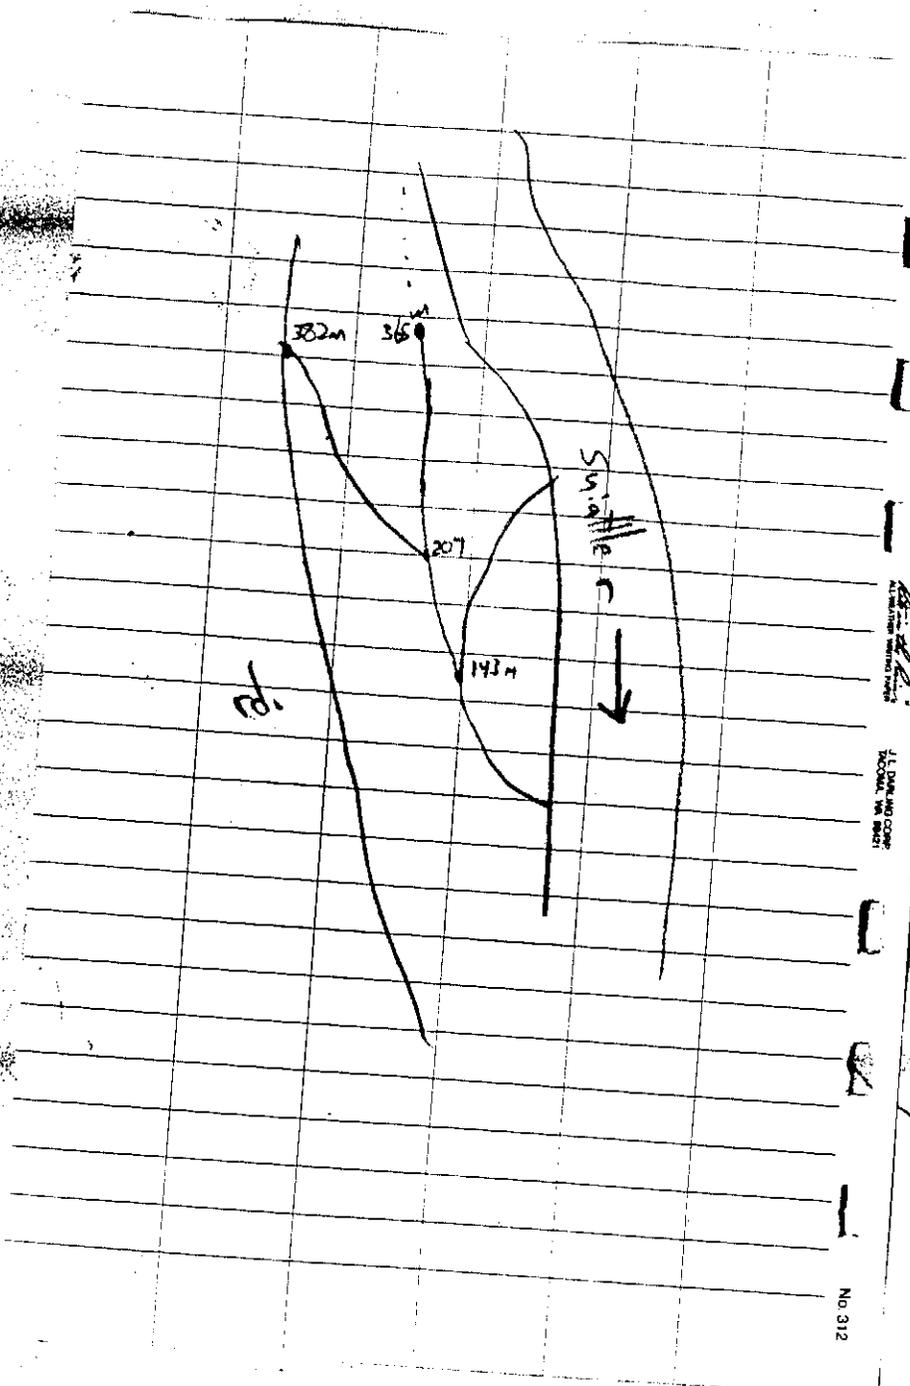
7/20/94 slo-co. ch. Survey
 estimated flow 5 gal/min temp. 56°

station	BS°	W(M)	comment
17.5	215°	30" 0.25	sn Seeded growth timber & hardwood Flood Ht. 1' above lower site
43.5	270	24" 0.6	AB 4' LB 2'
72.0	285	42" 1	
143	280	4' 1.2	Floody swale on L ^s ^{NO Flow enters}
186	255	10' 3	Now on upper branch
207	255	10' 3	channel forks, equal flow one cutthroat seen (LF)
252	270°	10' 3	3' below this, Beginning of pool
304	270°	2' 0.6	end of pool
310			end of water
365	270	0	End of proposed ch. Beyond here we get into large trees
Right fork			
0	235	2' 0.6	large trees
100	240	3' 0.9	
145	245	1' 0.3	end of water
175			to rd
