SITE INFORMATION

Site Identifier : SU6LB2 **Landowner Type :** Federal
Site Name : Pedestal Ponds **Landowner Name :** USFS
WRIA : 03.0710X **Address :**
Region : NS **Address2 :**
Trib to : Suiattle R **City :**
River Mile : 19.60 **State :**
River System : Suiattle R **Zipcode :**
Legal Description : NW1/4S19T32NR12E **Phone :**
County : Snohomish
Habitat Type : man-made impoundment

Date : 07/25/1995 **Observer :** Barkdull **Survey Type :** initial

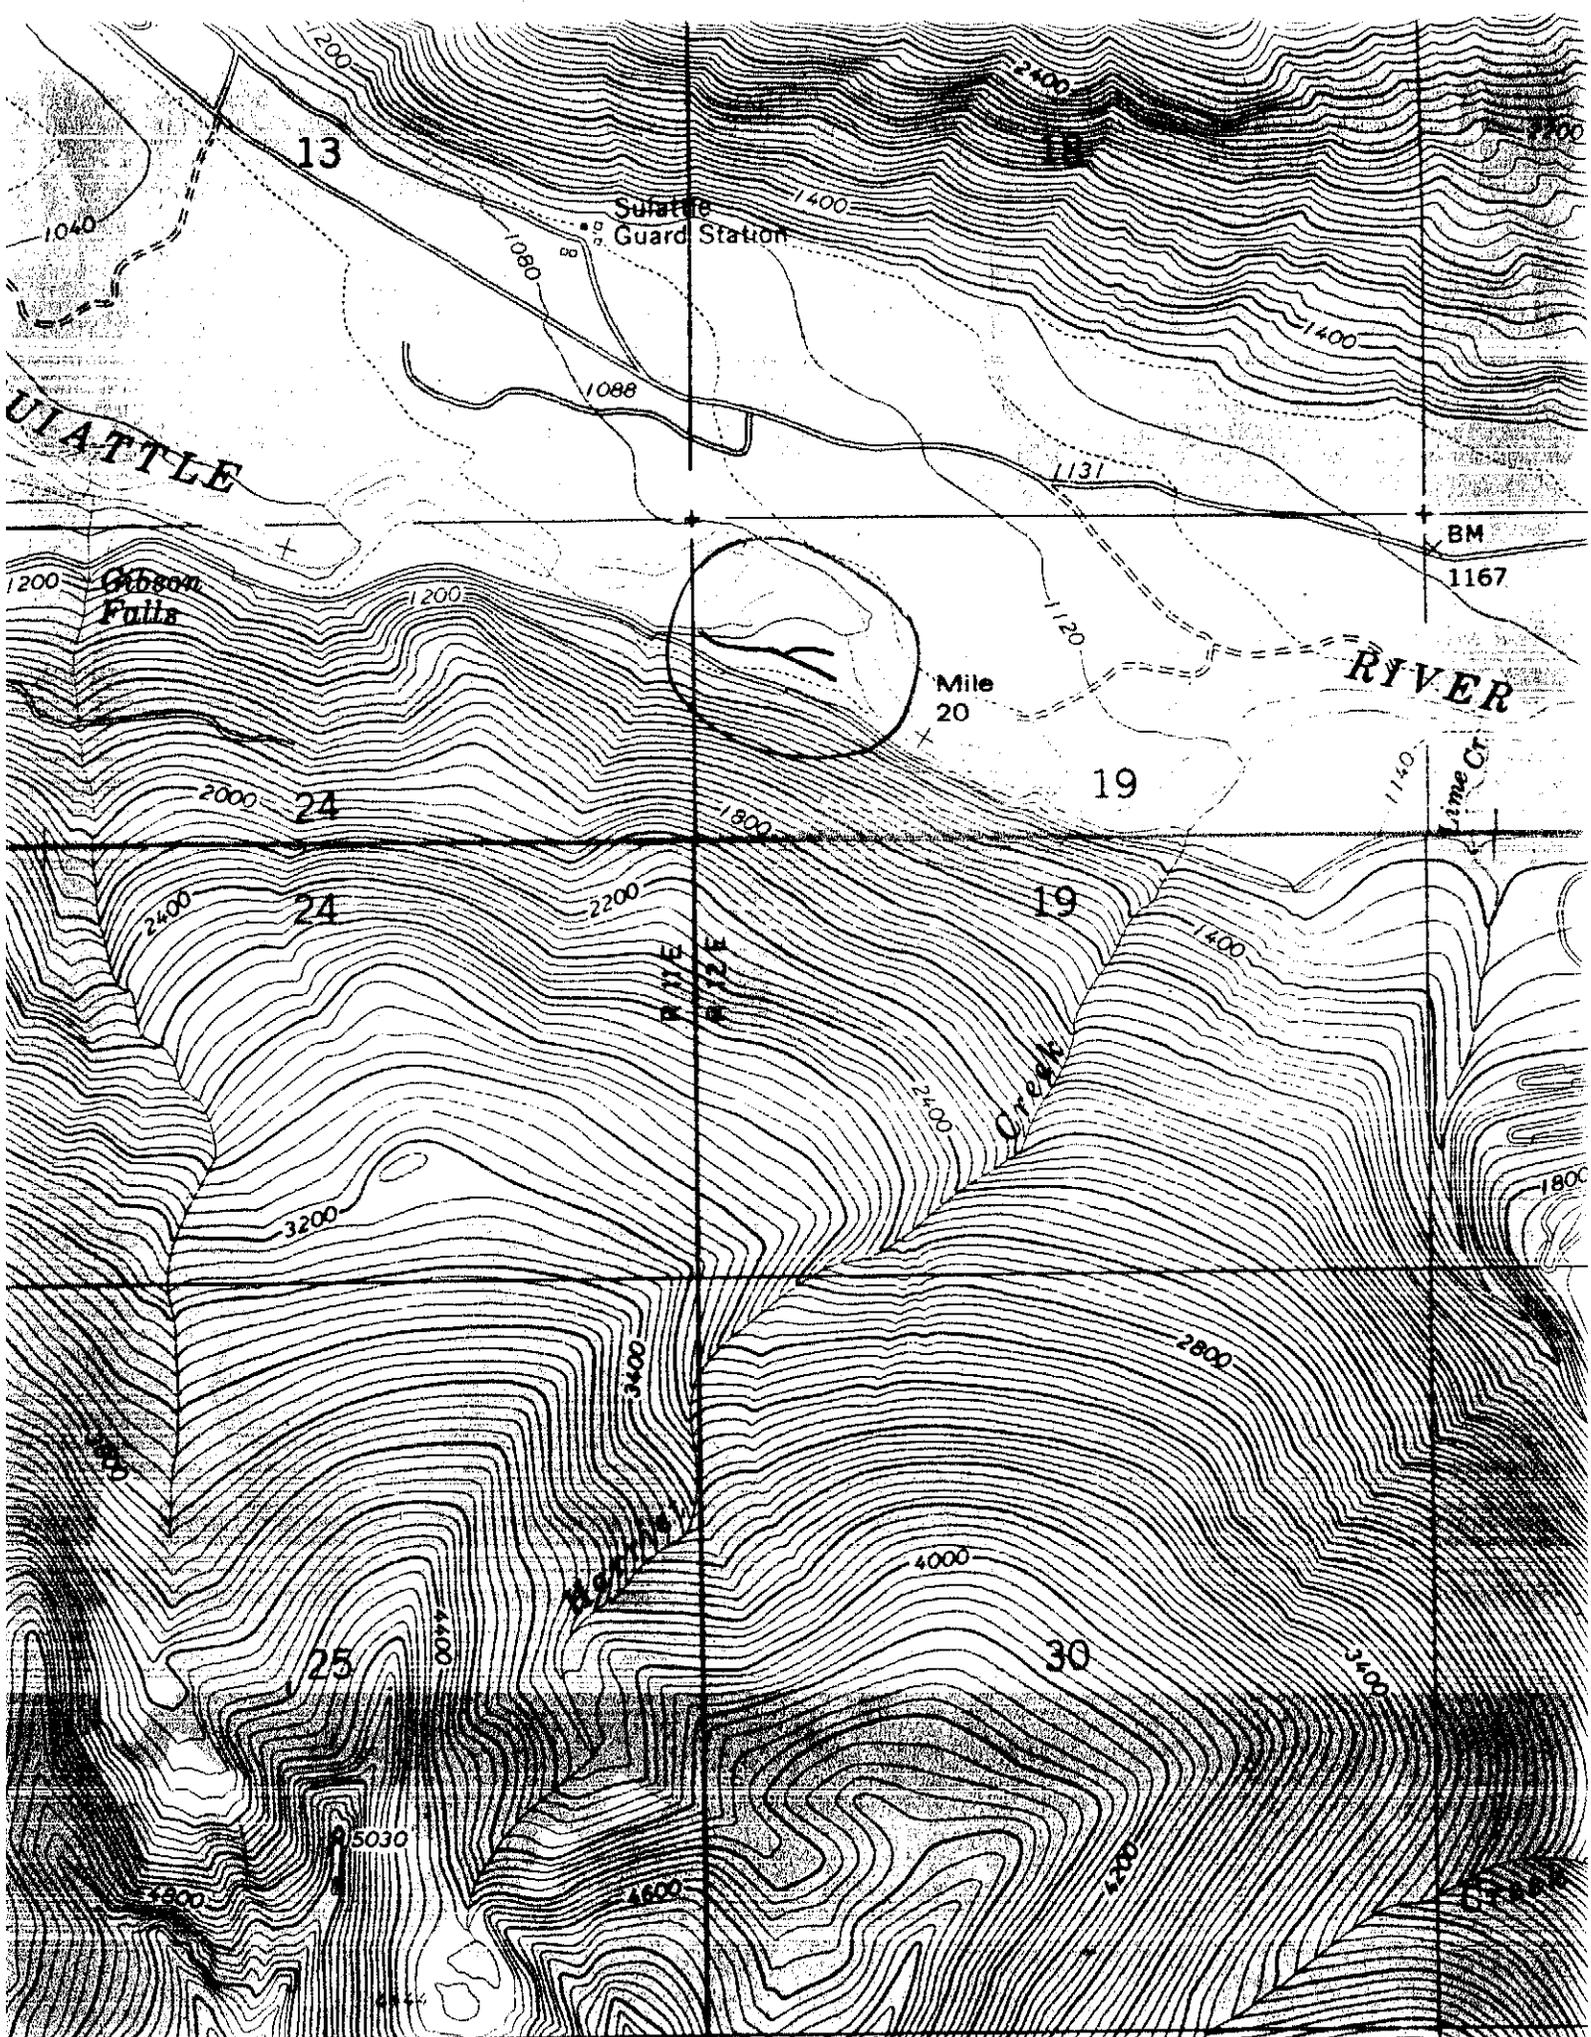
Scale 1" = 33 meters

Swattle 6 LB 2
 AM. 19.6
 NW 19 T32N R12E

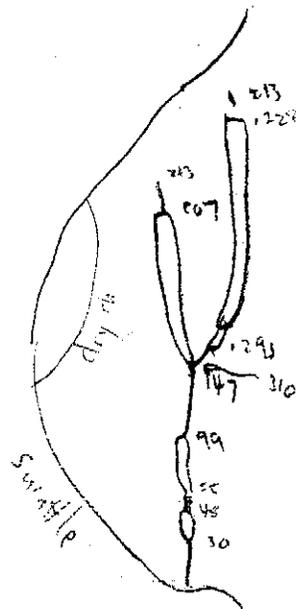
7/25/95 Pedestal pond (channel)
 0.0 4' 1.0 water parsley choked
 36.0 6' 4.6 ave. pond above patch spaw
 48.0 15' 1.6 ave. end of pond
 59.6 5' 2.7 ave. next pond
 99.0 12' 1.0 ave. pond
 147.0 6' 1.0 ave. stream/they lots parcel
 ch. split RB ch. first
 207. 15' ave. 3' deep end of pond
 213 1' ave. end of water
 heavy flooding in this fork
 213 LF from upper end
 228 ave 2' pond
 298 Ave 15' end of pond
 310 Ave 2' to forks
 Many fish in mainstem, R fork
 Lr fork few fish - poor entrance
 1/3 → 2/3 flow total 1.0 CFS
