**SITE INFORMATION**

**Site Identifier :** WN3LB1 **Landowner Type :** Private  
**Site Name :** **Landowner Name :**  
**WRIA :** 03.0227X **Address :**  
**Region :** NS **Address2 :**  
**Trib to :** Lake Cr **City :**  
**River Mile :** 12.60 **State :**  
**River System :** W F Nookachamps **Zipcode :**  
**Legal Description :** SE1/4S18T33NR5E **Phone :**  
**County :** Skagit  
**Habitat Type :** lower valley wall tributary

**Field Survey Information**

**Date :** 12/14/1998 **Observer :** Olis **Survey Type :** initial

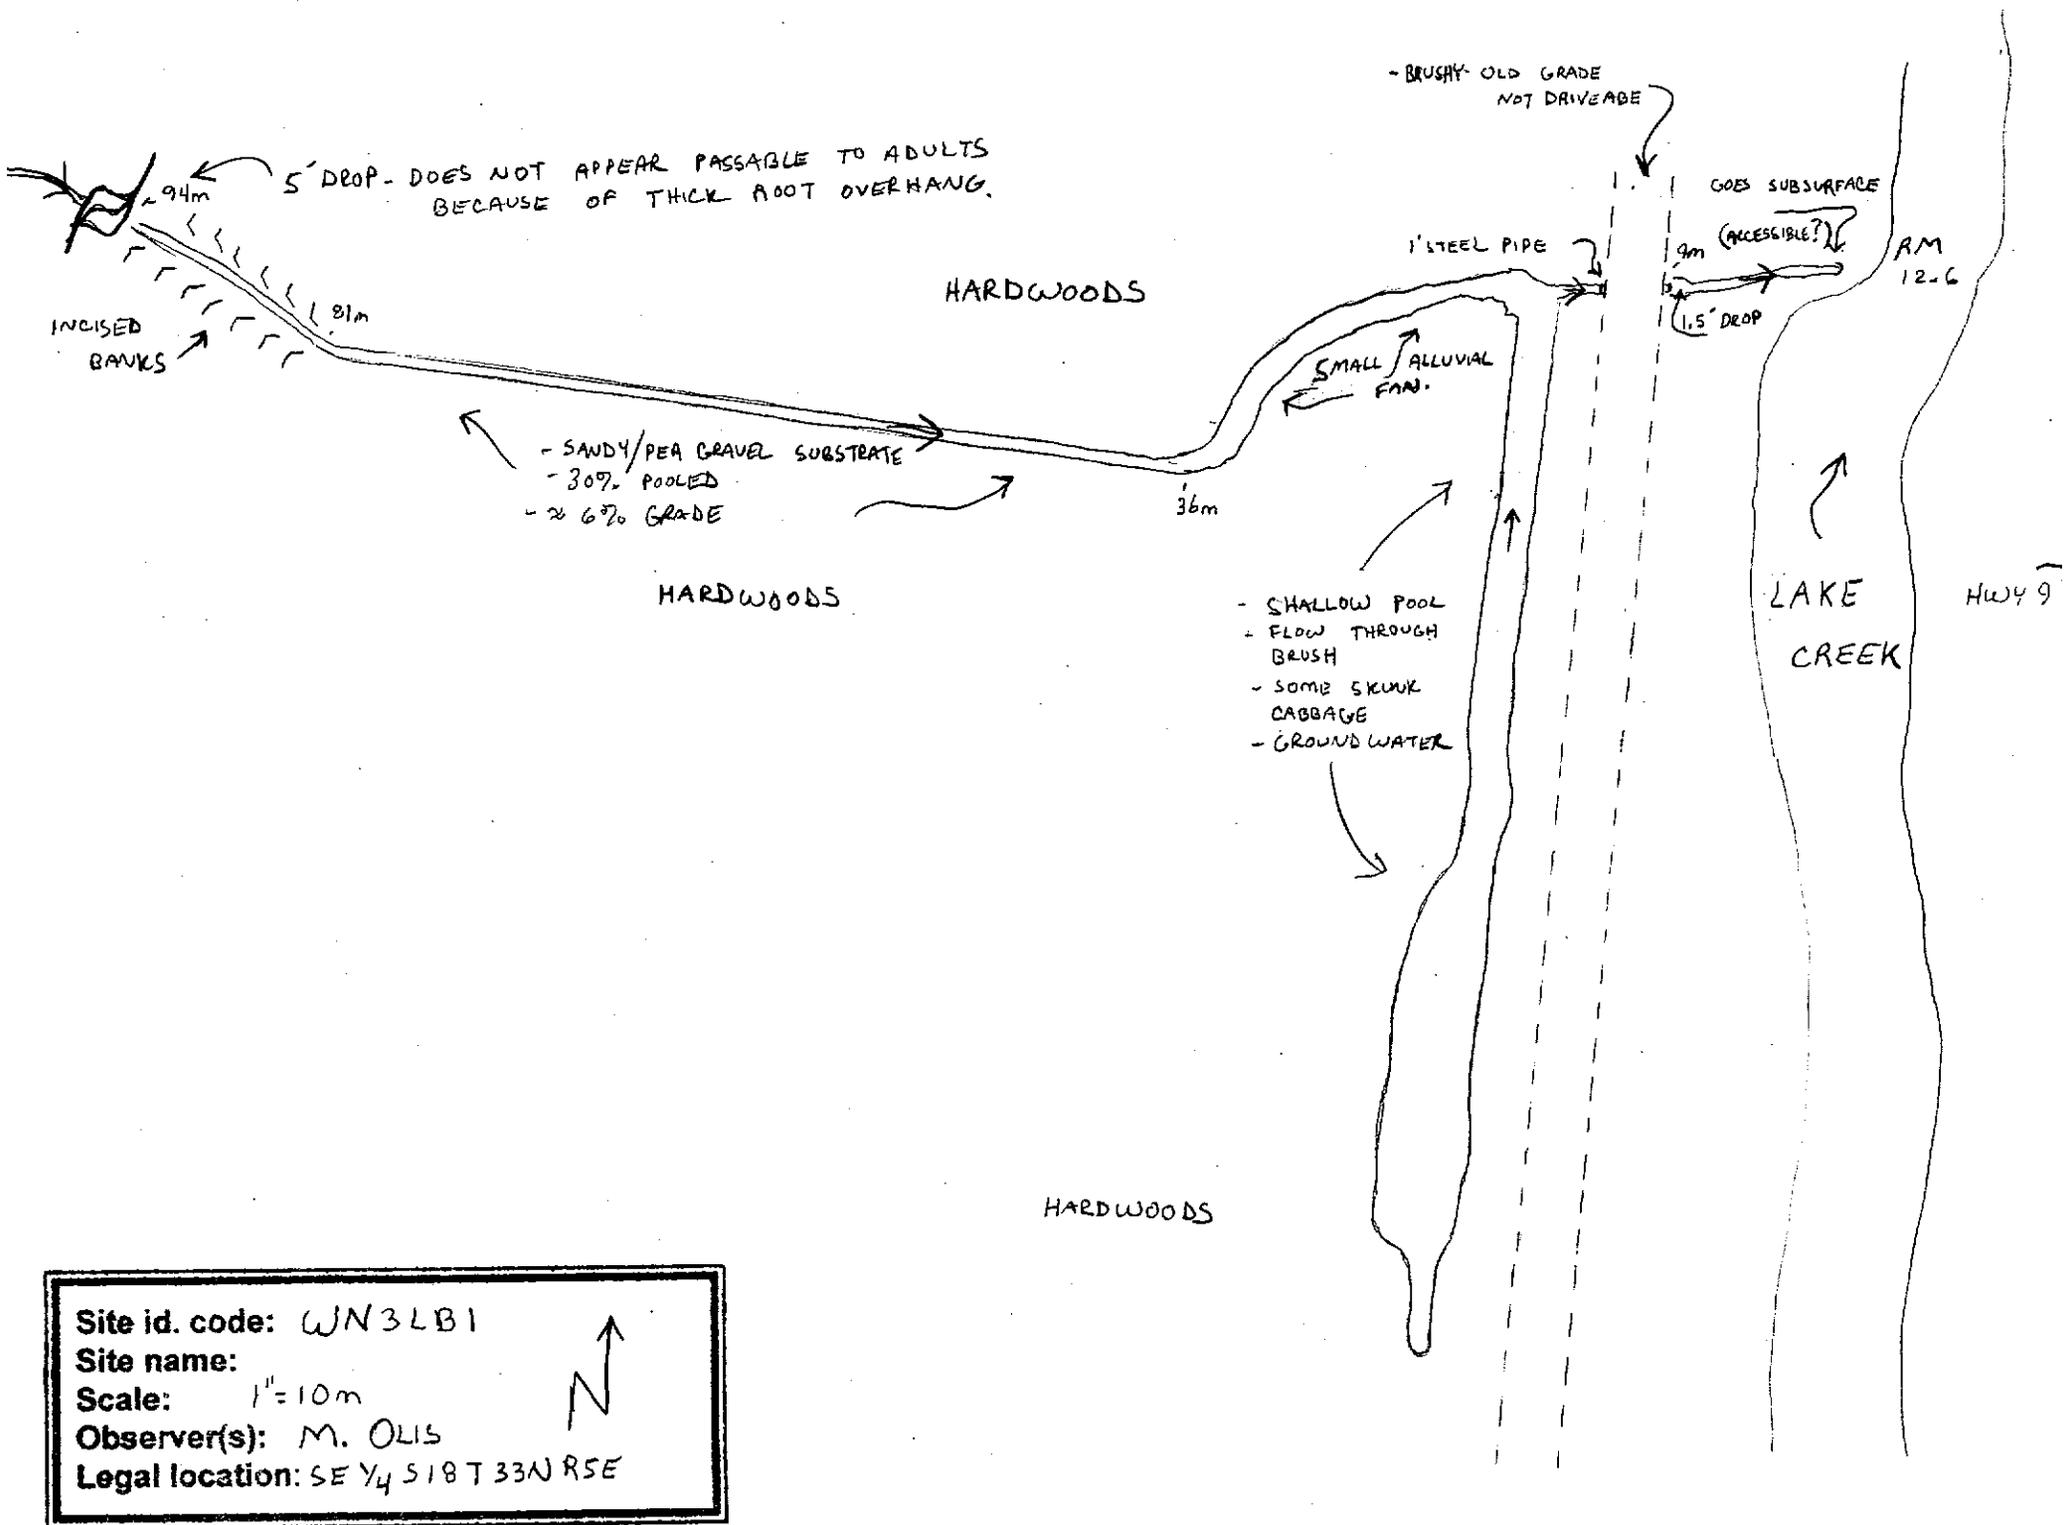
This intermittant trib does offer a small amount of good over-winter rearing habitat but it is unclear if fish can enter the site because of a subsurface connection with the mainstem. There is also a culvert at 9m that has a 1.5' drop and appears to be a barrier to juvenile migration.

Describe: It appears that there would be no adult use because of the lack of available spawning habitat. Also, it is difficult to determine if juveniles can enter the site with the subsurface connection to the mainstem that exists. Furthermore, there is a culvert at 9m that has a 1.5' drop that appears to be a barrier to juvenile passage. No fish were observed on day of the survey.
