Cowlitz Wildlife Area Fish Retrofit

Habitat Program
Salmonid Screening, Habitat Enhancement
and Restoration (SSHEAR) Section

*Washington
Department of*
**FISH and
WILDLIFE**

December 2002

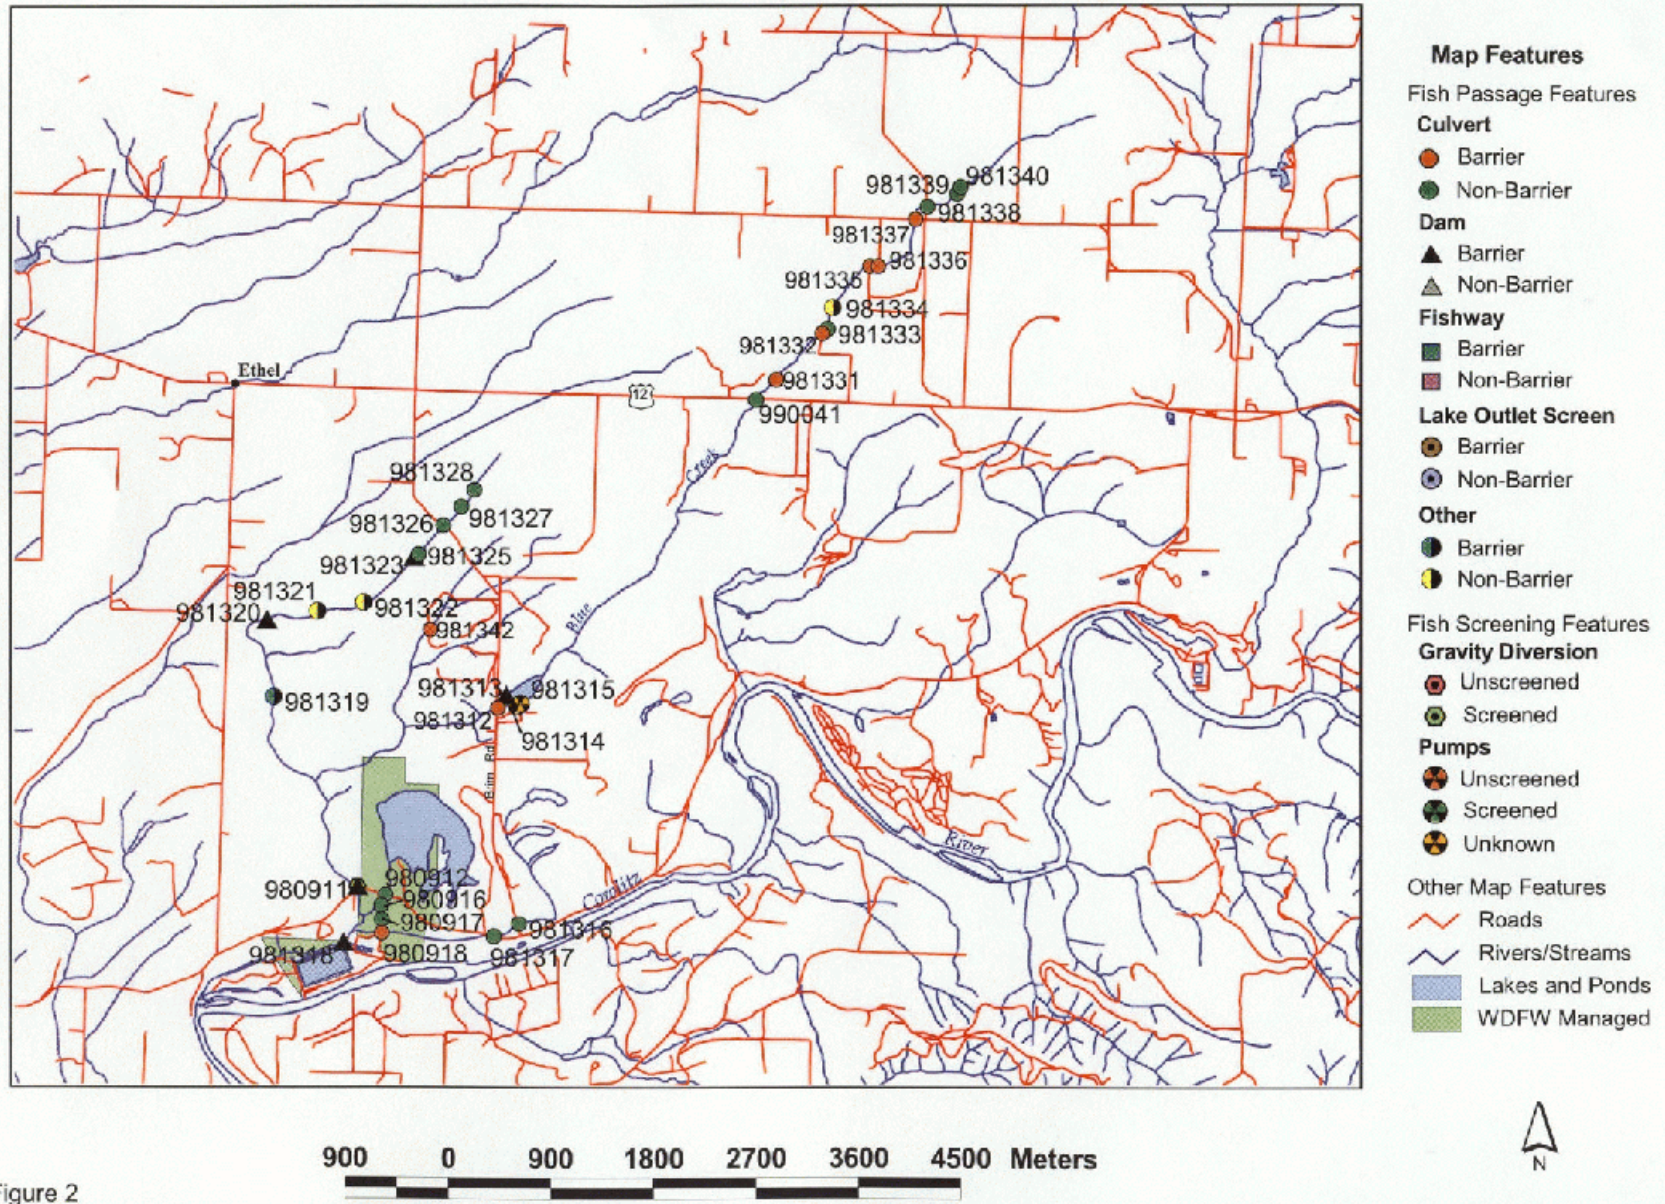
Figure 2

A total of 13 additional fish passage features and two pump diversions were identified while surveying the rest of Blue Creek. Twelve of the 13 fish passage features are either partial or total barriers. The next fish passage feature (culvert site 981312) is located 3,532 meters upstream of 980911 (Figure 2). This county owned culvert passes under Brim Road and is barrier. Another 128 meters upstream is barrier dam site 981313. This dam is privately owned and impounds a large pond (approximately 40,000 square meters). Near the downstream end and along the left bank of the pond are two pump diversions (sites 981314 and 981315). These pumps were active during the survey however, screening function is unknown due to offshore intakes.

The first tributary encountered during the upstream survey of Blue Creek was Alexander Creek. Located 305 meters upstream of the confluence, within the unit, barrier culvert site 980918 was identified (Figure 2). This site blocks access to an estimated 587.3 square meters of spawning habitat and 15,186.3 square meters of rearing habitat. Two non-barrier culverts (county owned) were identified upstream.

The third tributary enters Blue Creek well beyond the unit boundary, at 2,135 meters upstream of the Cowlitz River. Associated with this intermittent stream are 12 fish passage features. The first barrier feature (site 981319) is located approximately 1,014 meters upstream of the confluence (Figure 2). Site 981319, causing a vertical falls, was created by an old ford crossing that has been replaced with a bridge.

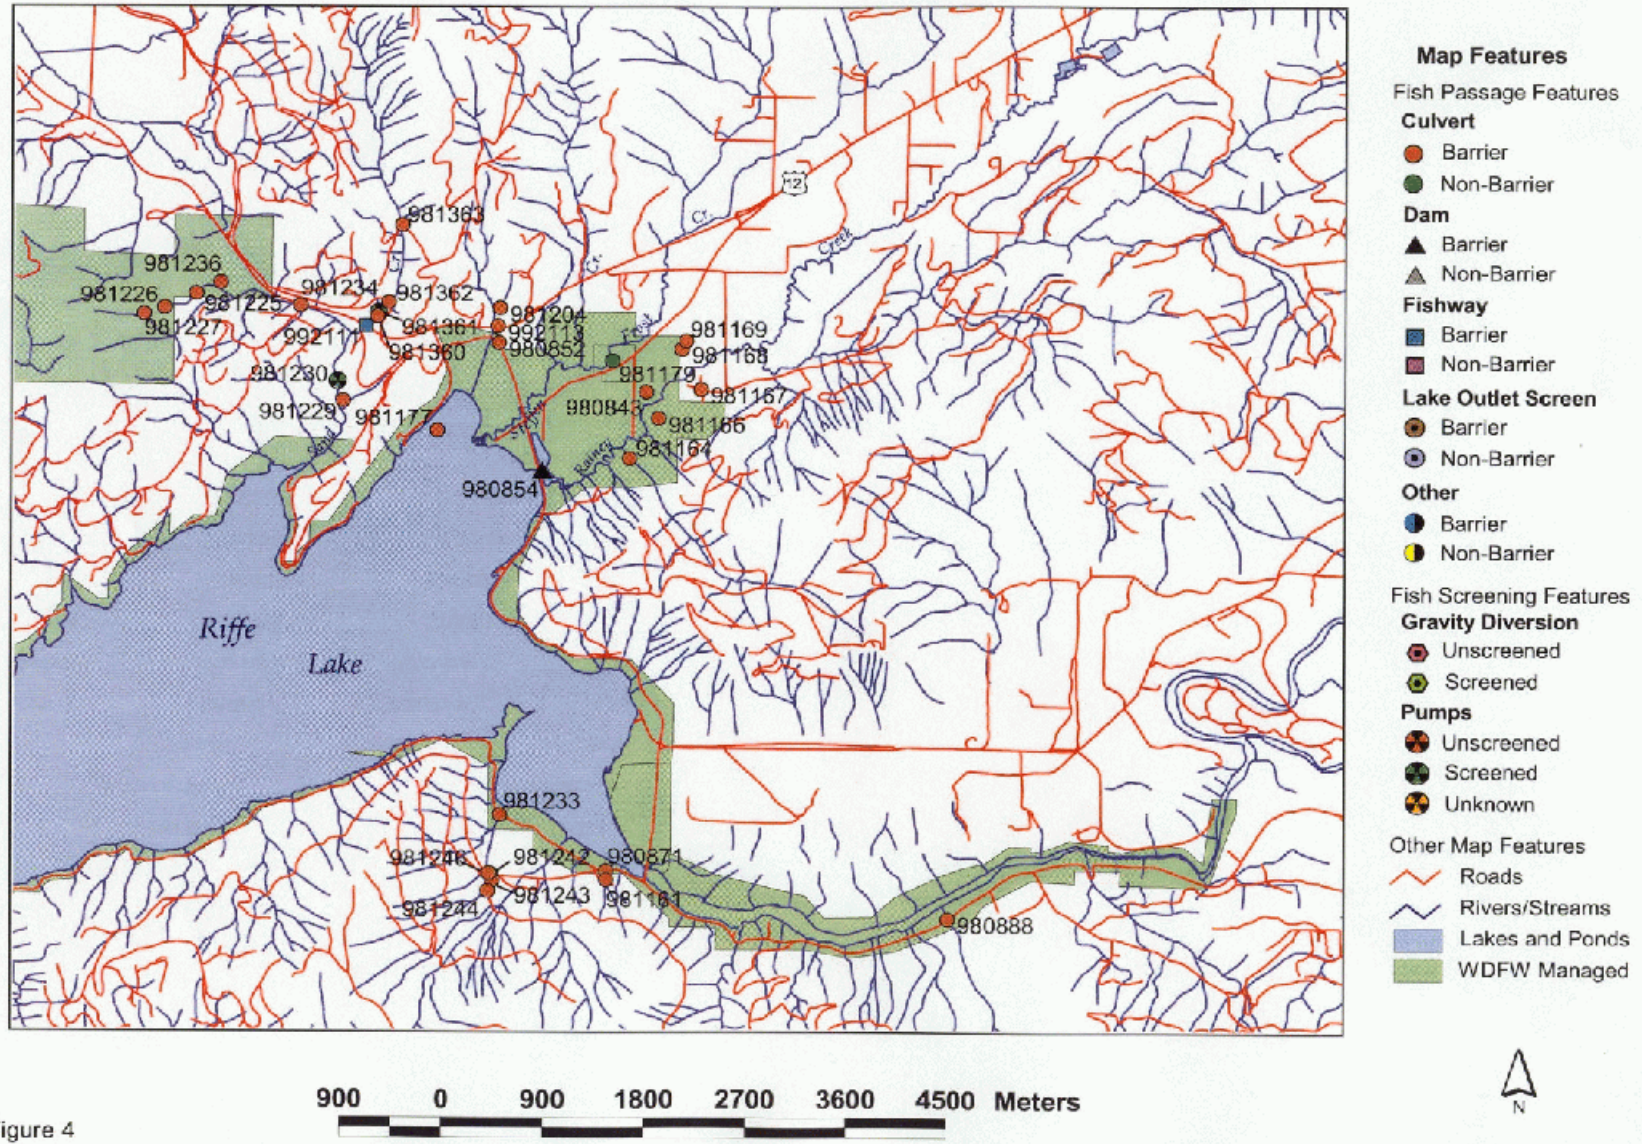
Figure 4

Beginning with the Rainey Creek drainage and on the unit, a dam (site 980854) at the mouth of a unnamed tributary to Rainey Creek was encountered immediately east of the Champion Haul road (Figure 4). This total barrier structure creates a wildlife enhancement pond (Photos 2 & 3). Located on the flood plain, the pond is fed by groundwater and is influenced by the fluctuating water levels of Riffe Lake and Rainey Creek. Should the dam be redesigned to allow for fish passage, a potential habitat gain of 19,392 square meters of rearing habitat could be realized.

Several barriers were documented on an unnamed tributary to Riffe Lake, which flows through the northwest portion of the unit near the Kosmos boat launch (Figure 4). During the winter months when Riffe Lake is lowered, this stream actually enters the lake bed channel of Steffen Creek.

Starting the survey from the confluence with Steffen Creek and within the unit, culverts 981177 and 980852 were evaluated. Washington State Department of Transportation culvert 992113 and private culvert 981204 were identified beyond the unit. All features just described are barriers, which require repair. The potential habitat gain associated with this unnamed stream drainage amounts to 591.9 square meters and 3,135.3 square meters of spawning and rearing habitat, respectively.

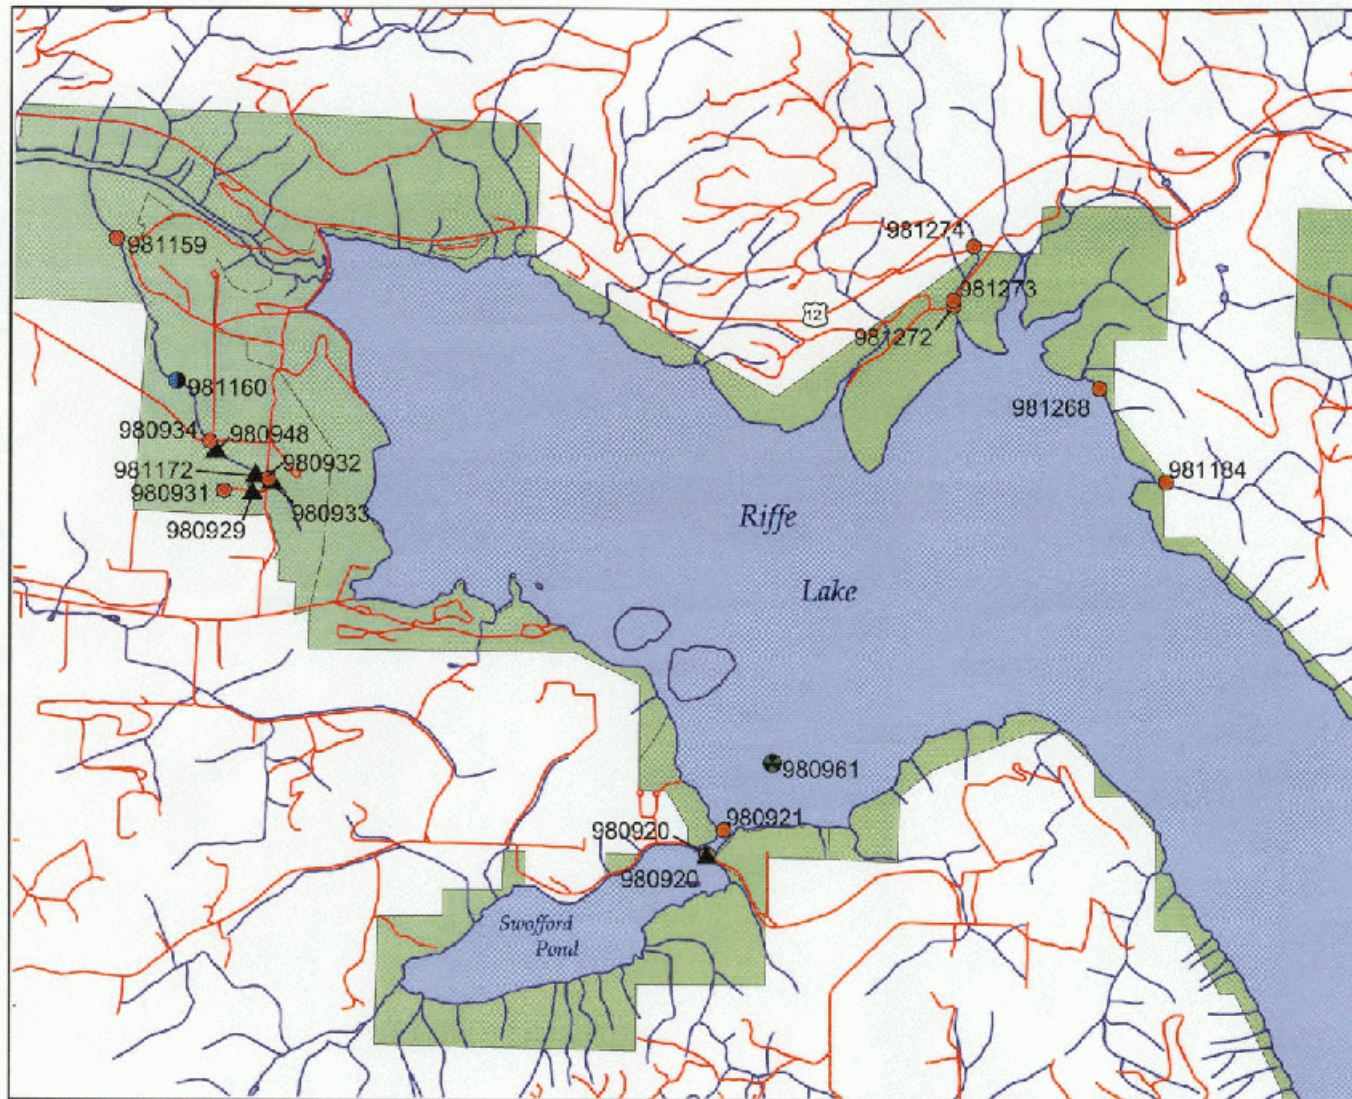
Figure 5

There is one unnamed stream that flows through the unit and enters the Cowlitz River a short distance downstream of the Mossyrock dam (Figure 5).

Sites 981172, 980929, and 980931 are associated with a left bank tributary which enters the main stream approximately 2,453 meters upstream of the Cowlitz River (Figure 5). Dam site 981172 is located at the confluence. The impoundment of the dam extends 107 meters upstream to dam site 980929. Both sites are total barriers and block fish passage to approximately 1,644.3 square meters of rearing habitat. Culvert site 980931 will not require repair at this time, due to an insignificant habitat gain upstream.

Further west along the shoreline, barrier culvert site 981184 was identified on another small, unnamed stream (Figure 5). Located approximately 80 m upstream of the lakes' ordinary high water elevation, and requiring repair, this culvert blocks fish passage to approximately 287.1 square meters and 706.4 square meters of potential spawning and rearing habitat, respectively.

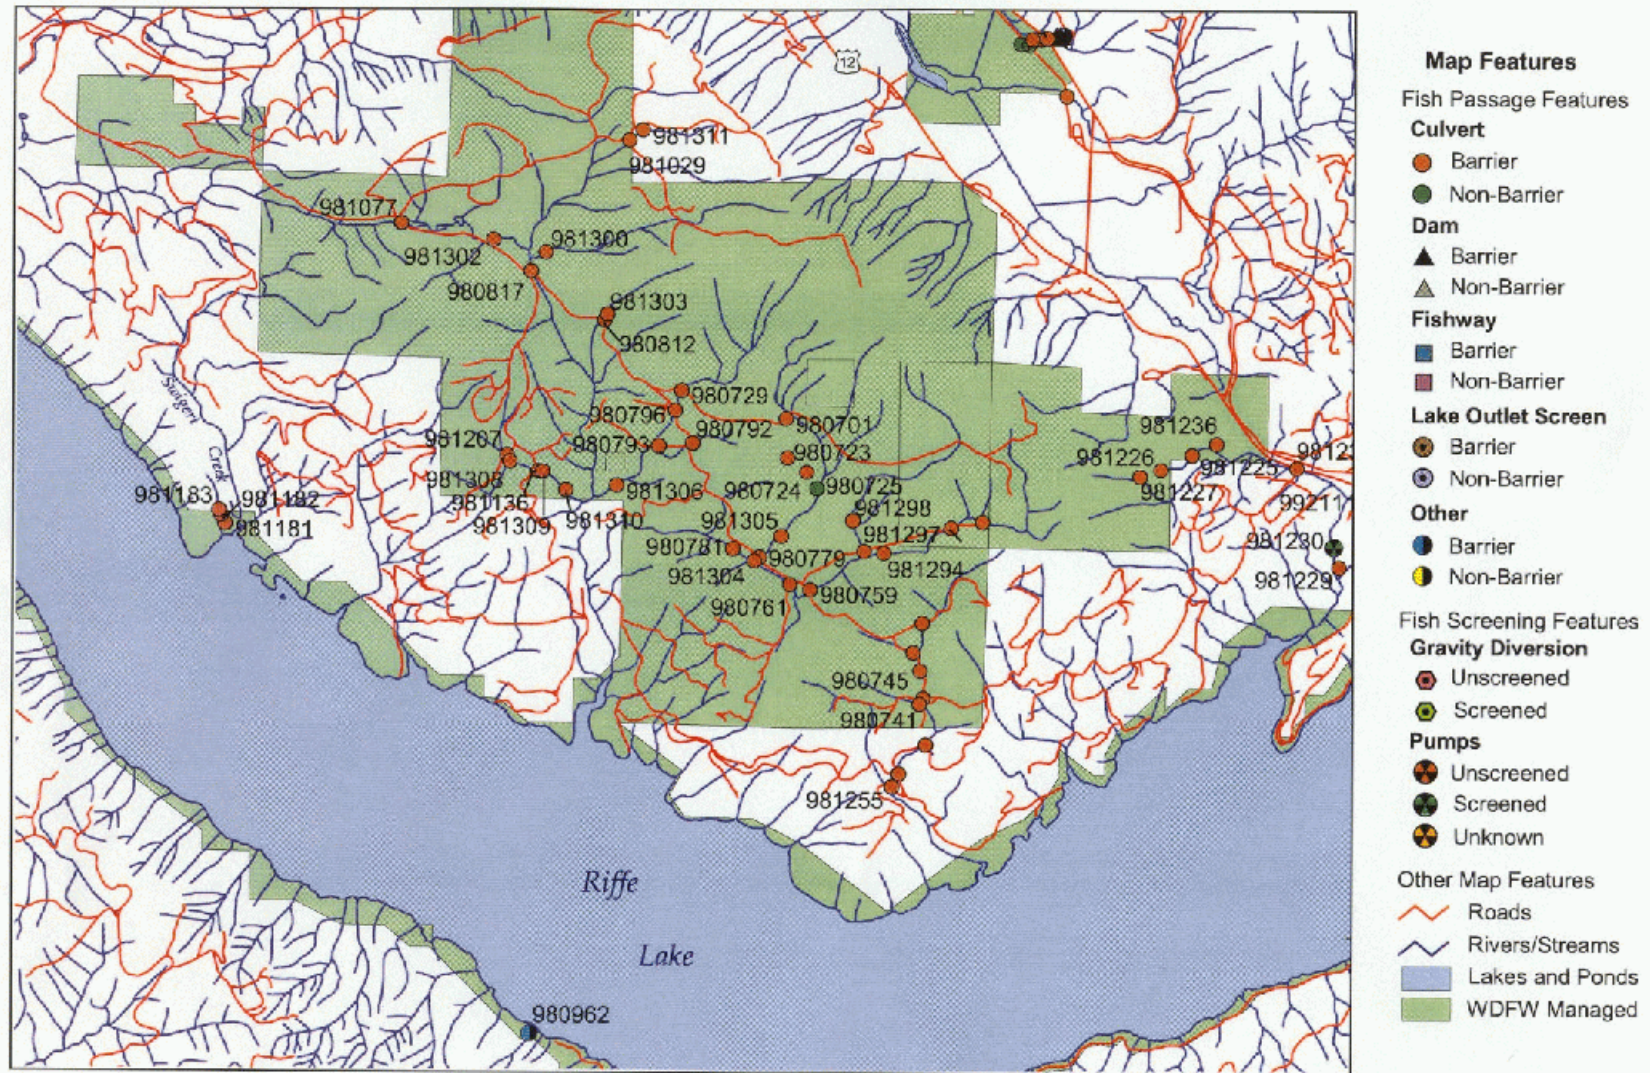
Figure 6

The first human-made structure, a partial barrier culvert (site 980781), was located 2,948 m upstream of the confluence with Riffe Lake. Along with partial barrier culverts 980761 and 980759 located further upstream, these three repair required sites have an overall habitat gain of 3,549.3 square meters and 17,111.3 square meters of spawning and rearing habitat, respectively (downstream).
