**Skagit Wildlife Area
Fish Passage and Diversion Screening
Prioritization Inventory**

Habitat Program
Technical Applications Division
Habitat and Passage Projects Section

October 2003

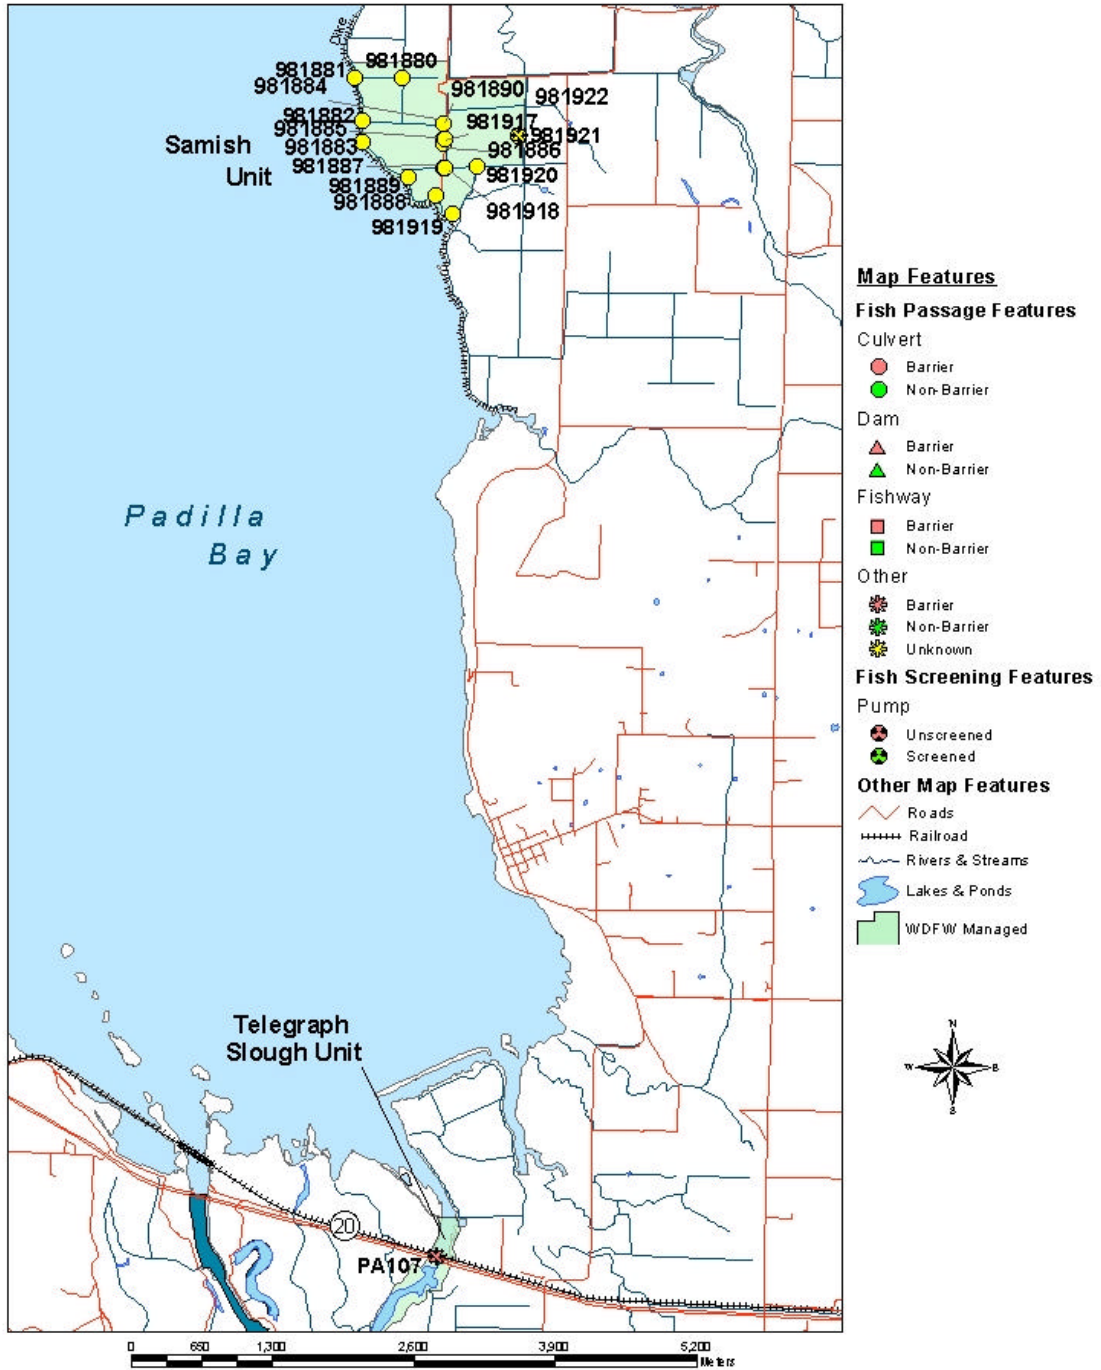
Figure 5. Samish and Telegraph Slough Units

The only human-made feature affecting fish habitat on the Telegraph Slough unit is 'other' site PA 107 (figure 5). Consisting of the State Route 20 road fill and a railroad grade, this site disconnects the inter-tidal flow from Padilla Bay to the Swinomish Channel.

The slough area to the north of SR 20 is still influenced by tidal waters of Padilla Bay, but training dikes running parallel to the slough prevent lateral flooding. As a result of the inter-tidal blockage, substantial growth of grasses, shrubs and other vegetation occurs throughout the slough channel on the south side of SR 20. However, tidal backflow from the Swinomish Channel appears to partially flood the south end of Telegraph Slough.

Historically, the entire area surrounding this unit was emergent estuary (Collins, 2000) Corrective action to restore connectivity of the slough and estuary habitat will require the cooperation of the state agencies and possibly private landowners.
