# SKAGIT WILDLIFE AREA FISH PASSAGE AND DIVERSION SCREENING SCOPING REPORT

HABITAT PROGRAM  
TECHNICAL APPLICATIONS DIVISION (TAPPS)

BY  
CHRIS DETRICK

**WASHINGTON DEPARTMENT OF FISH AND WILDLIFE  
SKAGIT WILDLIFE AREA  
FISH PASSAGE AND DIVERSION SCREENING SCOPING REPORT  
TECHNICAL APPLICATIONS DIVISION (TAPPS)-HABITAT PROGRAM  
JANUARY 2007**

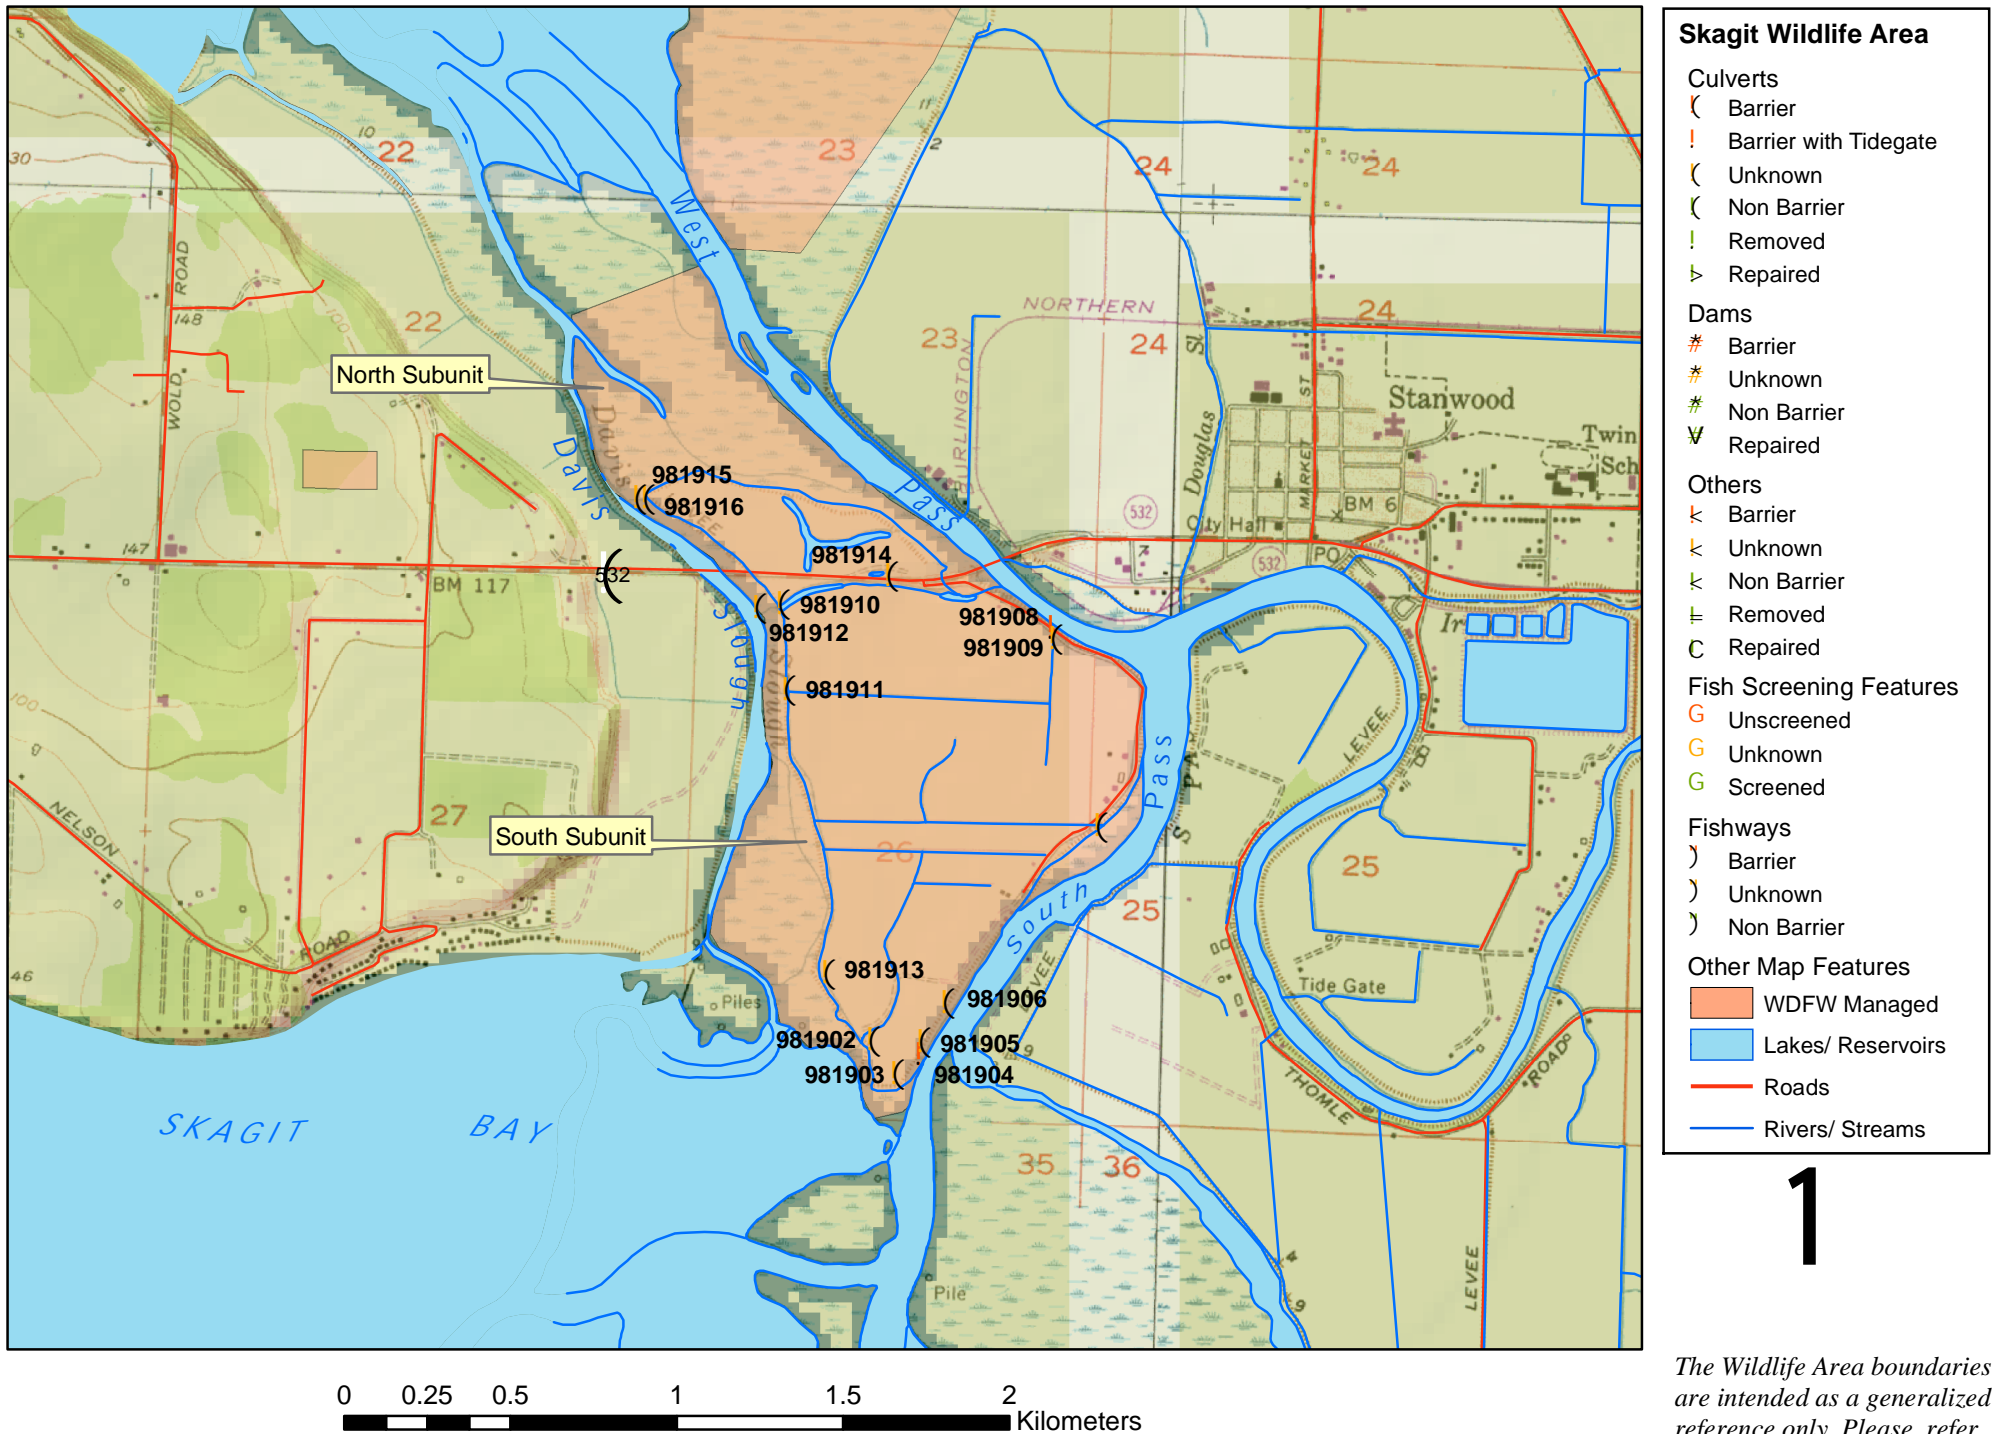
Figure 3. Skagit Wildlife Area, Leque Unit.

The Leque Island Unit was part of a large tidal emergent marsh between Skagit Bay and Port Susan prior to diking for agriculture in the 1930's. The north and south segments are divided by SR-532 (Figure 3). Dikes around the perimeter of each segment join the road fill prism at the east and west sides for complete protection of the inner areas. There is one tide gate on the north segment and three on the south segment that prevent salt water intrusion and allow drainage of accumulated freshwater. Culverts not associated with the tide gates that were identified in the inventory serve as farm equipment crossings of interior drainage ditches. WDFW acquired these properties in their current condition and has farmed all or most of both segments for waterfowl most years. There is one private inholding on the southeast side of the south segment.

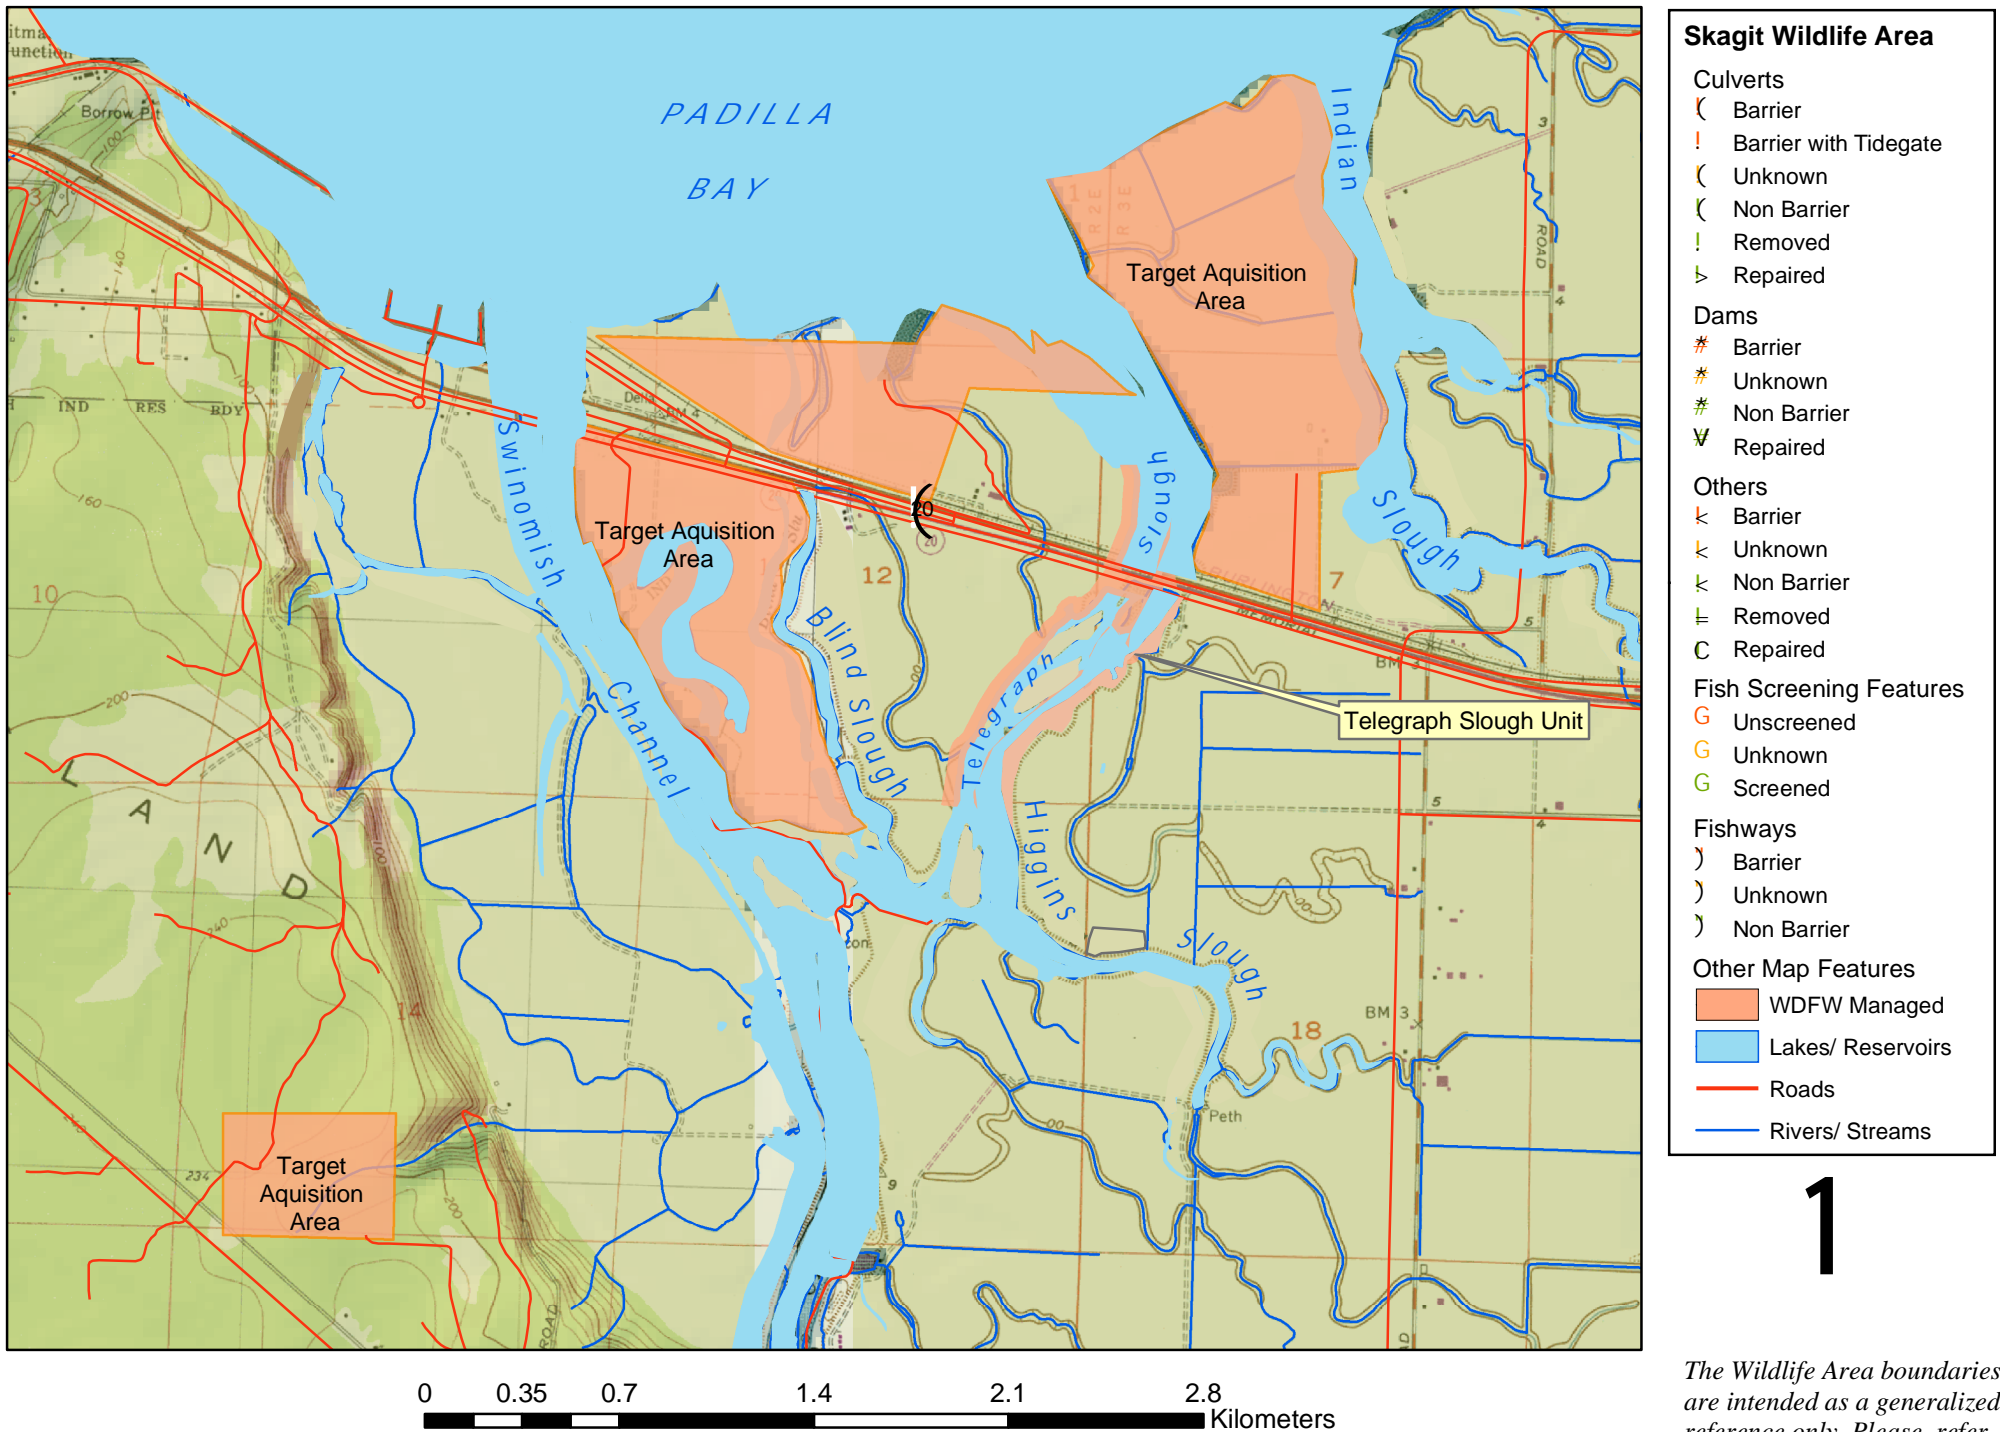
Figure 6. Skagit Wildlife Area, Telegraph Slough Unit and Target Acquisition Areas.

This unit is located at the south end of Padilla Bay immediately east of the Swinomish Channel (Figure 6). It is divided into a north section continuous with the bay and a south section that is totally isolated by the road fill for SR-20 (shown in blue). There is no culvert, bridge or other structure providing an aquatic connection from the bay south across the highway.

A mapped inventory of bank armor along the Skagit indicated both the parcels we already own and the prospective purchase were protected with large rip-rap rock. However, in a recent boat survey, it appears most of the rock along the currently owned section has washed away. This most likely occurred in the flood of October 2003 (20-30 year event in this reach). The inventory had been conducted previously. The adjacent prospective purchase property is still armored with a significant amount of large rock. If obtained, removal of this rock would help restore floodplain function and be acceptable to the Wildlife Program (Mike Davidson, pers. comm.). Grant funds to get this done could be pursued through the SRFB or the Tribes.

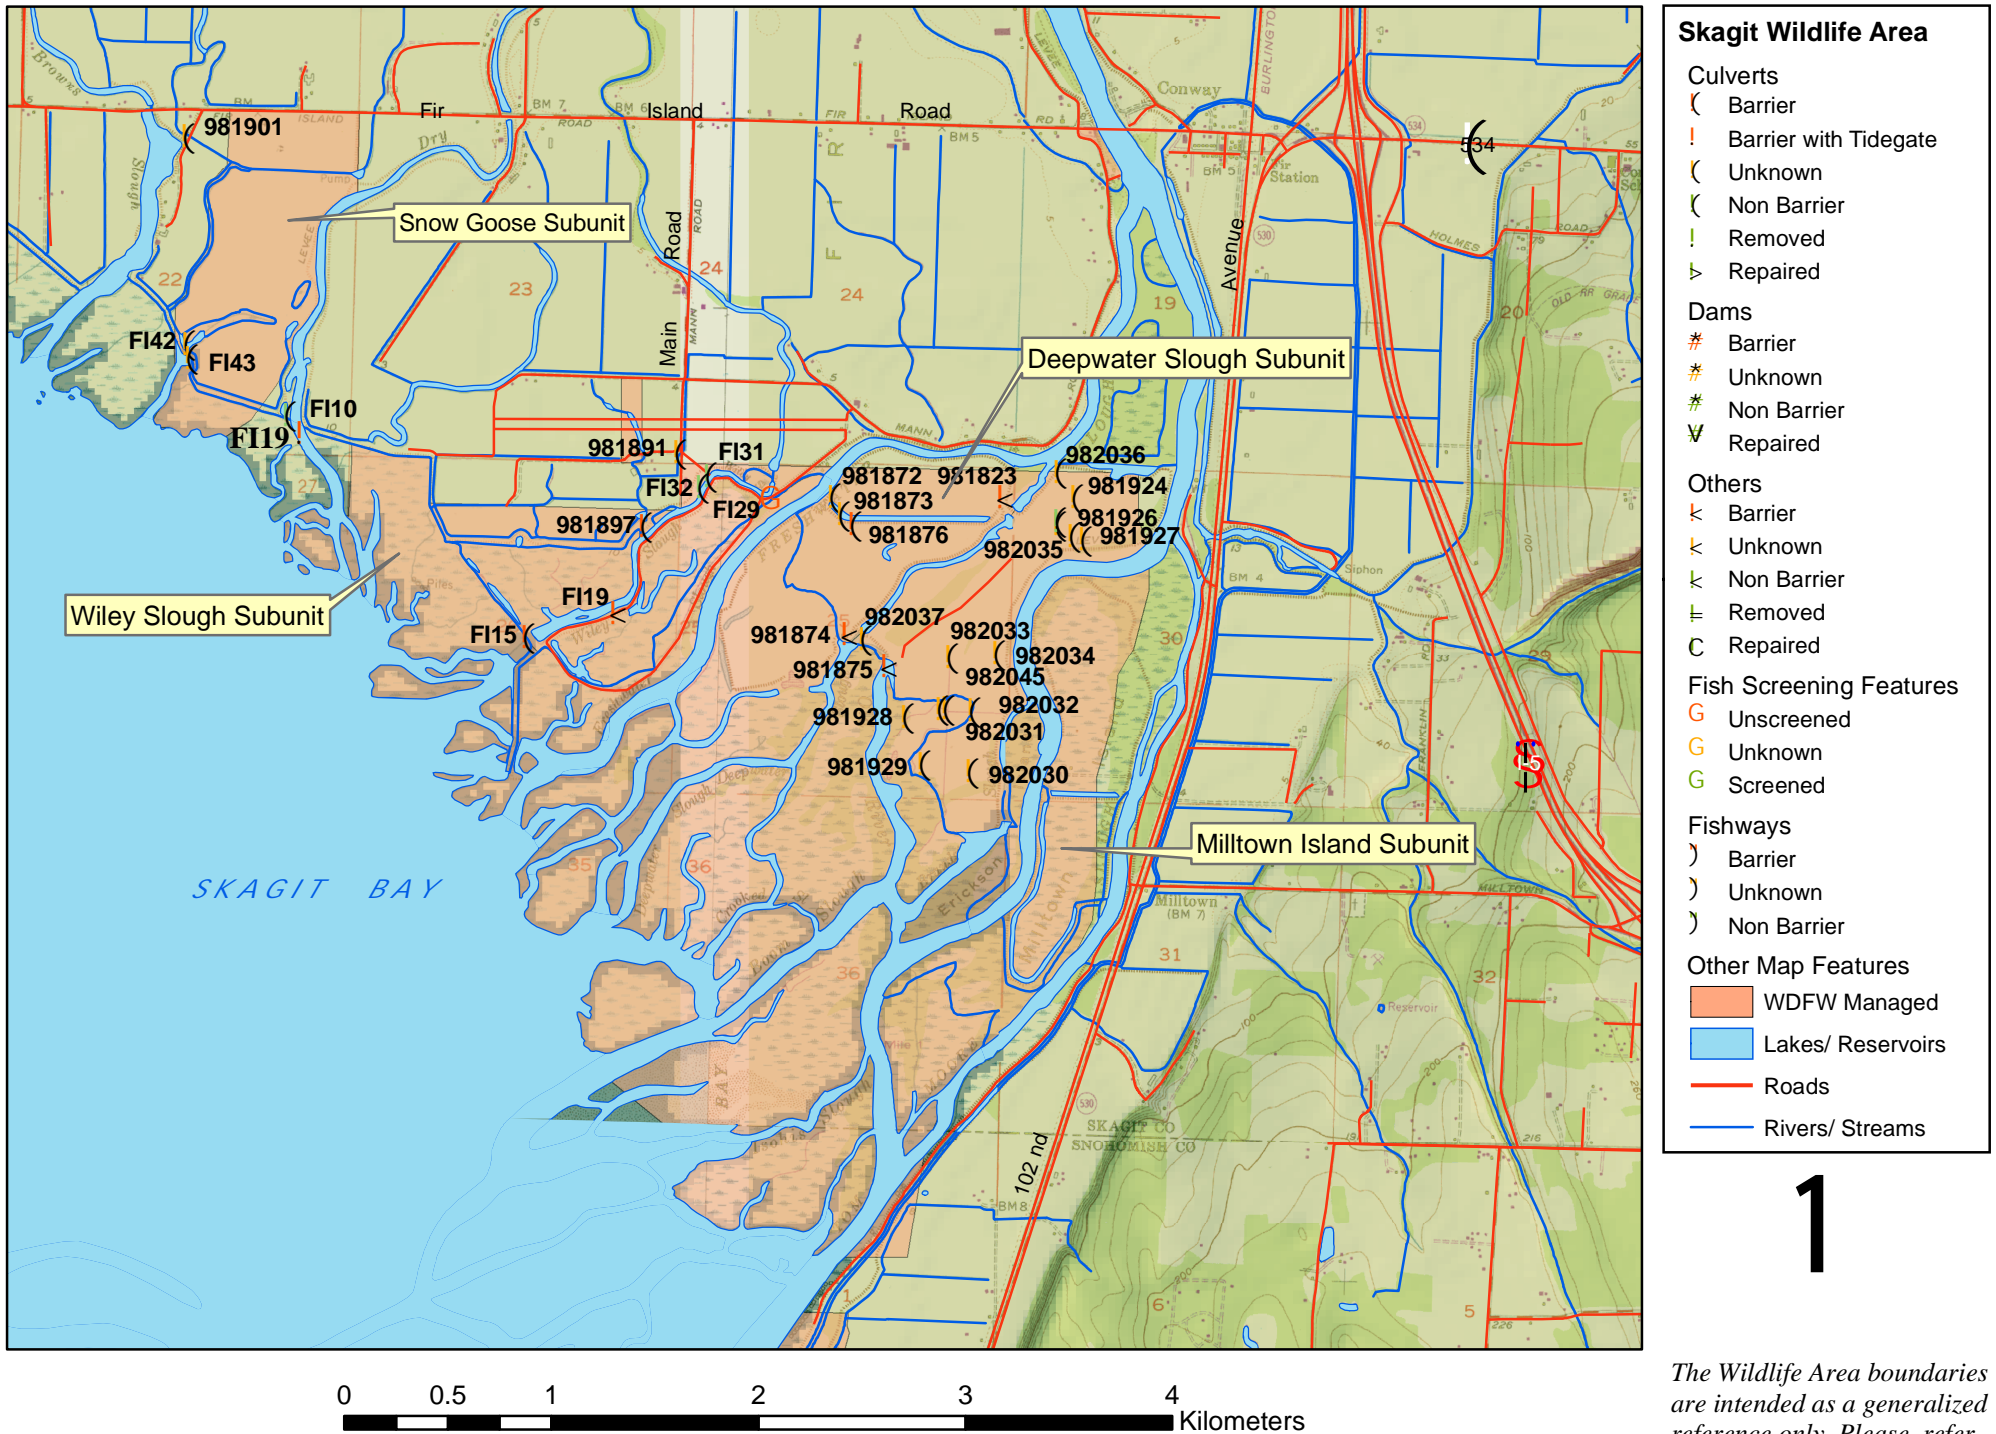
Figure 8. The Four Subunits of the Fir Island Management Unit of the Skagit Wildlife Area.

The Milltown Island segment is located due east of Deepwater Slough (Figure 8). Work by the CORPS in the early 1900's to establish a single navigation channel in the South Fork of the Skagit River spoiled much of the excavated material on Milltown Island. The spoiled material was later shaped into a perimeter dike so the interior area could be farmed. The navigation project was maintained until the 1950's and "de-authorized" in 1978.

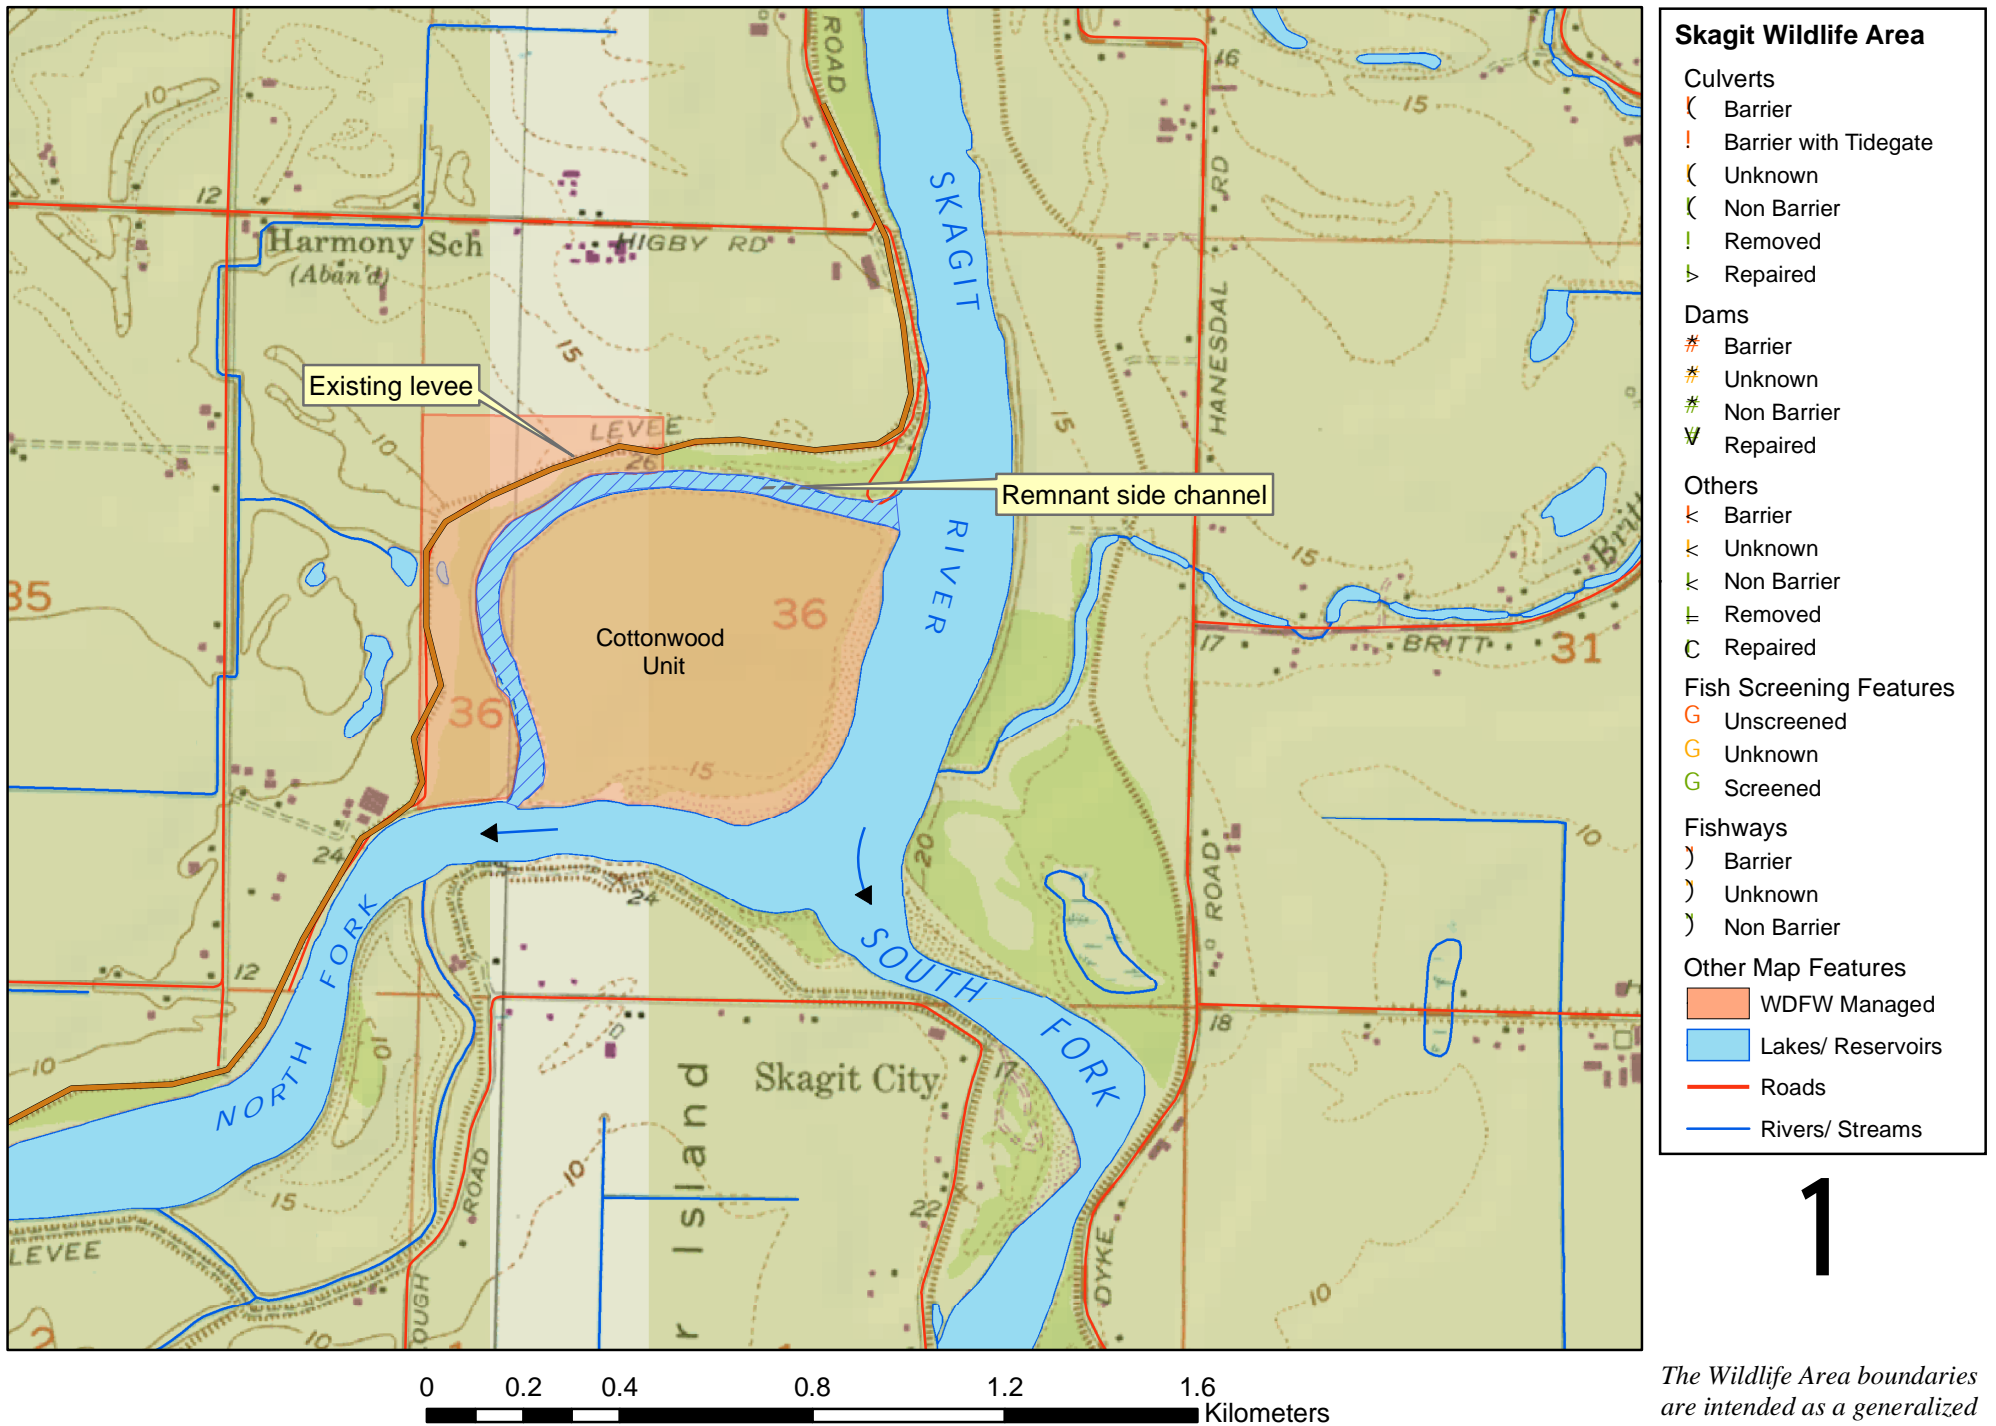
Figure 13. Skagit Wildlife Area, Cottonwood Unit.

Cottonwood Island is a recently acquired parcel from DNR located immediately upriver from the divergence of the North and South Forks of the Skagit River. River flow to and around this island is not affected by dikes. As recently as 70 years ago, the river actively flowed around the north side of the island maintaining an excellent length of off-channel habitat (Figure 13). Since that time, the channel has largely been filled with sediment for a variety of reasons including changed sediment loads of the river, changes in hydrology, reorientation of levees and other land use activities. It now only functions as salmonid habitat during flood events.

The Cottonwood Island Unit was one of many sites considered in an overall review of opportunities to recover habitat outside the existing levee network of the lower river (Miller Consulting 2004). Using this review in 2005, various stakeholders (including WDFW) began to focus on specific restoration opportunities in the Forks area. However, before any one project was seriously planned, these interest groups agreed more information was needed about the local and current hydrology, sediment loading etc. That information will be required to drive a logical sequencing of projects, identify properties not currently dedicated to restoration that must be part of the plan, and key construction elements to achieve the desired result. Funding for this study is currently being sought in the next round of the SRFB grant cycle. If funding can be obtained, project planning could begin in 2007 for possible implementation beginning in 2008/2009. Where restoration at the Cottonwood Island Unit will fall in the proposed sequencing is not known. Indications are that it may not be the best project to implement first but final evaluation will depend on the outcome of the study and flow modeling. As can be seen in Figure 13, restoration will require some type of land exchange/purchase for the WDFW parcel section behind the levee for the DeVries Investments section on the river-side.
