CONCEPTUAL RESTORATION PLAN, REACHES 6 TO 10 TUCANNON RIVER PHASE II

Columbia Conservation District
202 South 2nd Street, U.S. Post Office Building
Dayton, Washington 99328

Anchor QEA, LLC
1605 Cornwall Avenue
Bellingham, Washington 98225

November 2011

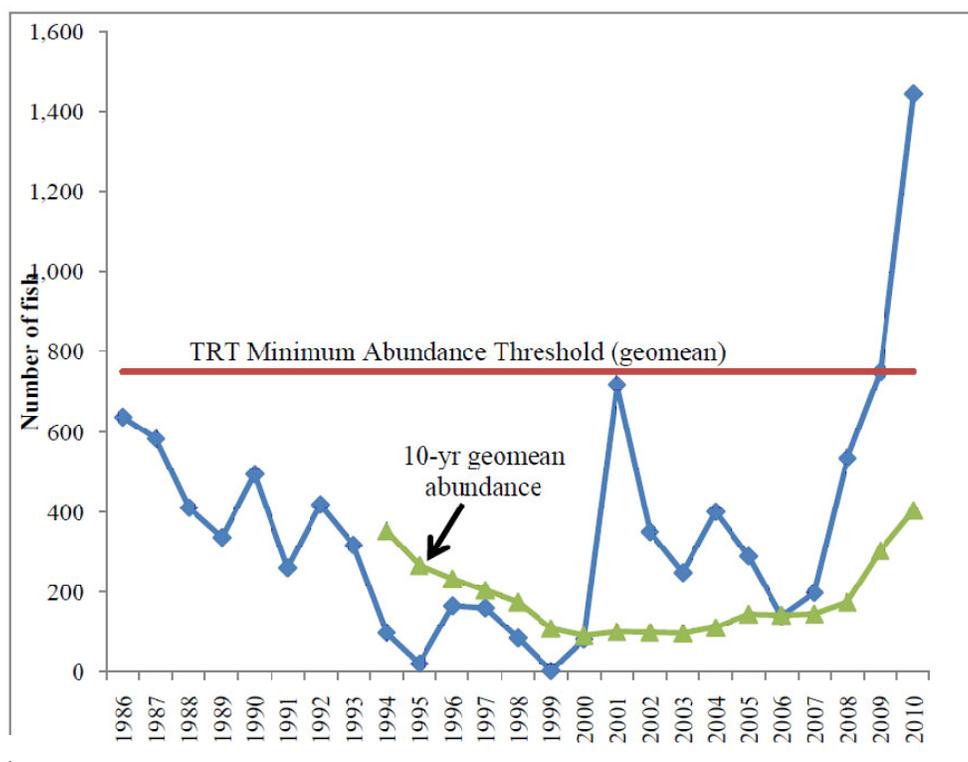
Chart 1

Between 1986 and 2010, the annual returns of natural-origin spring Chinook to the Tucannon River ranged from 0 to 1,500 adults; the high of about 1,500 returning adults occurred in 2010 and the low of 0 returning natural-origin spawners occurred in 1995 and 1999 (Chart 1, Gallinat and Ross 2011). The 10-year geometric mean abundance has varied between approximately 100 and 400 returning adults. The Interior Columbia Technical Recovery Team (ICTRT) estimated that the minimum abundance threshold of returning adults is 750 and the current average is 371 (SRSRB 2011c).

Estimated Abundance of Tucannon River Natural-Origin Spring/Summer Chinook Salmon Adults and 10-year Geomean between 1986 and 2010 (Gallinat and Ross 2011)

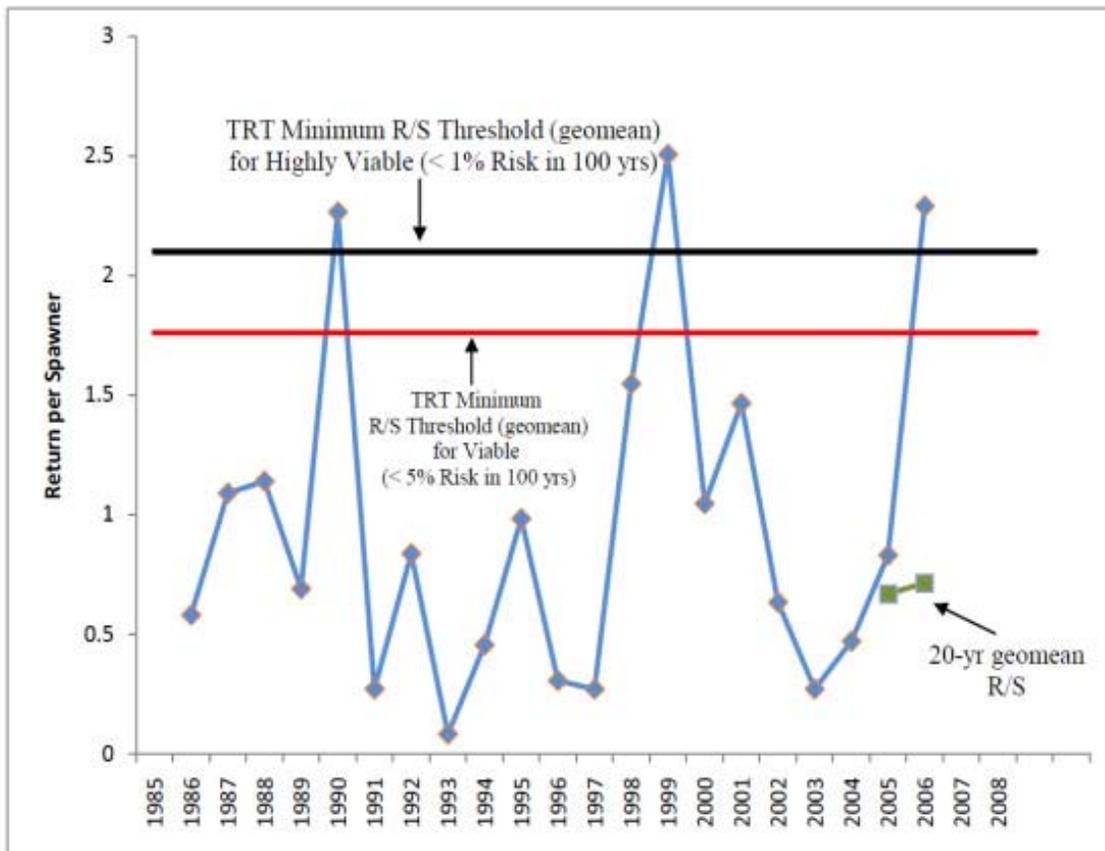
Population growth rate (λ) or productivity over the entire life cycle is a key measure of population performance in a species' habitat. In simple terms, it describes the degree to which a population is replacing itself. A population growth rate of 1 ($\lambda = 1.0$) means that a population is exactly replacing itself (one spawner produces one spawner in the next generation), whereas a $\lambda = 0.71$, the λ value determined in the Tucannon for spring Chinook, means that the population is declining at a rate of 29 percent annually—a trend that is obviously not sustainable in the long term (Chart 2). This return to smolt (R/S) value does not account for the nearly 25 percent of returning adults that bypass the Tucannon River upon return, based on PIT-tag detections, and ascend the Snake River without returning back to the Tucannon River. Nevertheless, recruits per spawner are often less than 1 and documented R/S is nearly always less than 1 for spring Chinook (SRSRB 2011c). The Technical Review Team estimated that an R/S of 1.8 is needed for an extinction risk of less than 5 percent and an R/S of 2.1 is needed for an extinction risk of less than 1 percent (highly viable criteria) (SRSRB 2011c).

Chart 2
Estimated Productivity of Natural-Origin Spring/Summer Chinook Salmon Adults and 20-year Geomean from the Tucannon River

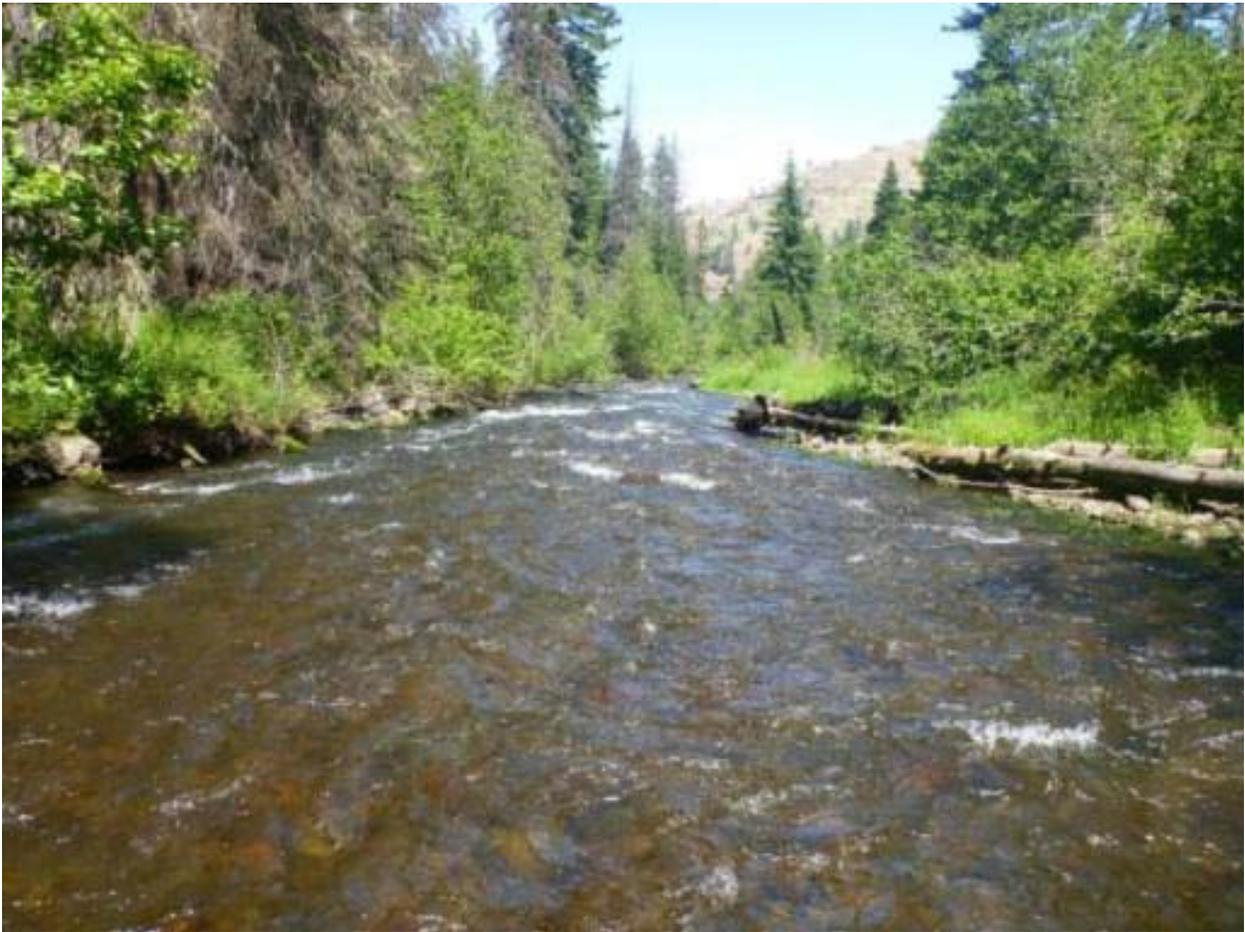
The channel through PA-1 is characterized as a single-thread, plane-bed channel with local rapid sections (Photograph 4-1). This area is located in a relatively steep, narrow section of the valley. Five rock weirs are located within the project area and likely contribute to grade control of the channel profile. Multiple rock-rootwad restoration features were also observed throughout. Several minor side channels were observed during site reconnaissance, although many of these features are likely dry during the low-flow period. At approximately RM 49.05, a spring originates south of the campground and flows parallel to the river for approximately 0.1 miles.

Photograph 4-1
PA-1 near RM 49.6, looking downstream

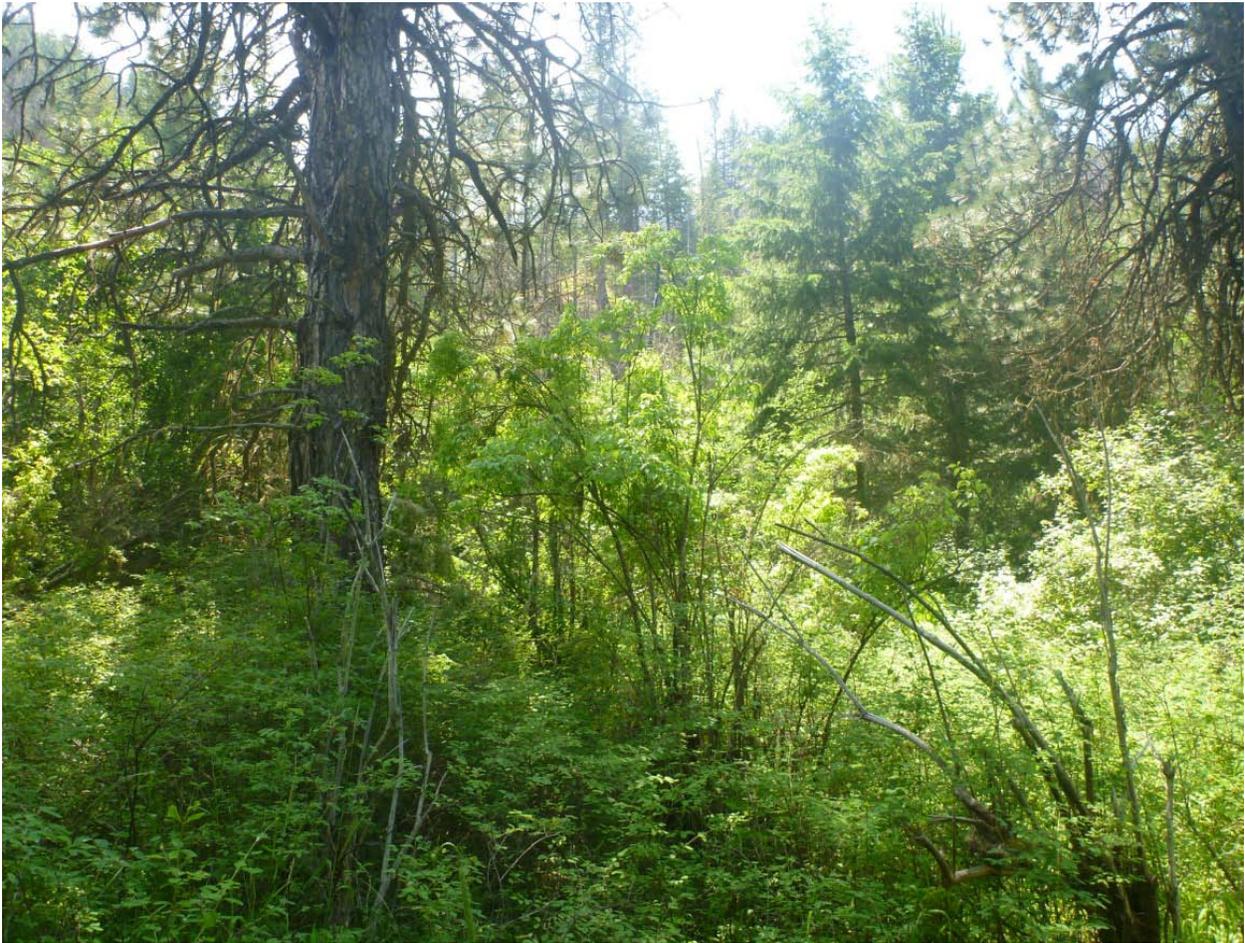
Photograph 4-2

by Ponderosa pine and dogwood. Understory vegetation is generally thick and healthy, containing fern and saplings that provide overhanging shade in the spring channel (Photograph 4-2). Species are moderately diverse, but contain many invasive plants, including reed canarygrass, St. John's wart, teasel, and creeping buttercup.

Vegetation on the floodplain at the existing spring channel near RM 49.0

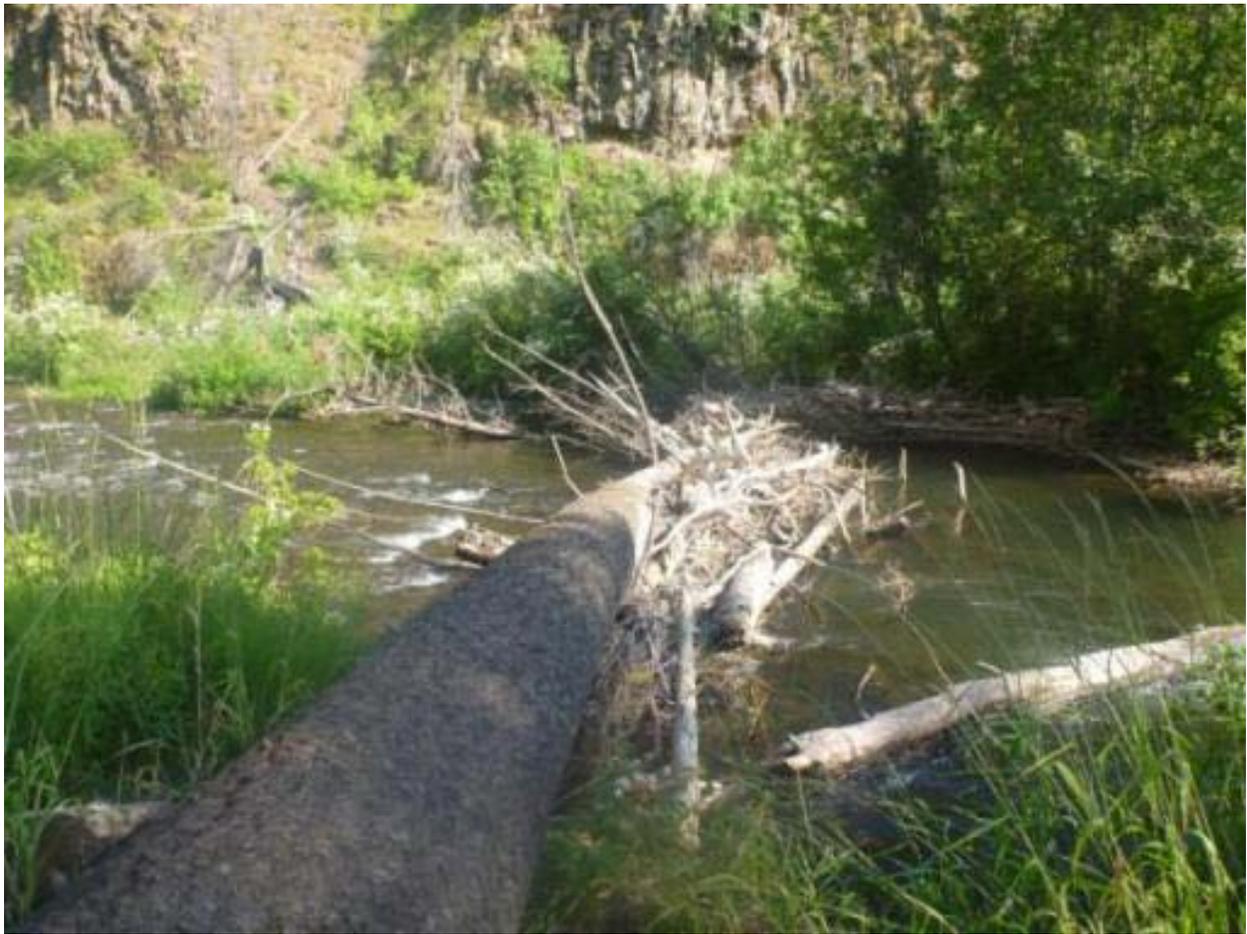
The availability and quality of instream habitat is limited by lack of complexity and hydraulic conditions that prevent the retention of sufficient volumes of LWD and sediment. The spatial distribution of existing LWD is limited. Large jams and sediment deposits are present but sporadic (Photograph 4-3); the log jams that were observed were typically associated with local areas of high temporary sediment storage, split flow, and side channels. However, the majority of the project area is made up of long, straight, plane-bed stretches that lack any adequate cover or hydraulic complexity.

Photograph 4-3
A channel-spanning log jam near RM 47.5

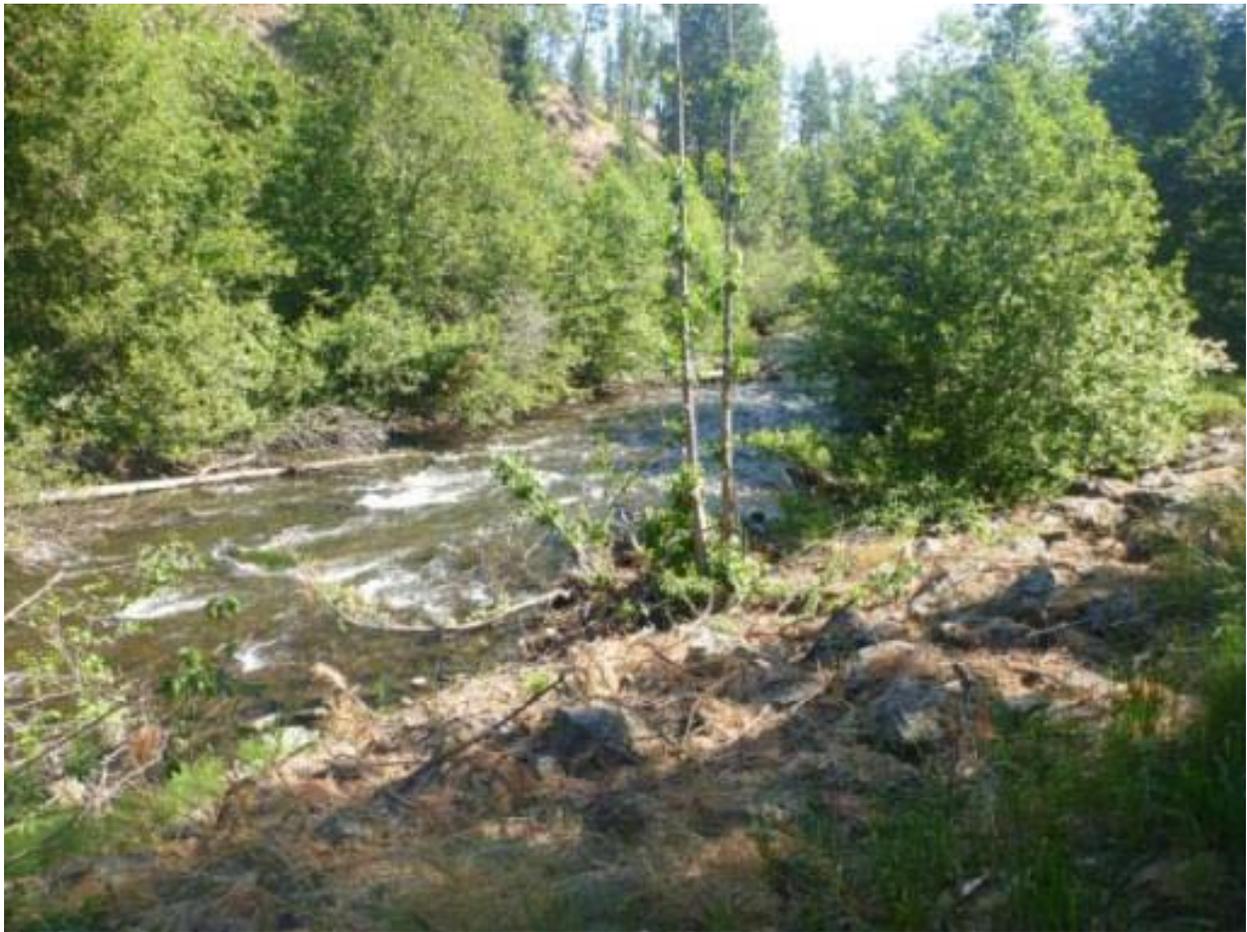
Photograph 4-4

In the upper portion of the project area from RM 46.8 to 46.65, the river contains multiple rapid/run channels separated by forested islands. Downstream of RM 46.65, the river and floodplain are highly confined between a levee and the road grade, which has resulted in a single-thread, high-velocity channel with large armor substrate and angular riprap banks (Photograph 4-4). The levee on the right bank currently serves as an access road to the upstream side of the Camp Wooten facilities, including Donnie Lake. The lake outfall channel flows along the toe of the road, meeting the main channel at approximately RM 46.55. Several juvenile fish were observed in the outfall channel. It is not clear if the pond itself is spring-fed or receives water via diversion from the river.

PA-4 near RM 46.5, looking downstream from the right bank levee

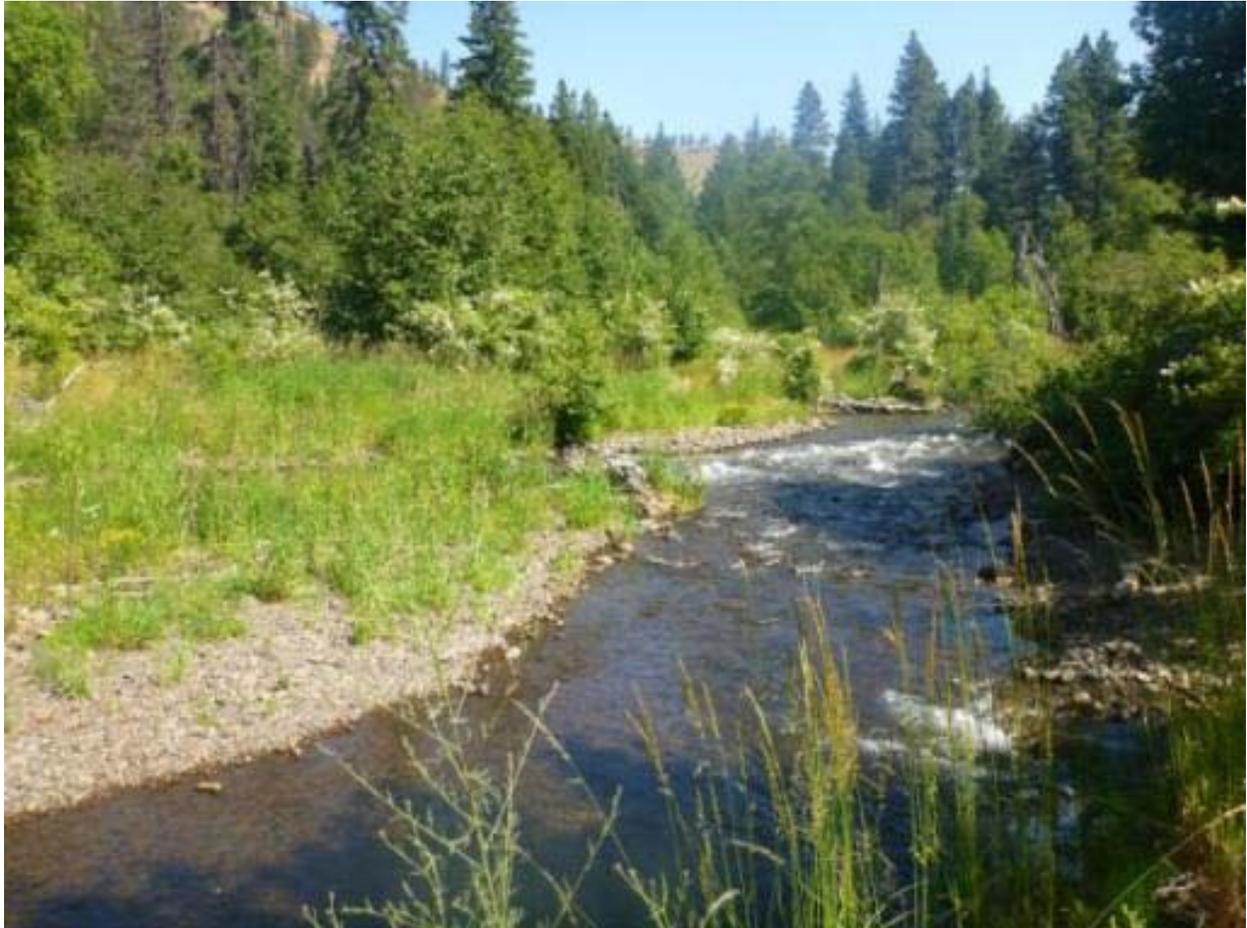
Photograph 4-5

Throughout the project area, the river is characterized by multiple channels separated by unvegetated gravel bars or forested islands. This portion of the channel is located downstream of a tightly confined section (PA-4). The active channel area is relatively wide and wood and sediment is more likely to deposit resulting in a relatively dynamic reach with a greater volume of LWD, temporary sediment storage, and channel migration than has been observed in upstream reaches (Photograph 4-5). Steady migration of meander bends was observed in many of the outside meander bends, most notably at RM 46 along the left bank. Side channels ranging from perennial to high-flow were observed with variable depths and

A secondary flow path within PA-5 near RM 46.1, looking downstream

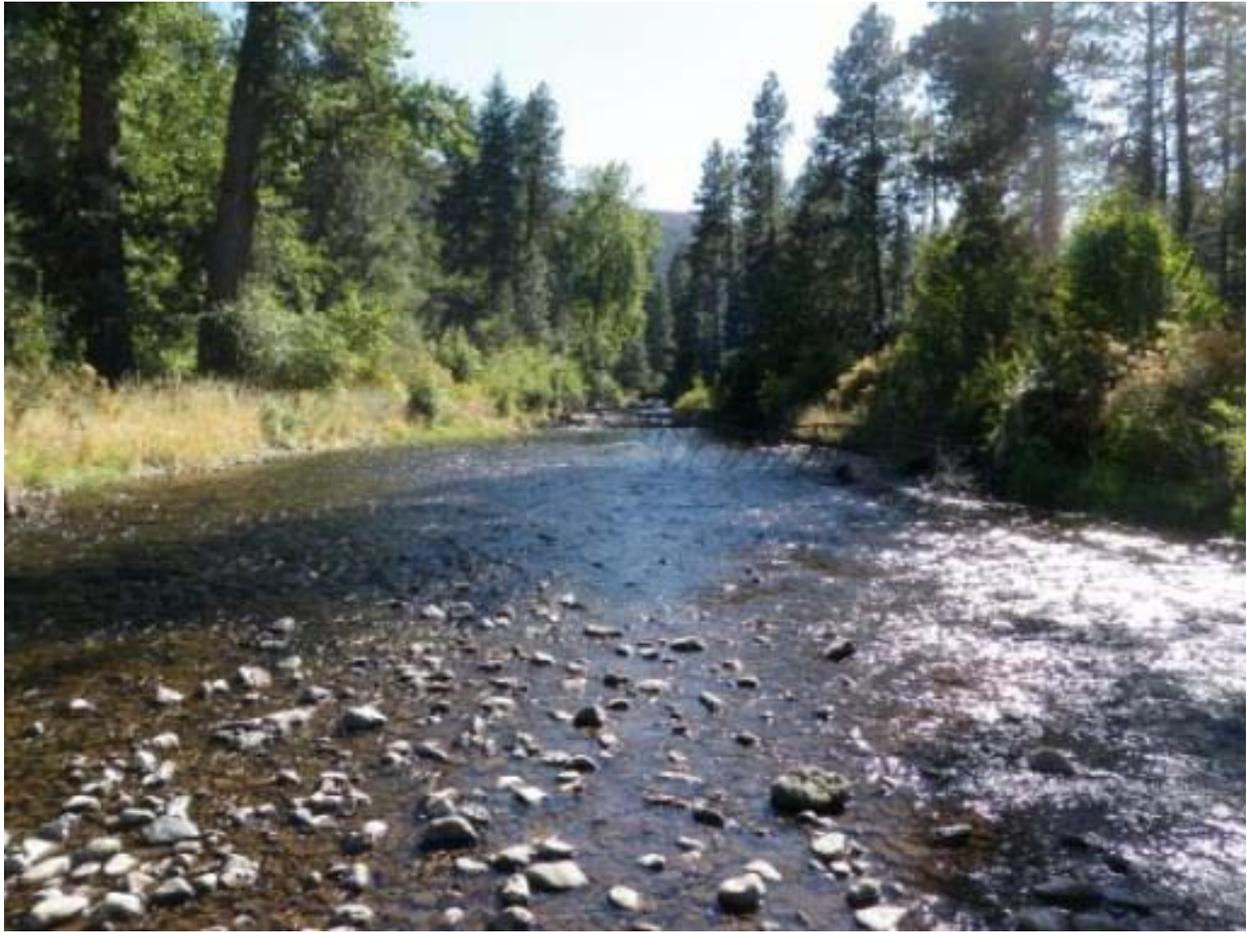
Photograph 4-6a

In the upper portion of the project area from RM 45.95 to 45.7, the channel is a single-thread, plane-bed channel with little complexity (Photograph 4-6a). Two vortex weirs between RM 46.0 and 45.8 hold the channel grade and form deep pools on the downstream end. This portion of the channel contains very little LWD or other hydraulic complexity, other than the pools at the weirs. Very little suitable habitat for juvenile fish was observed except near the channel margins. Habitat conditions may also be affected in the summer months by recreational use as this portion of the river is adjacent to the campground.

The plane-bed section of the channel during low flow near RM 45.8, looking upstream

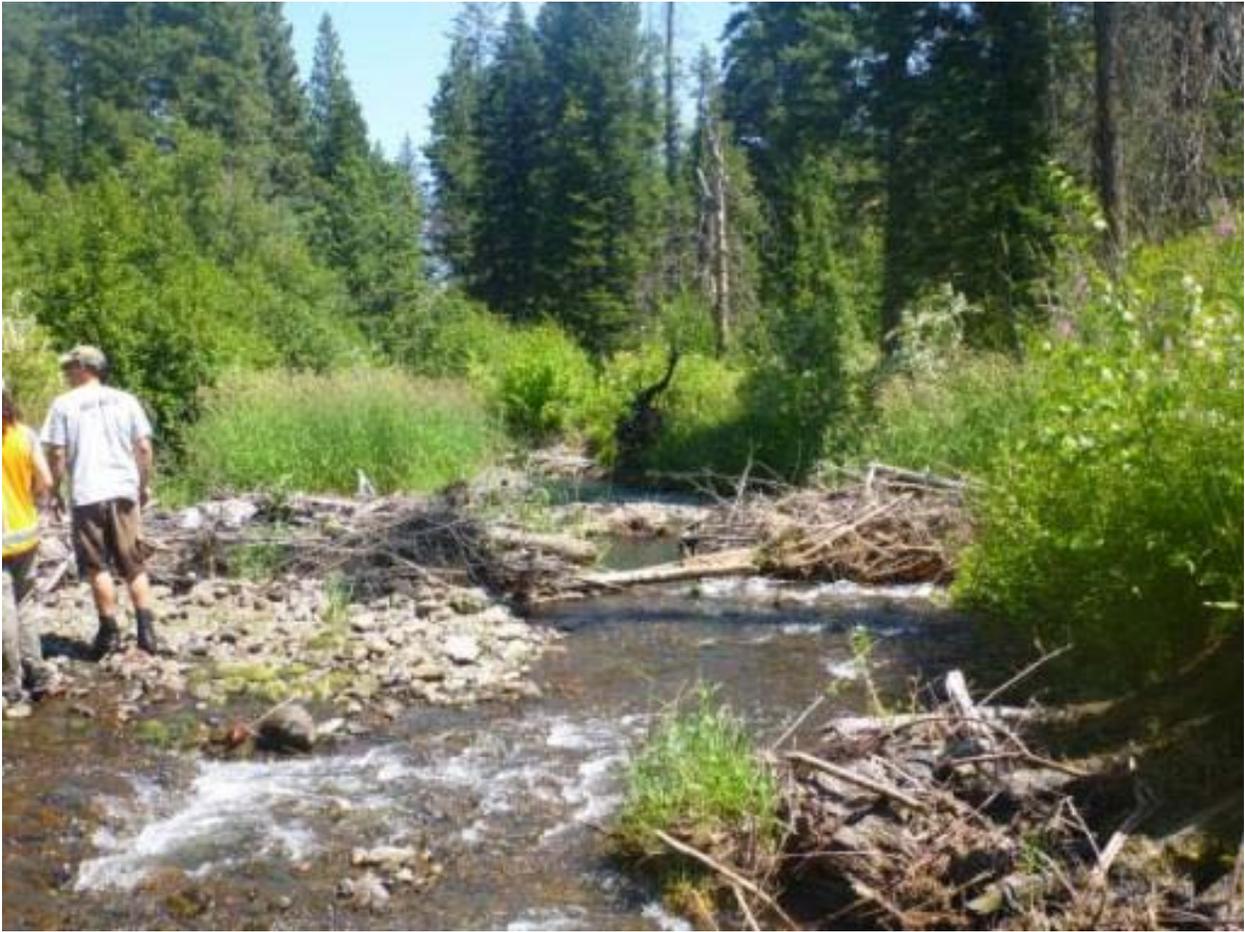
Photograph 4-6b

Between RM 45.7 and 45.3, the channel is a more complex, multi-channel configuration with forced pools and riffles at LWD and along the bedrock valley wall (Photograph 4-6b). Instream habitat conditions in the main channel are generally good, due to the presence of large LWD that retains additional mobile wood and forces deep pools. Two large side channels that meet the main river at approximately RM 45.5 and RM 45.3 provide good off-channel rearing habitat with ample cover, depth, and low velocities.

A side channel with moderate woody debris near RM 45.4, looking downstream

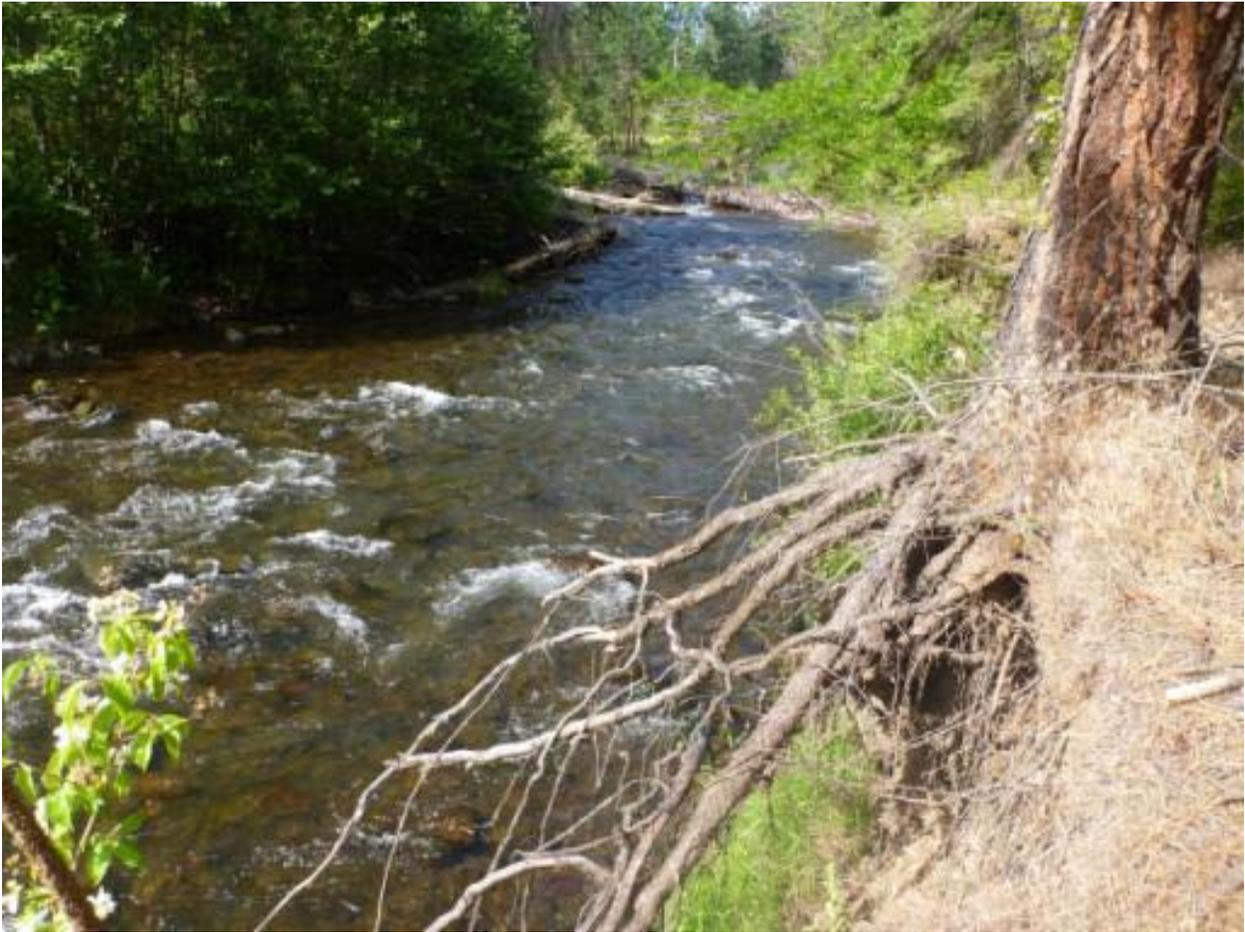
Photograph 4-7

Within this project area, the channel is a single-thread, plane-bed channel with local rapid sections. Between RM 45.2 and 45, the channel is entrenched and incised between alluvial fan deposits and Tucannon Road, which appears to be built mostly on remnant fan deposits. An approximately 10-foot high bank between RM 44.9 and the Curl Lake intake also indicates an incised condition (Photograph 4-7). The section of the channel between RM 45.3 and RM 44.9 contains multiple rock and rootwad restoration features that force pools along the margin of the channel. Immobile boulders in the channel bed also provide a minor amount of pool formation and hydraulic complexity. Some riprap is present along the channel banks between RM 45.1 and 45.05, although it likely has no effect on channel migration in its currently entrenched state. At the Curl Lake intake, the channel is roughened with boulders and cobbles.

An incised section of the main channel near RM 44.9, looking upstream

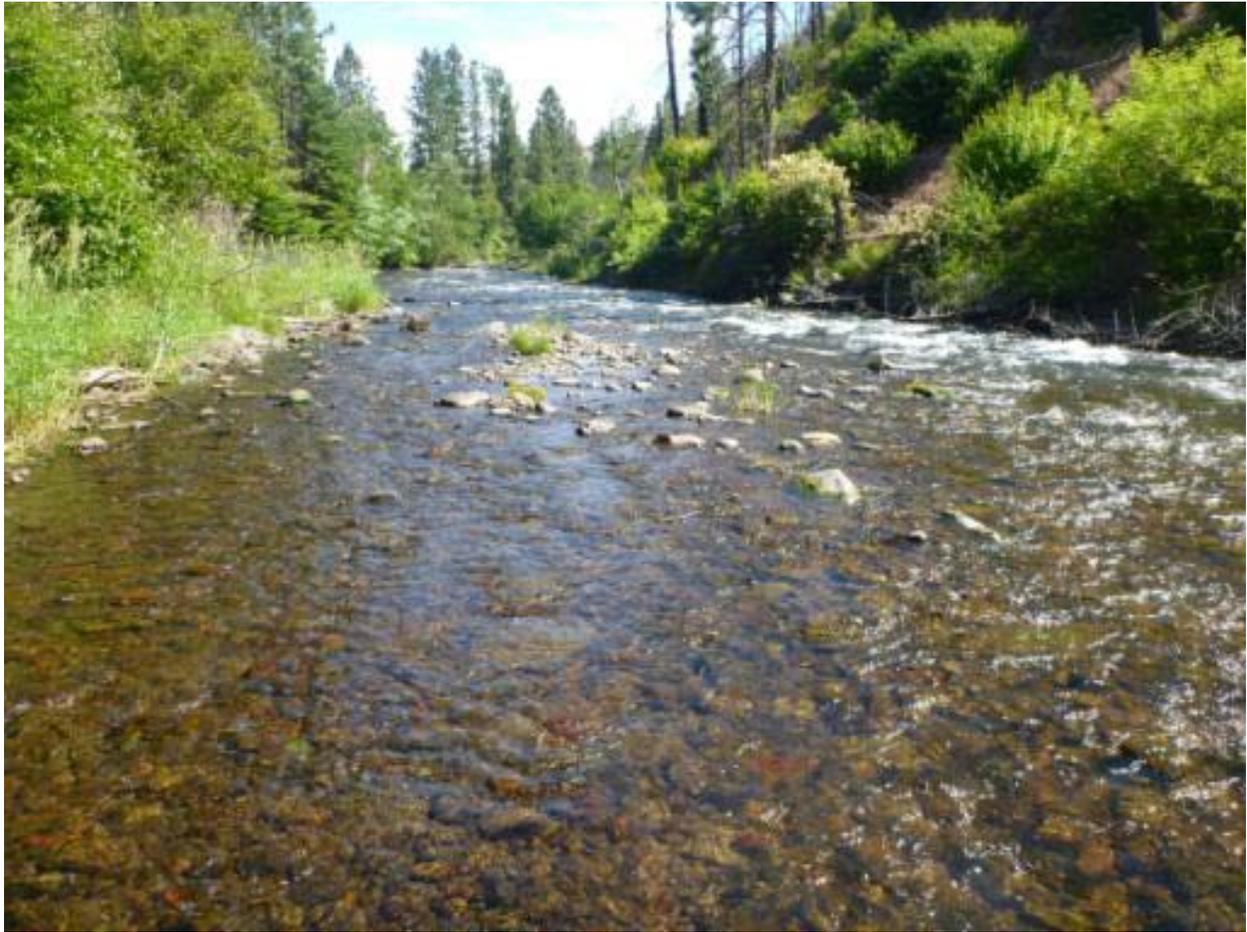
Throughout the project area, the single-thread channel is typically wide, shallow, and plane-bed. A few local high-velocity areas occur along the toe of the bedrock valley wall (Photograph 4-8). Levees are present along much of the left bank, confining the active channel and low floodplain to the far side of the valley. No side channels or secondary flow paths were identified. A large ELJ is present on the right bank at RM 44.8 and provides some cover and pool habitat. The channel contains little other LWD except small, transient material. Although juvenile fish may use the shallow margins of the channel, the lack of cover, complexity, and pools results in generally poor habitat conditions throughout this section of the river.

Photograph 4-8
The mainstem channel near RM 44.7, looking downstream

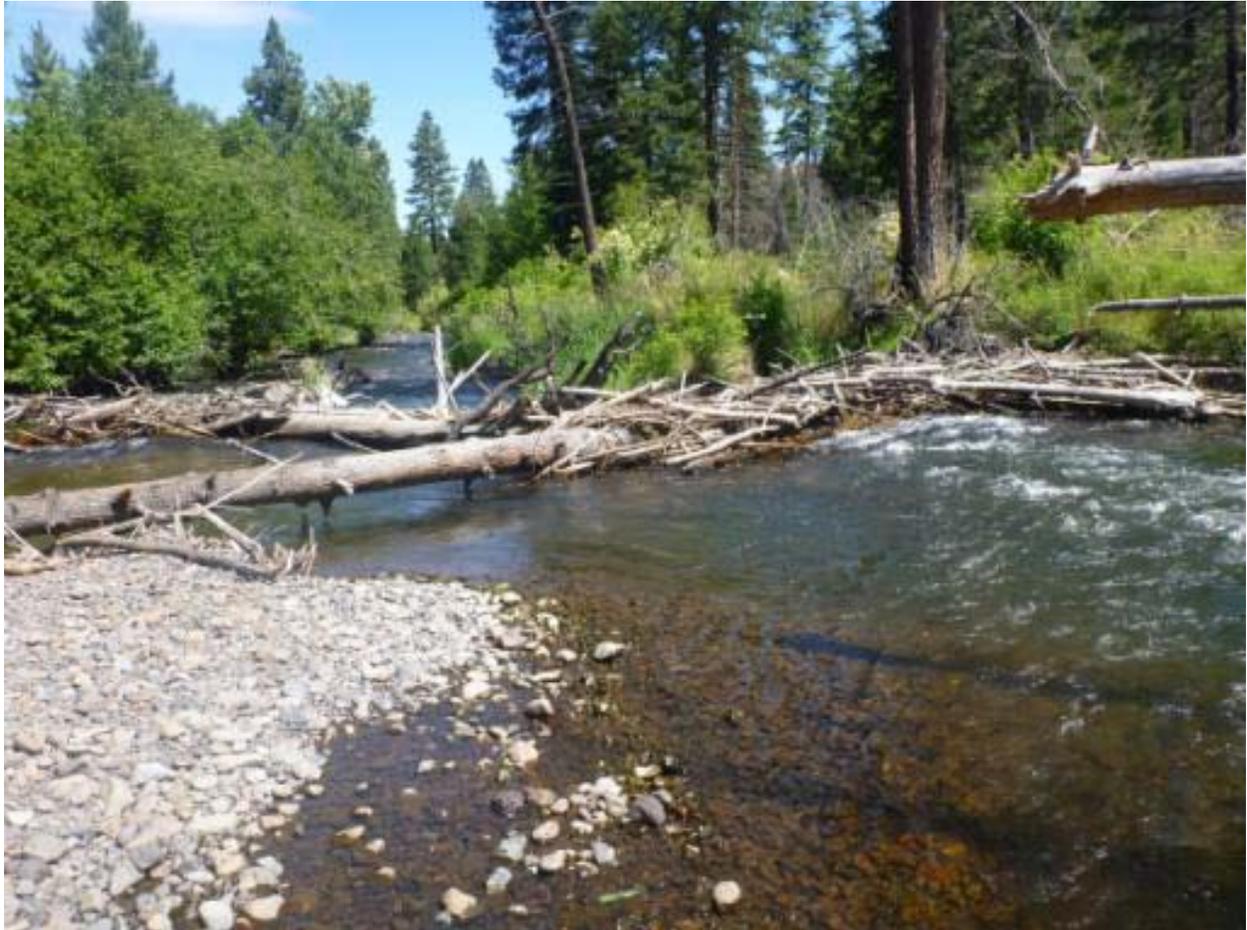
Photograph 4-9

Throughout PA-9, the river is characterized by multiple-channel pathways containing a variety of hydraulic conditions forced by the presence of LWD, including several pools and secondary flow paths (Photograph 4-9). Local channel expansion is occurring in the project area from just upstream of RM 44.4 to RM 44.25, as evidenced by bank erosion and multiple-flow path development, recently recruited trees in the channel and side channels, and high amounts of temporary sediment storage. A levee is located along the right bank from approximately RM 44.4 to RM 44.3 at the diversion structure to Big Four Lake. The structure is composed rock armoring and some rootwads along the toe. The channel adjacent to the levee is wide, shallow, and relatively well-armored due to locally high velocities. A straight, plane-bed stretch of channel adjacent to Big Four Lake near RM 44.1 had a well-armored bed lined with large cobbles. In general, the project area has good side channel

Deep pools and complex hydraulic conditions caused by LWD, near RM 44.4

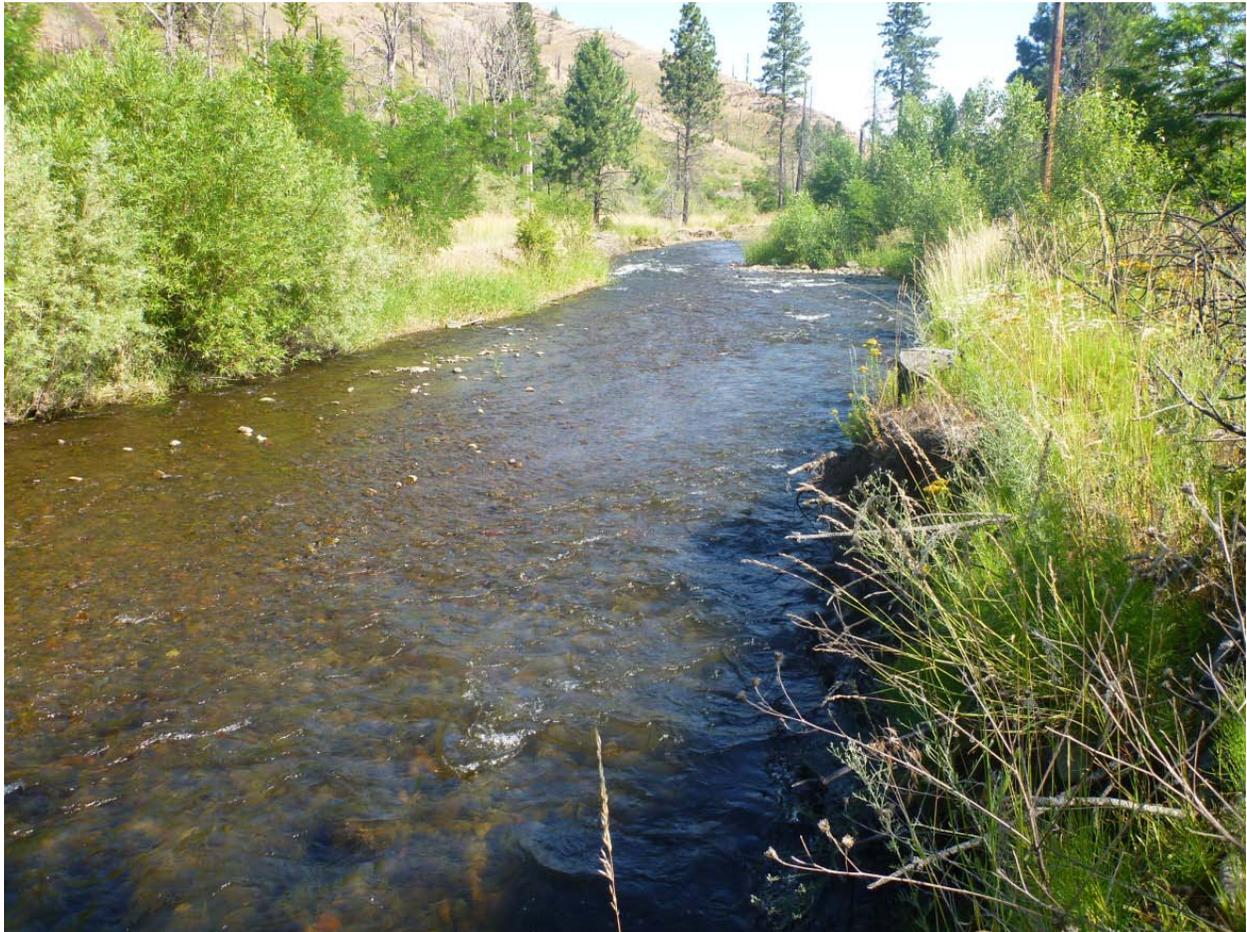
The channel through PA-10 is typically a single-thread, plane-bed channel. The channel contains very little hydraulic complexity and is highly incised throughout a majority of the project area. One section of the project area between approximately RM 43.85 and 43.65 is a highly dynamic, aggrading channel containing many flow paths forced by LWD that has been placed by the WDFW in previous years. The downstream sections of the project area are more characteristic of a single-thread channel with forced pools and riffles (Photograph 5-1). In addition to the placed LWD, rock/rootwad placements and other rock structures such as barbs were observed in a few locations. Multiple armored rock and “sugar dike”-style levees were observed throughout the project area from approximately RM 43.1 to 42.85. The left bank levee at RM 42.9 confines the channel against the valley wall at Waterman Creek, resulting in a deep, narrow, rapid section with high velocities. The upstream end of the

Photograph 5-1
A section of the main channel in PA-10 near RM 42.6

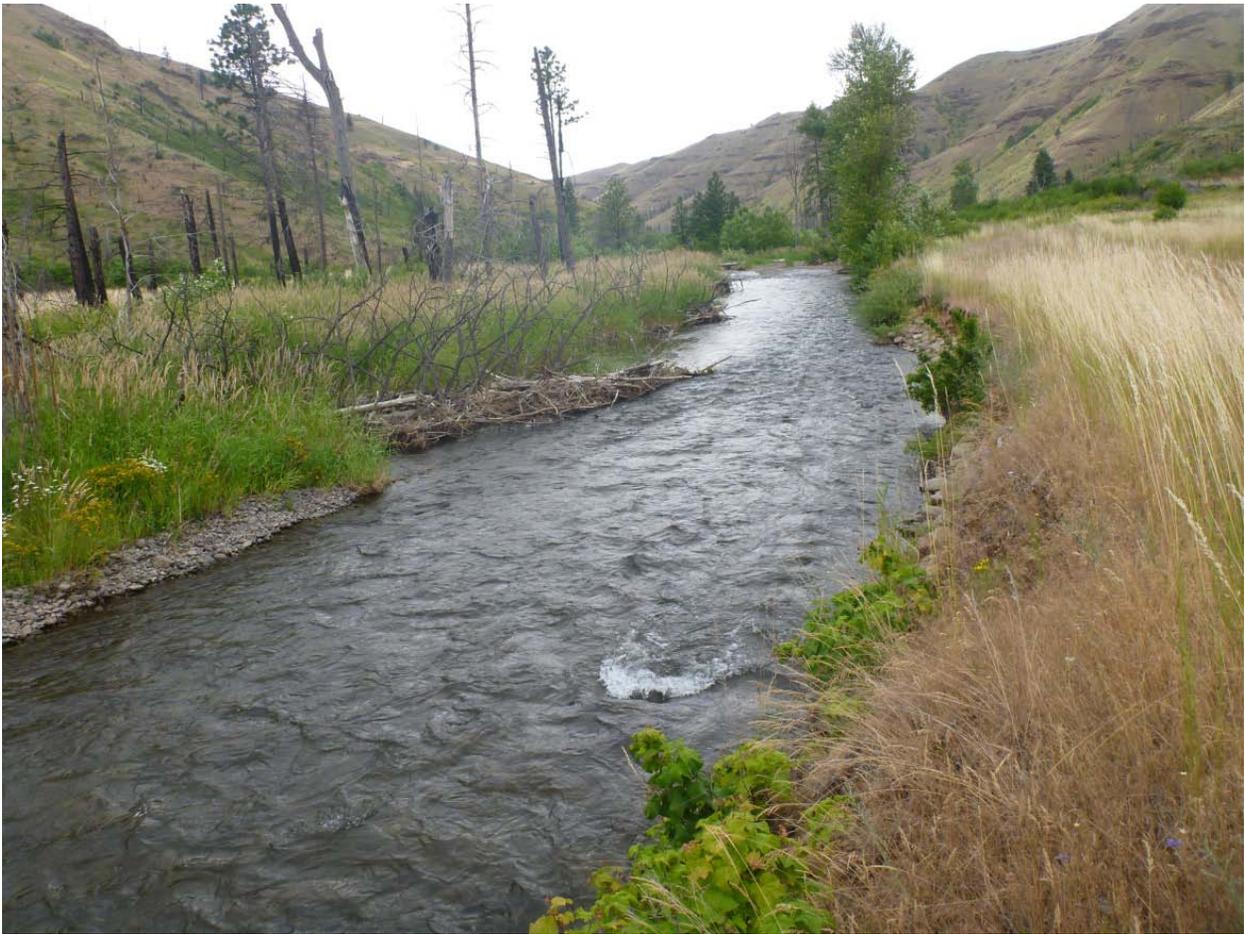
Photograph 5-2

The channel through PA-11 between approximately RM 42.3 and RM 41.4 is characterized as a single-thread, plane-bed channel with few LWD-forced pools (Photograph 5-2). The channel is relatively straight and somewhat incised and was likely channelized historically. Downstream of RM 41.4, a large log jam has initiated an anabranching channel pattern and that extends to the downstream end of the project area. This portion of the channel contains more diverse channel types, although it is also somewhat incised and lacking instream complexity. Three weirs are located adjacent to Watson and Beaver lakes, along with some rock and LWD placements along the banks at the lake access footbridge. An armored levee associated with the bridge and parking lot is located along the left bank from approximately RM 42.1 to 42. The intake for Deer Lake, which includes an armored levee, is located at the downstream end of the eastern split flow channel near RM 40.9. Few side channels were observed upstream of RM 41.4. Several flow pathways are present between approximately RM 41.4 and 41.1.

The main channel in PA-11 near RM 41.75, looking downstream

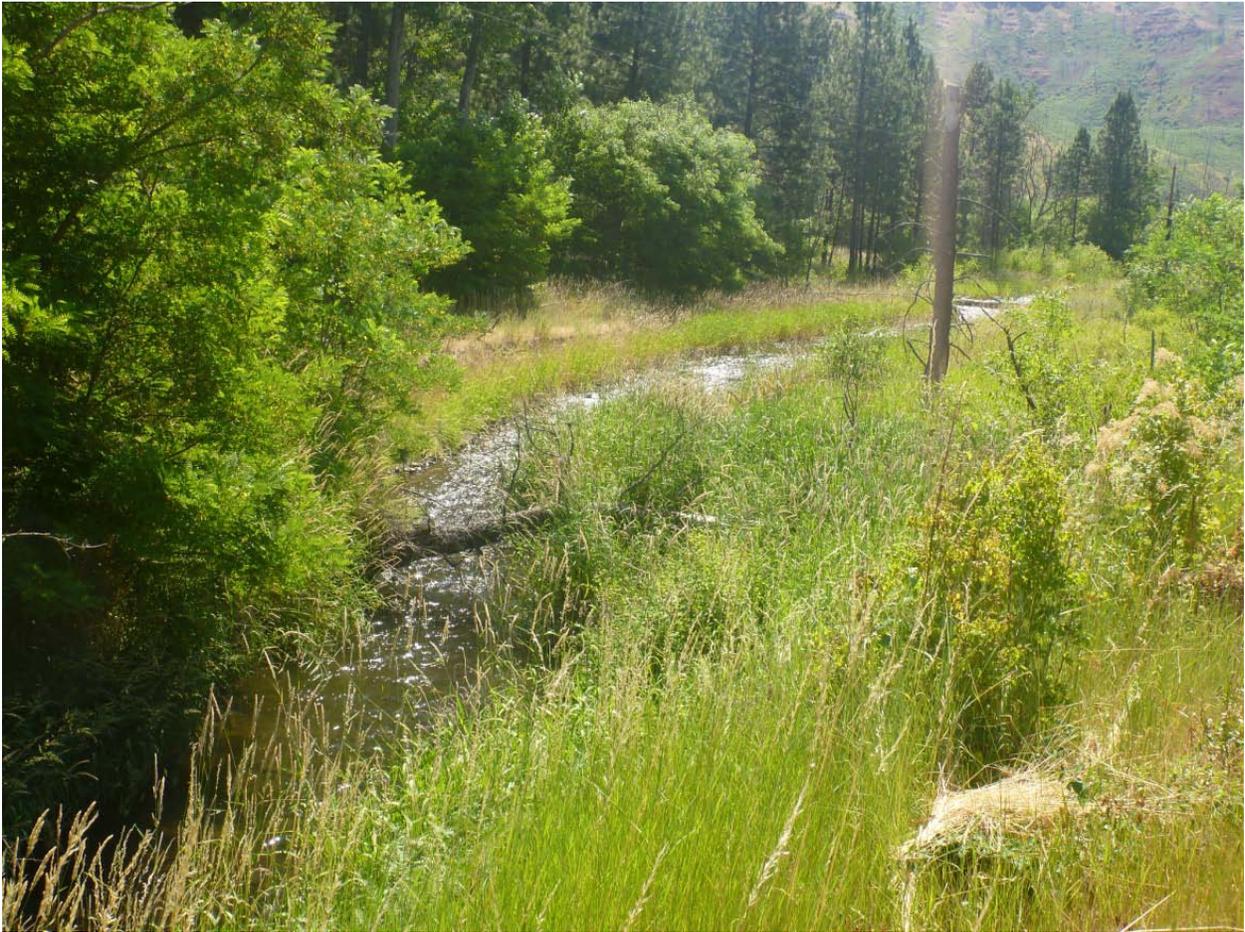
Photograph 5-3

The channel through PA-12 is relatively complex with many flow pathways through a relatively wide corridor; natural processes are occurring that are aiding in recovery through this area. No major infrastructure was observed within the channel, although the Hatchery Dam at the downstream end of the project area is a significant grade control. Several side channels were observed, a majority of which are initiated by LWD. An anabranching channel pattern is located between RM 40.5 and 40.1, where a significant side channel has cut through the floodplain along the left valley floor (Photograph 5-3). This channel runs below a power line adjacent to the road through a grassy area. Another major side channel observed between approximately RM 40.2 and 40.0 conveyed at least a third of the total discharge at the time of observation.

The side channel in the west floodplain near RM 40.4, looking upstream

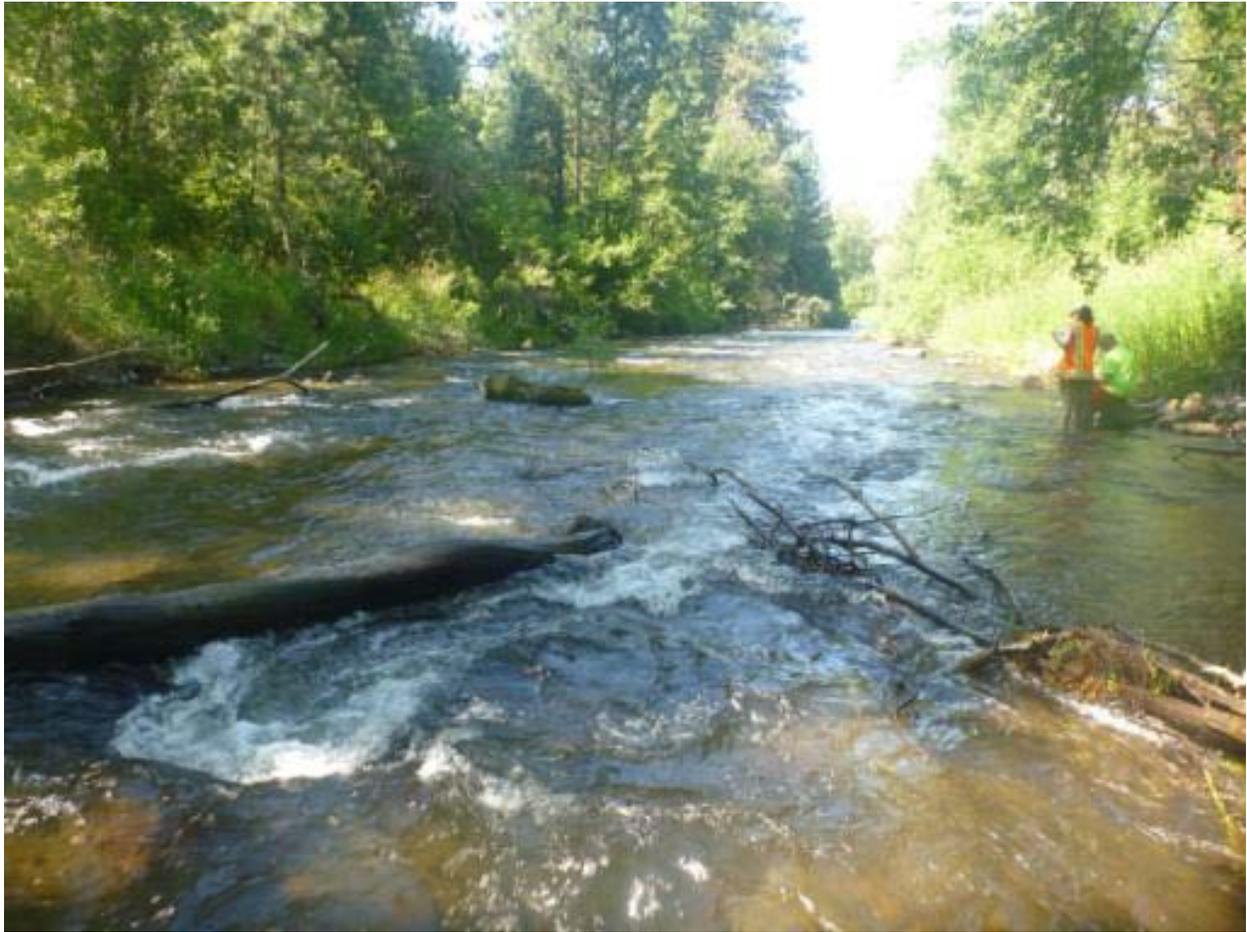
Photograph 6-1

The channel through PA-13 is characterized as a single-thread, plane-bed channel with forced pool-riffle and local rapid sections (Photograph 6-1). The channel is typically straight, wide, and contains little complexity in much of the project area. Large levees confine the channel along the right bank from approximately RM 39.95 to 39.8, at RM 39.6, and from RM 39.5 to 39.2. The levees are typically heavily armored with large angular boulders. The hatchery dam at the upstream end of the project area controls the channel grade. At the time of field observation, the dam had an approximately 3-foot drop in water surface elevation with a deep plunge pool on the downstream side. No significant side channels or off-channel areas were observed in the project area at the time of field reconnaissance.

The main channel near RM 39.6 just upstream of the large levee on the right bank, looking downstream
