CONCEPTUAL RESTORATION PLAN, REACHES 6 TO 10 TUCANNON RIVER PHASE II

Columbia Conservation District
202 South 2nd Street, U.S. Post Office Building
Dayton, Washington 99328

Anchor QEA, LLC
1605 Cornwall Avenue
Bellingham, Washington 98225

November 2011

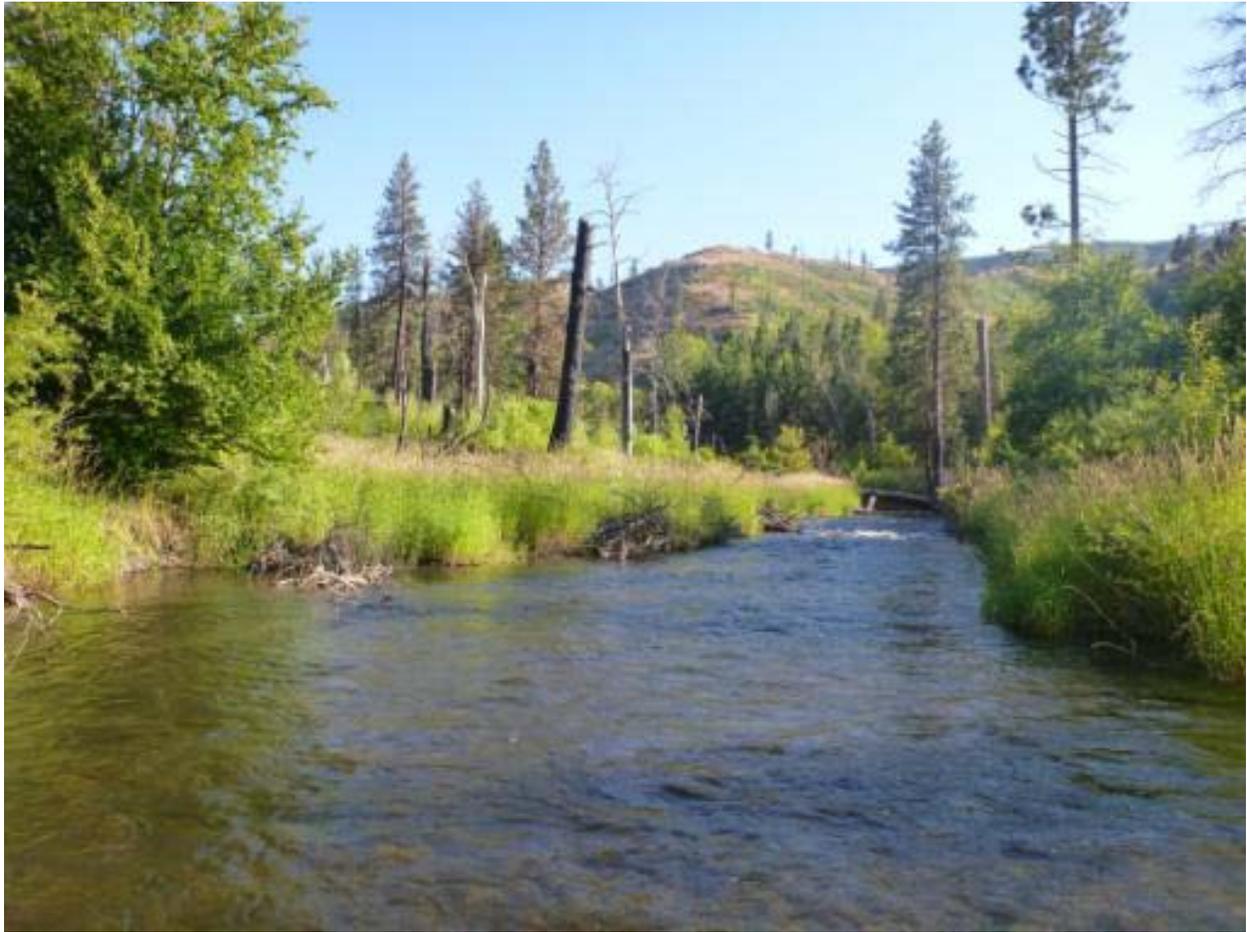
Photograph 6-2a

The channel through PA-14 is primarily a single-thread, plane-bed channel with local forced pool-riffle and boulder rapids (Photograph 6-2a). Adjacent to the hatchery, the channel is relatively straight and simplified. Existing WDFW hatchery infrastructure, including the hatchery bridge and the levee adjacent to the hatchery ponds, confines the channel from approximately RM 39.2 to 39.0. From RM 39.0 to RM 38.5, the active channel widens slightly and a few side channels and split-flow paths are present.

The main channel and floodplain near RM 38.3, looking upstream

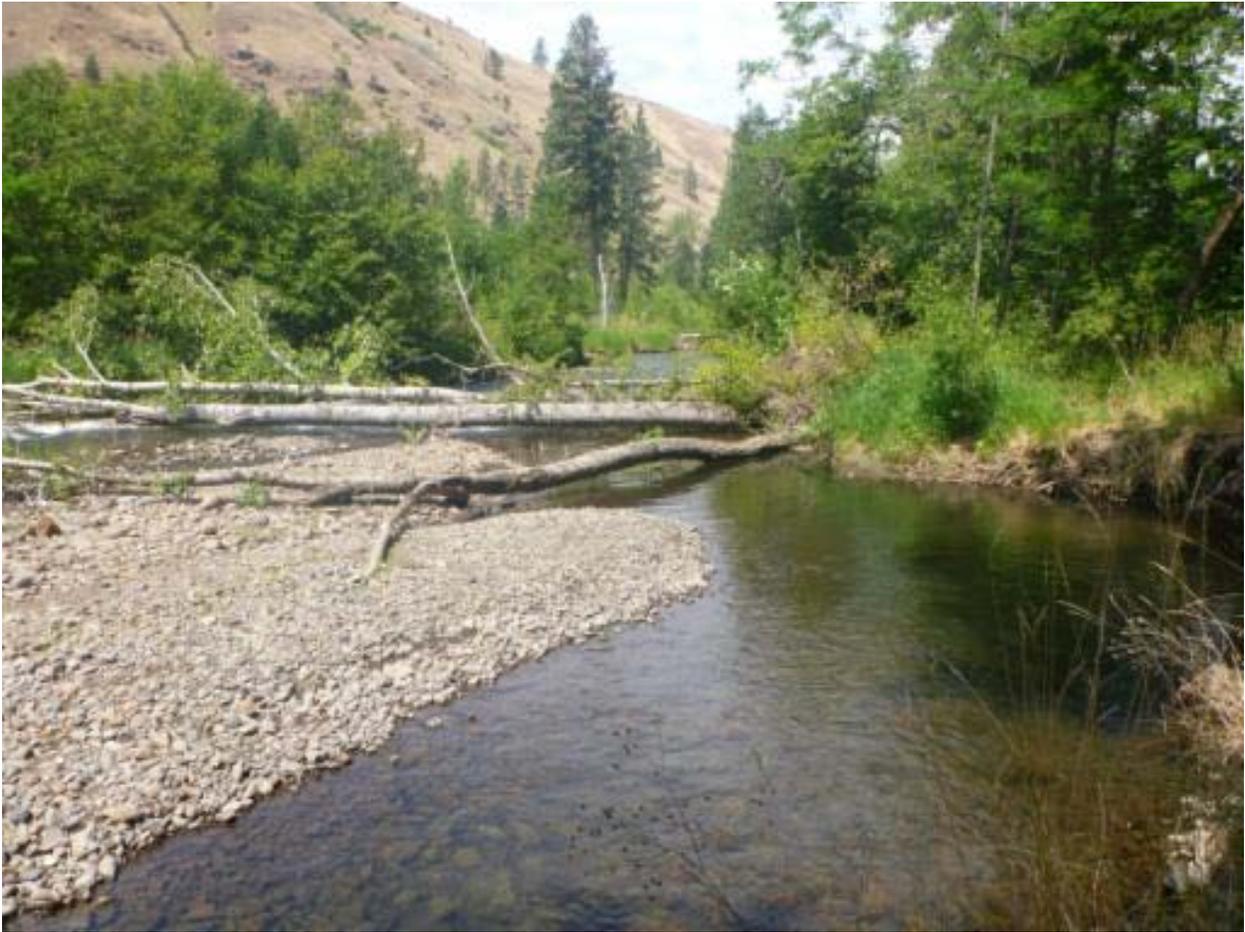
Photograph 6-2b

Wood recruitment in the channel near RM 37.5

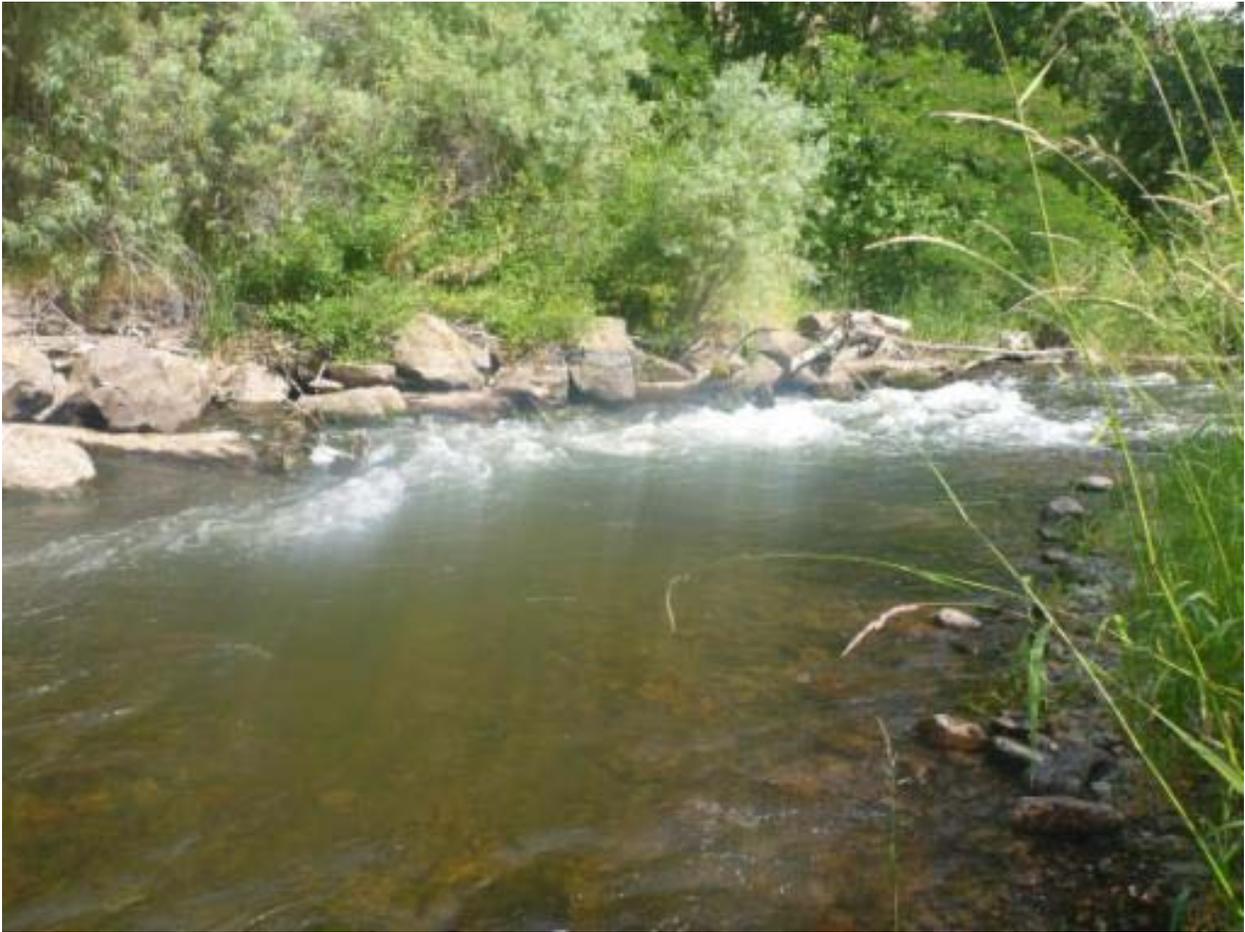
Photograph 6-3

Local incision and rapid velocities along the face of a rootwad and rock revetment

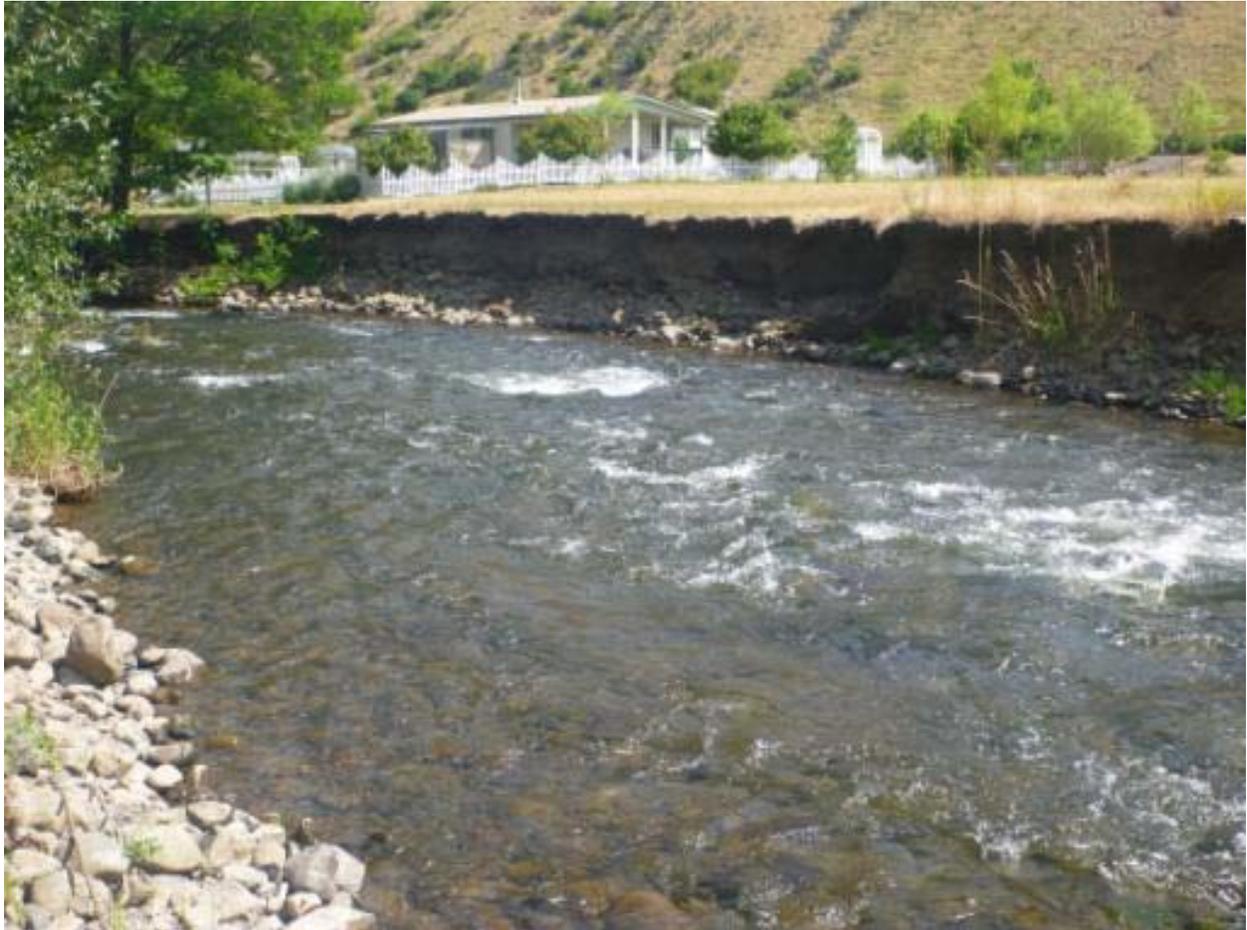
Photograph 6-4

Bank erosion adjacent to private infrastructure near RM 35.1, looking across at right bank

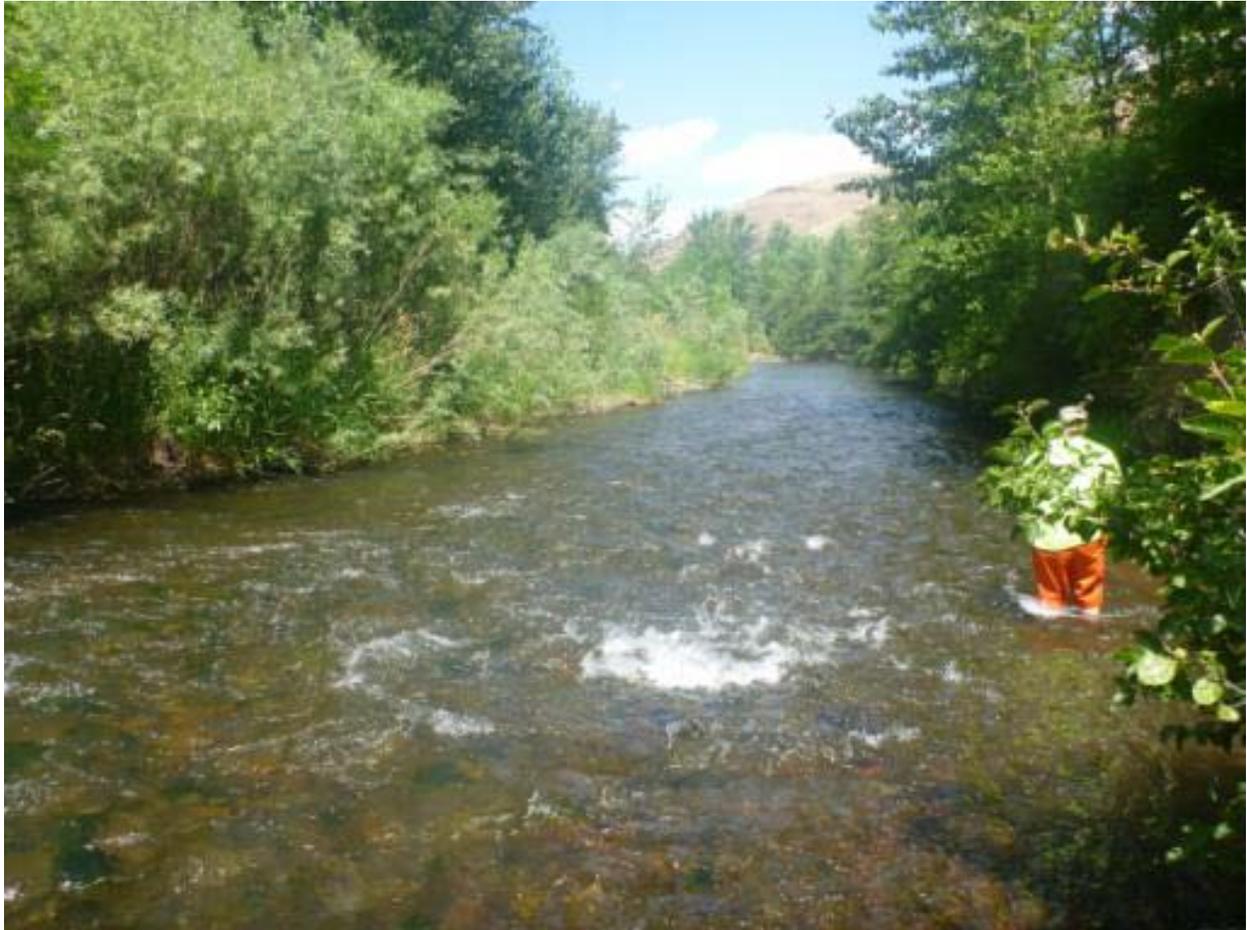
Photograph 6-5

A plane-bed section of the channel that flows along the base of a high terrace (right bank) near RM 34.4

The channel through PA-17 is characterized as a single-thread, plane-bed channel with local deep, rapid sections that contain little hydraulic complexity (Photograph 6-5). Resistant fine-grained material is located along much of the left bank. Bank armoring was observed in the upstream portion of the project area between RM 34.85 and 34.75 on both the left and right banks. From this section to approximately RM 34.7, the channel is incised and disconnected from the floodplain; riparian planting projects undertaken here have been largely unsuccessful, likely due to poor hyporheic exchange with the channel. Downstream of RM 34.7, the channel is wide and plane-bed with some deeper areas adjacent to the

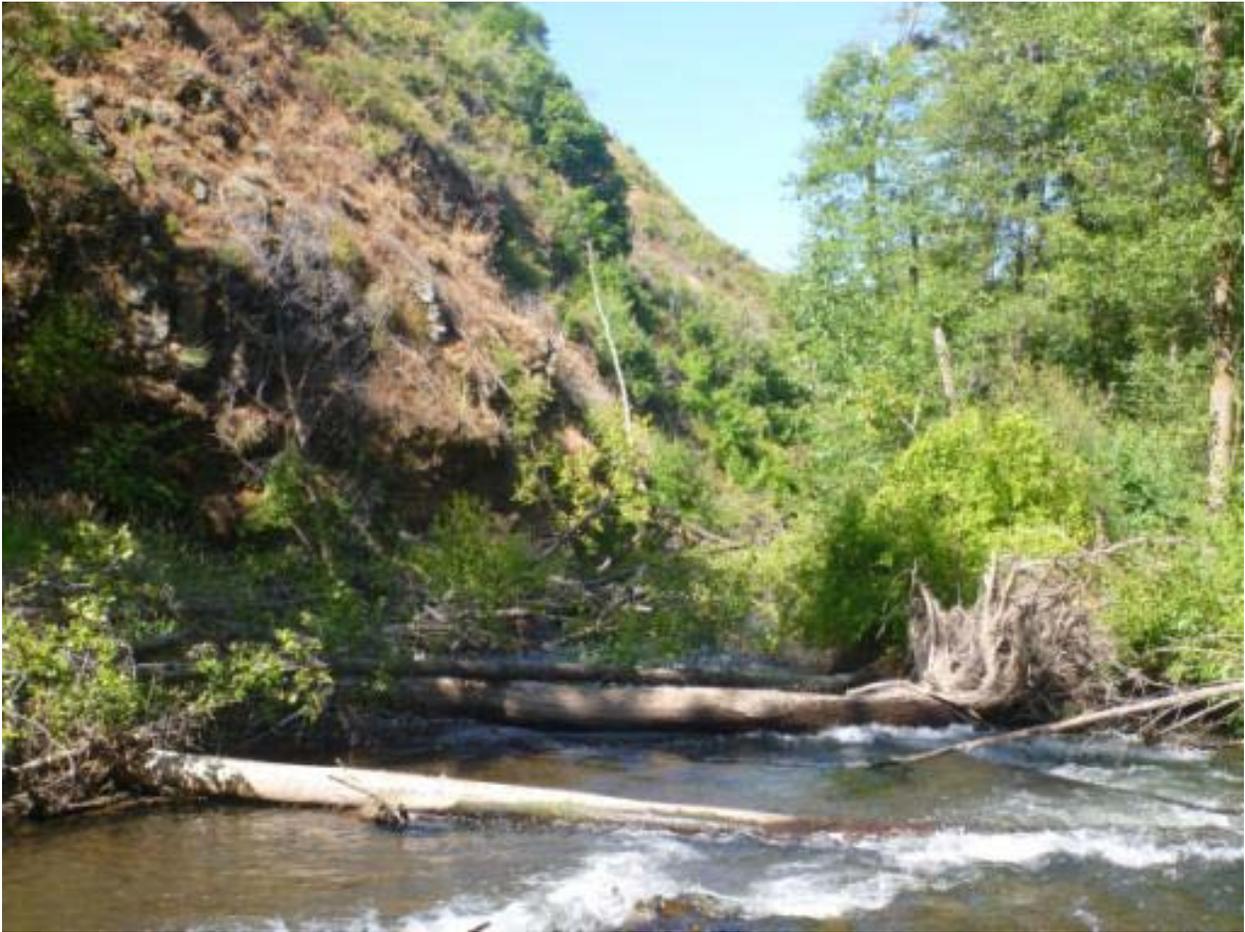
Photograph 6-6
Several large downed trees near RM 32.6

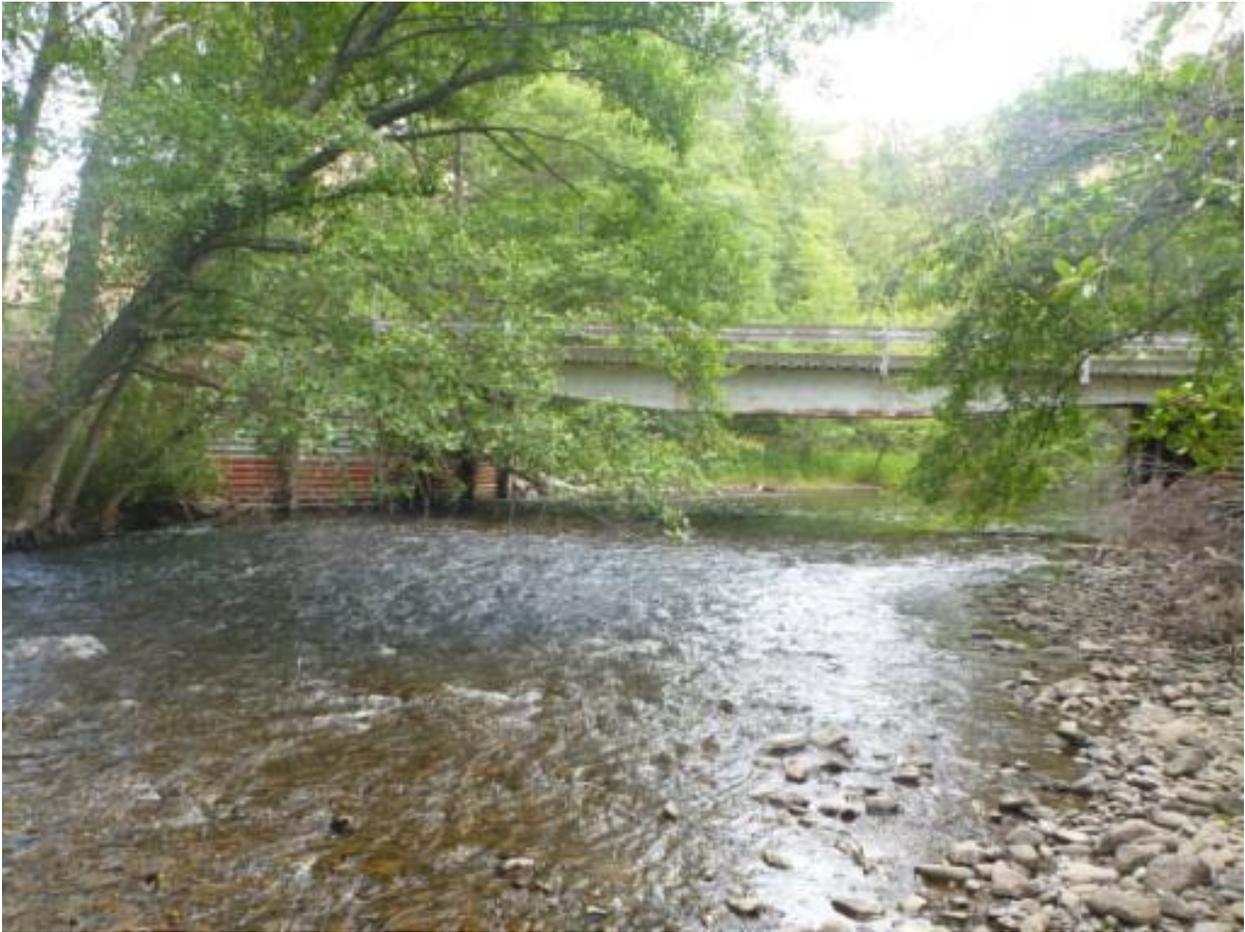
Photograph 7-1
The bridge at RM 31.8, looking downstream

The river through PA-19 is characterized as a single-thread, plane-bed channel. The channel is wide and shallow with little complexity. A rock-armored levee is located along the right bank near RM 31.95, and other large boulders and riprap were observed along the left bank upstream of the bridge. The bridge abutments are lined with corrugated steel sheeting. The bridge span and low chord elevation create a narrow opening beneath the bridge (Photograph 7-1). This likely constricts the river during high flows and creates high velocities through the bridge opening and on the downstream side. The bridge appeared to be old and in disrepair. No available off-channel areas other than a minor flow split near RM 32.0 were observed in this project area.

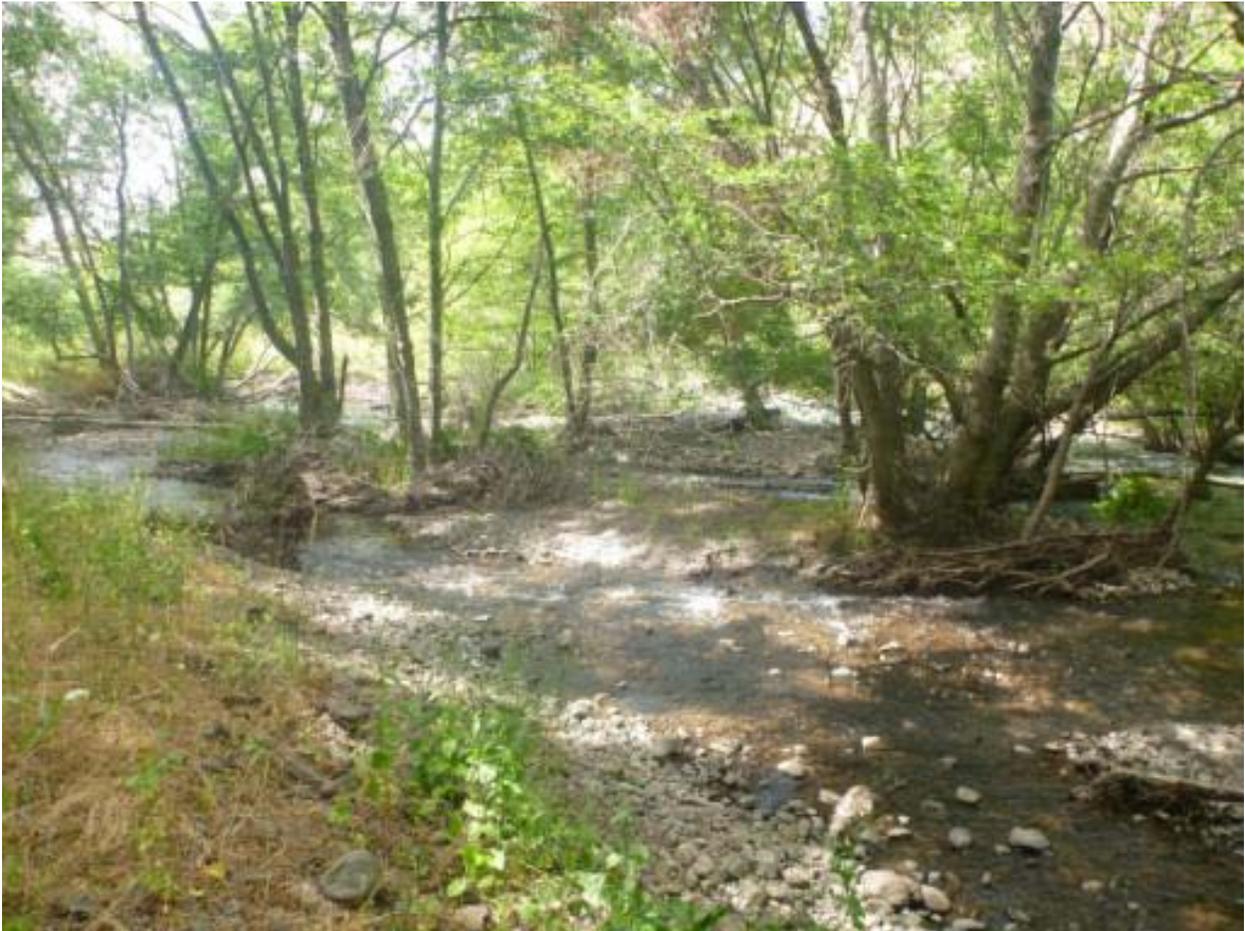
Photograph 7-2

Side channel development via channel expansion occurring near RM 31.7

actively migrating, expanding, and aggrading in this project area as evidenced by recent channel development and recruitment of trees along the banks (Photograph 7-2). Side channel connectivity is relatively good.

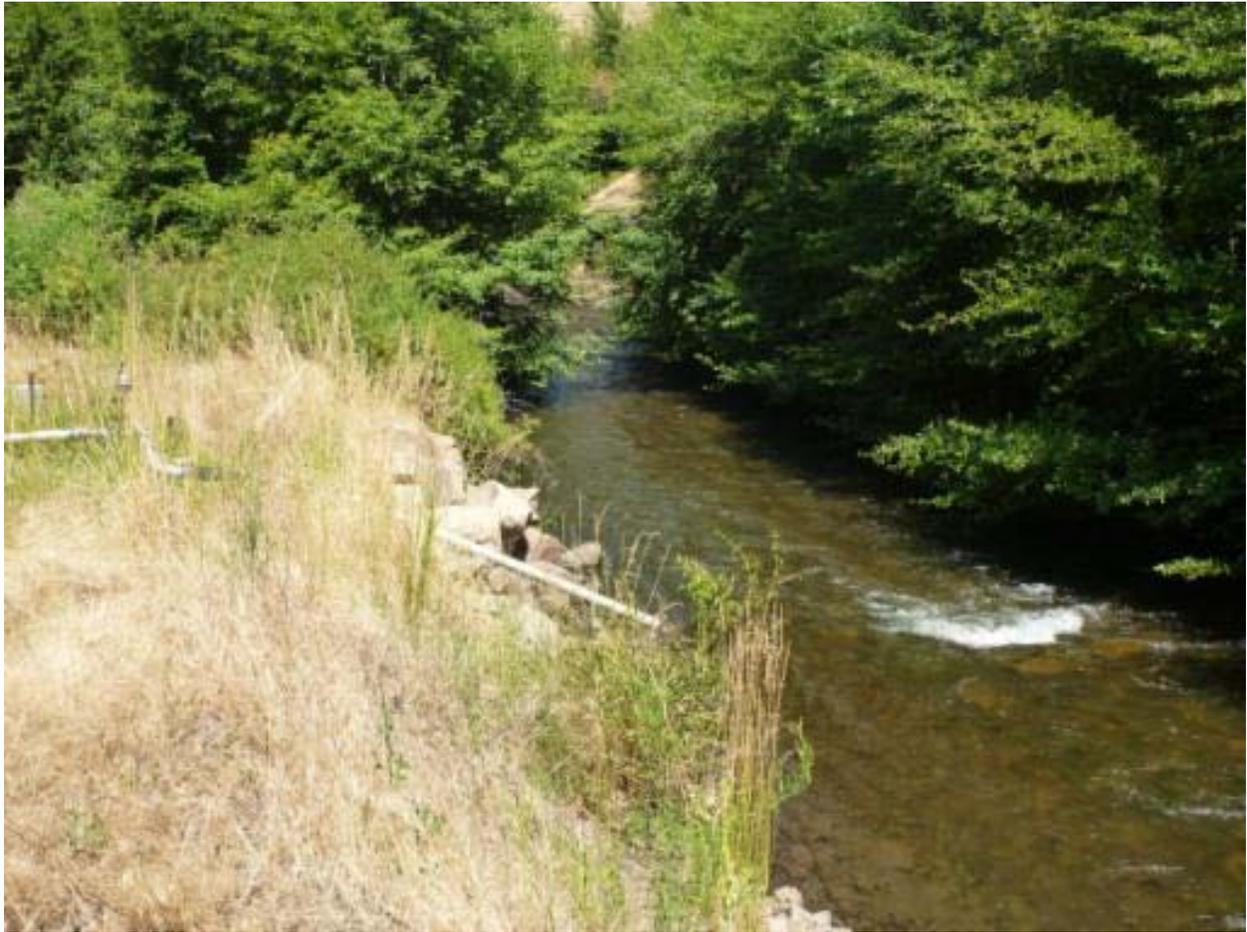
Photograph 7-3

An irrigation intake pump near RM 30.5, where the channel grade is several feet below the floodplain surface

The channel through PA-21 is characterized as a single-thread, plane-bed channel. Overall, the channel is highly impacted by human activities (likely dredging and straightening) and the presence of infrastructure. A majority of the channel is wide and shallow with little complexity. Local rapids and pools are associated with the presence of boulders and rock weirs. Two short split flow sections are present between RM 31.1 and 30.7, where a moderate amount of LWD has accumulated and formed relatively deep pools. Downstream of RM 30.7, the channel may have been dredged historically; the channel bed is several feet below the floodplain surface (Photograph 7-3). Throughout the project area, the right bank flows along the toe of the valley wall. Much of the left bank is lined by levees, riprap, and spoil piles that confine the channel against the valley wall. An access road located at approximately RM 30.9 also confines the left bank at the downstream end of a long dredge-spoil levee that lines the tributary that enters the river at approximately RM 31.0. Several rock weirs and rock structures throughout, and bedrock near RM 31.2, hold the channel grade throughout the project area. Three large rock weirs with deep plunge pools and one large rock barb are located between RM 30.7 and 30.6. Irrigation pumps are located at approximately RM 31.15, 30.9, and 30.5.

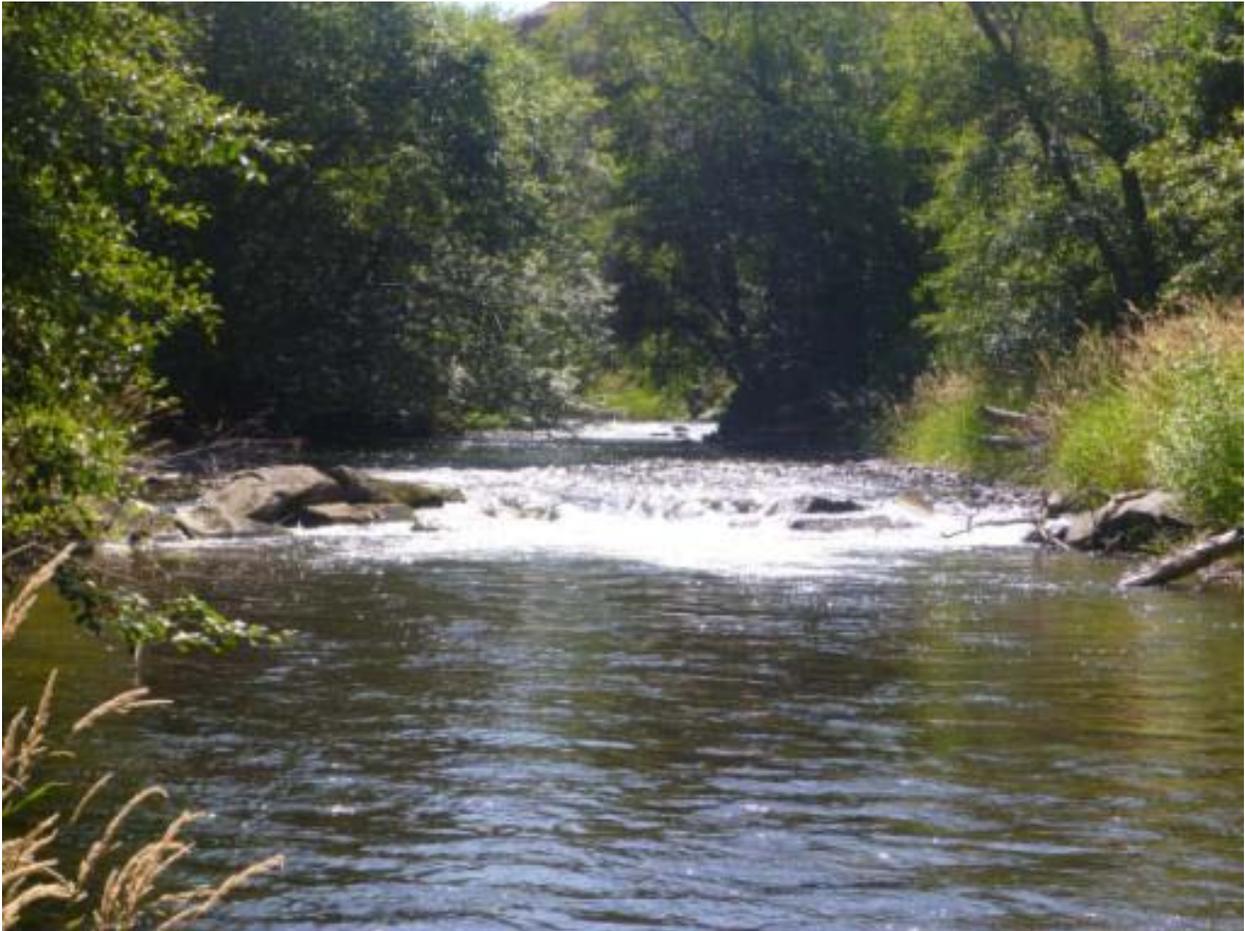
Photograph 7-4

A large rock weir near RM 29.4

The channel through PA-22 is characterized as a single-thread, plane-bed channel with local rapid sections and forced pools at weirs placed in the channel. The sinuosity of the channel is very low. The channel is primarily wide and shallow throughout the project area, except for a few local areas with boulder weirs and large plunge pools at rock weirs (Photograph 7-4). From the RM 30.3 bridge to the weir at RM 30.1, the channel is incised where it is confined between two large levees, as evidenced by undercutting of the bridge abutments. Throughout the project area, the channel is confined between the valley wall and levee and riprap infrastructure along adjacent farmland. Large levees are located along the majority of the right bank. Riprap and boulders were also observed throughout the project area, along both banks, and in the channel bed. Remnant spoil piles indicate that dredging and channel straightening may have occurred historically. At least nine rock weirs are located between RM 30.1 to 29.4 that control the channel grade throughout the area. There are multiple

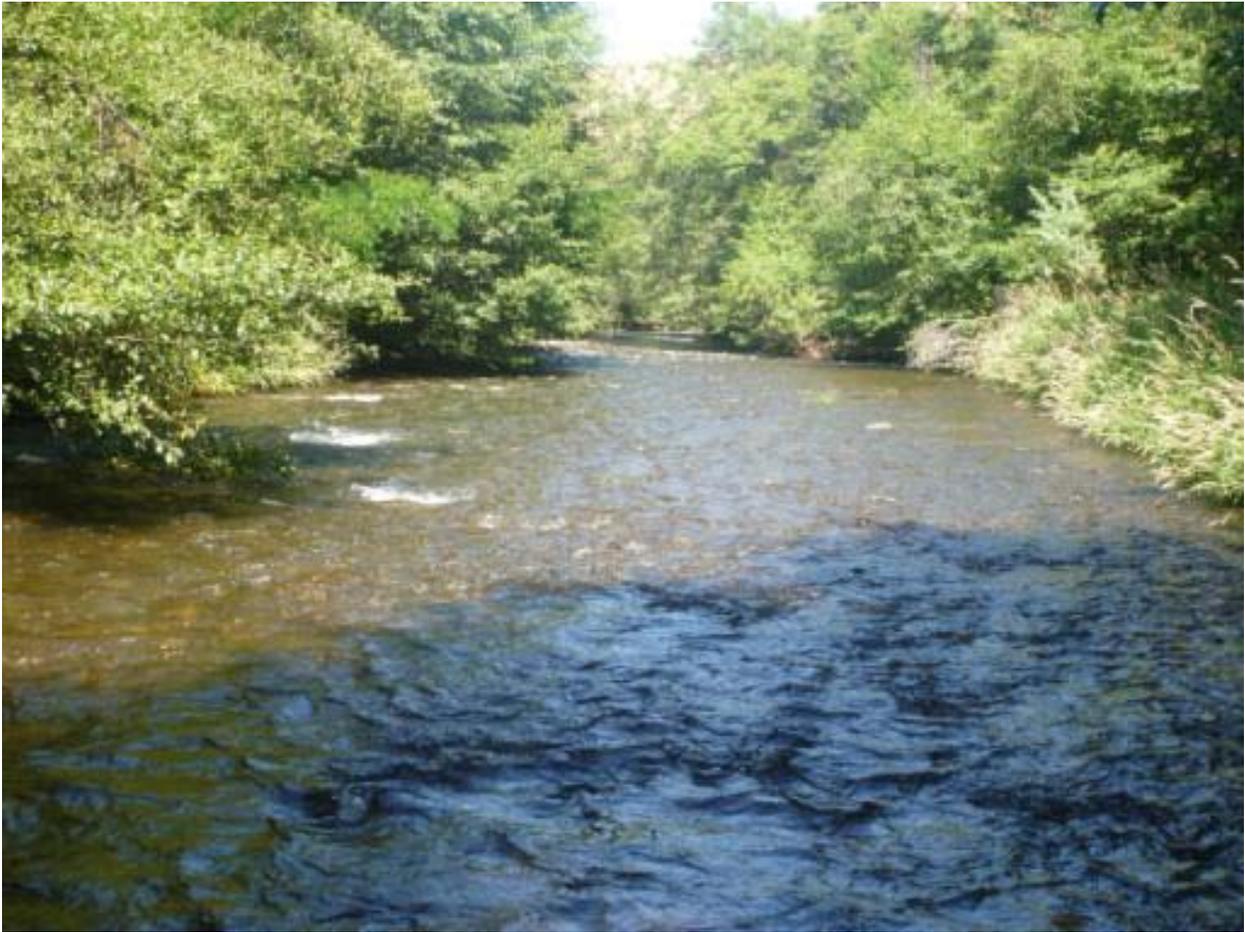
Photograph 7-5

A wide, shallow section of the channel near RM 29.4

The channel through PA-23 is a single-thread, plane-bed channel that is highly confined to a straight alignment between infrastructure and the valley wall (Photograph 7-5). Levees and spoil piles confine the upper project area between approximately RM 29.3 to 29.1, and much of the right bank downstream of this point is lined by levees. At approximately RM 28.6, a series of rock barbs are located along the bank, followed by a large rock weir at RM 28.45. Levees confine the channel between the weir and the downstream end of the area. One small spring or tributary is present in the left floodplain near RM 29.1, and a small alcove is present at the downstream end of this area. The low-lying floodplain area is disconnected from the channel at the upstream end by a large armored levee along the left bank that constricts the channel to a tight bend at RM 28.35.

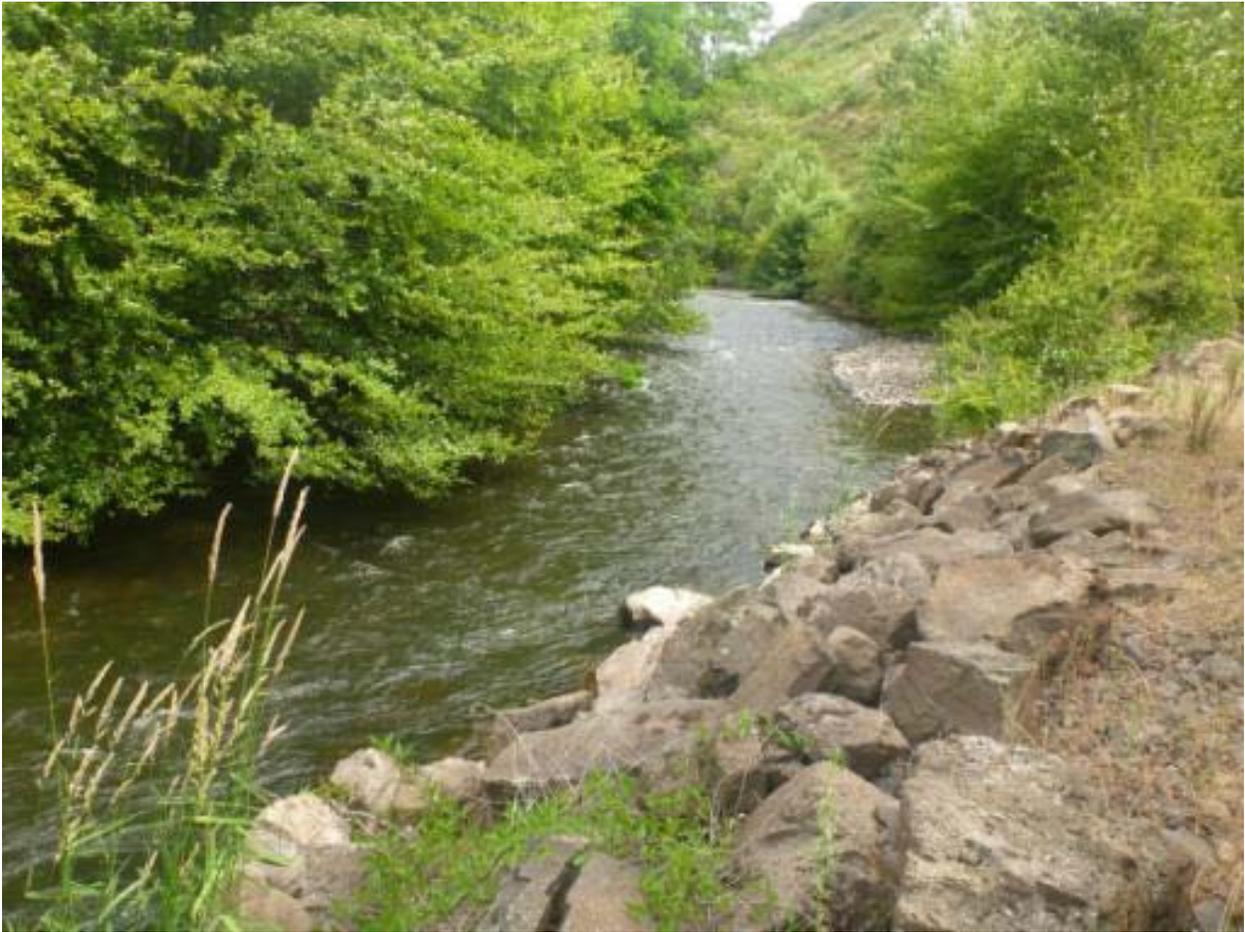
Photograph 7-6

A large rock levee on the left bank near RM 27.9, looking upstream

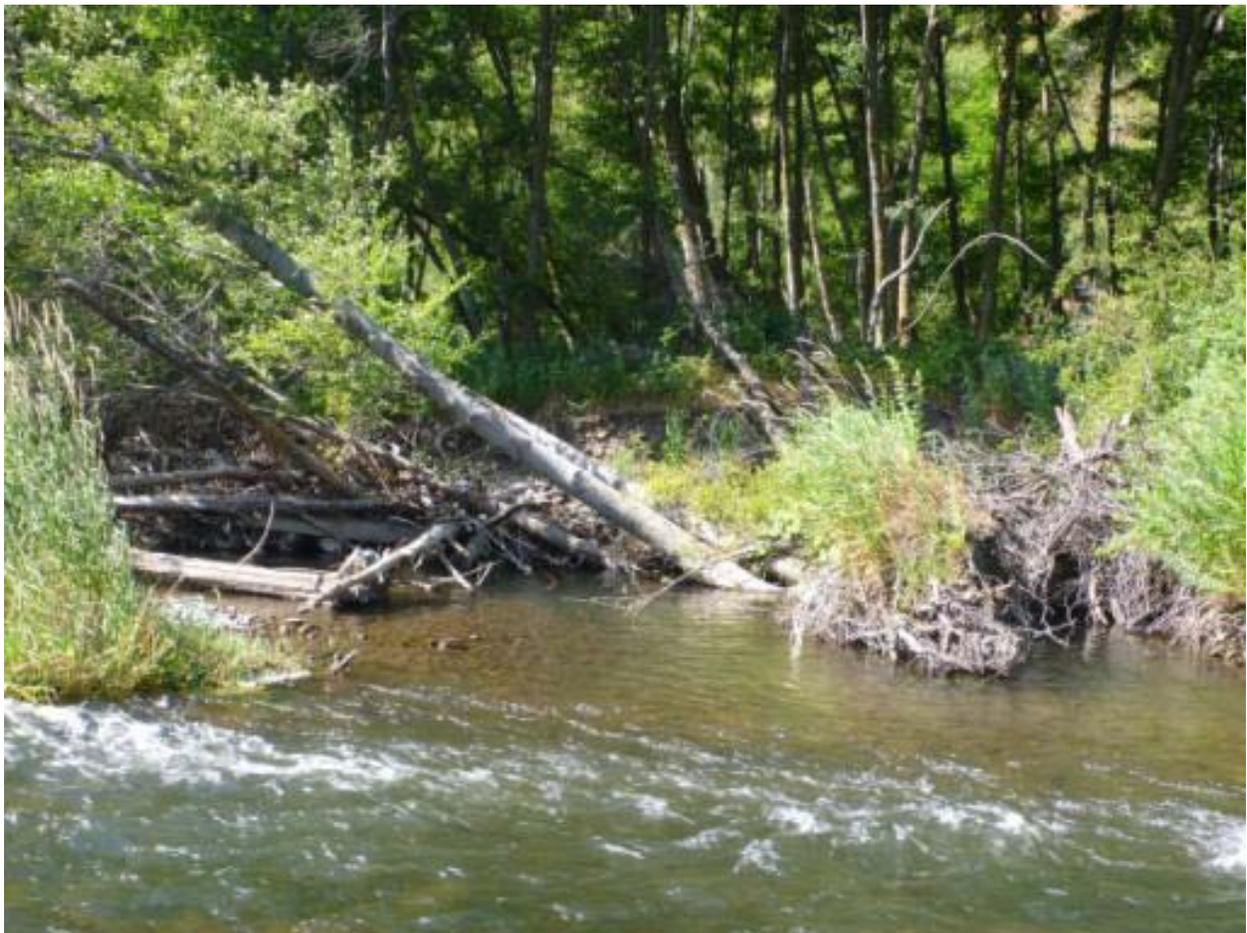
Photograph 8-1

Recently recruited trees along the left bank near RM 27.25

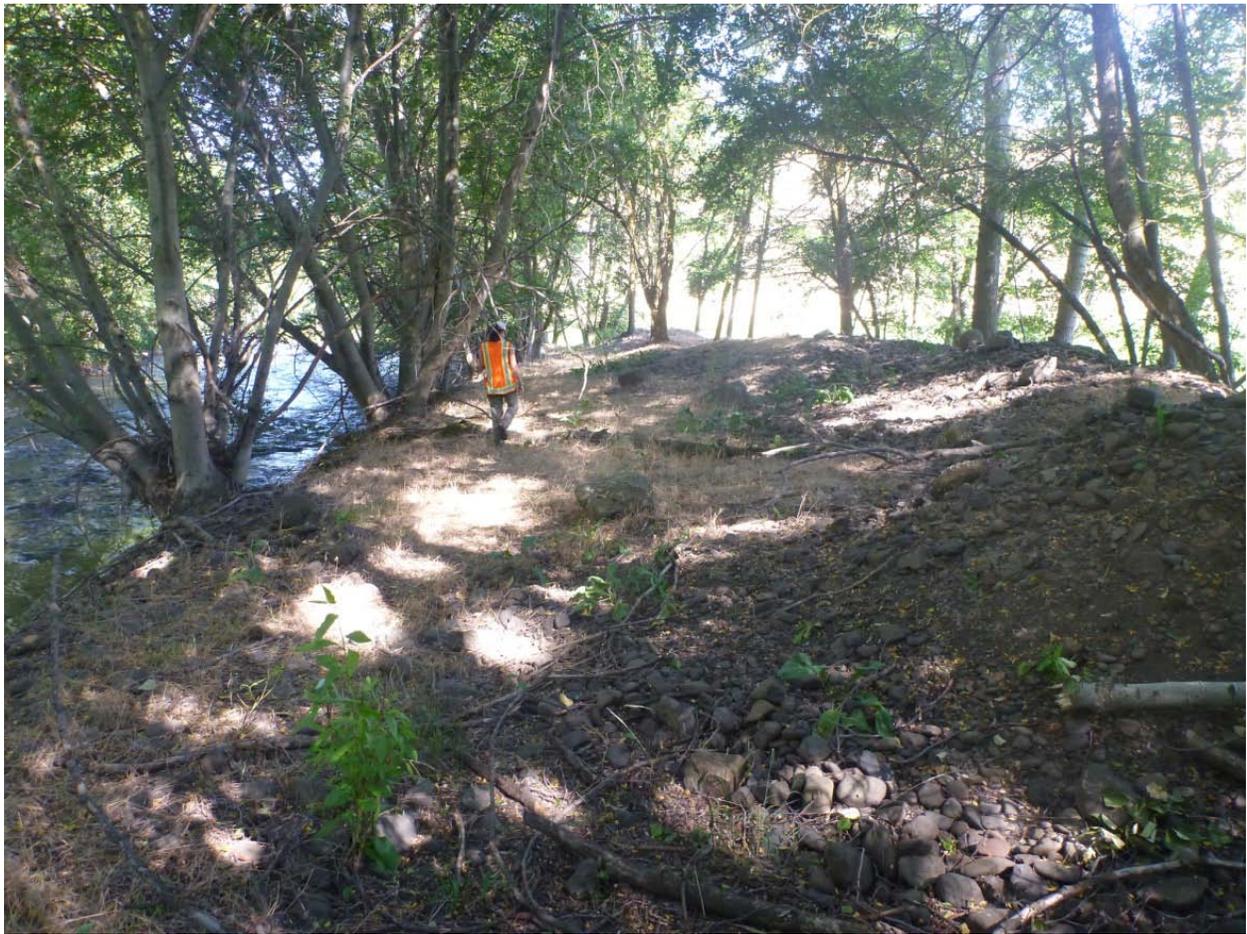
Photograph 8-2a
The right bank levee near RM 26.6, looking downstream

The channel through PA-26 contains both sections of dynamic and complex channel networks, as well as wide, plane-bed stretches with little complexity. In the upper portion of the project area, from Turner Road to approximately RM 26.0, the river is confined against the valley wall by bank armoring and levees to a single-thread, plane-bed channel (Photograph 8-2a). The levee materials are typically composed of angular armor rock, as well as a rock/wood revetment just downstream of the Turner Road Bridge. Three large vortex rock weirs located between RM 26.3 and 26.2 control the channel grade.

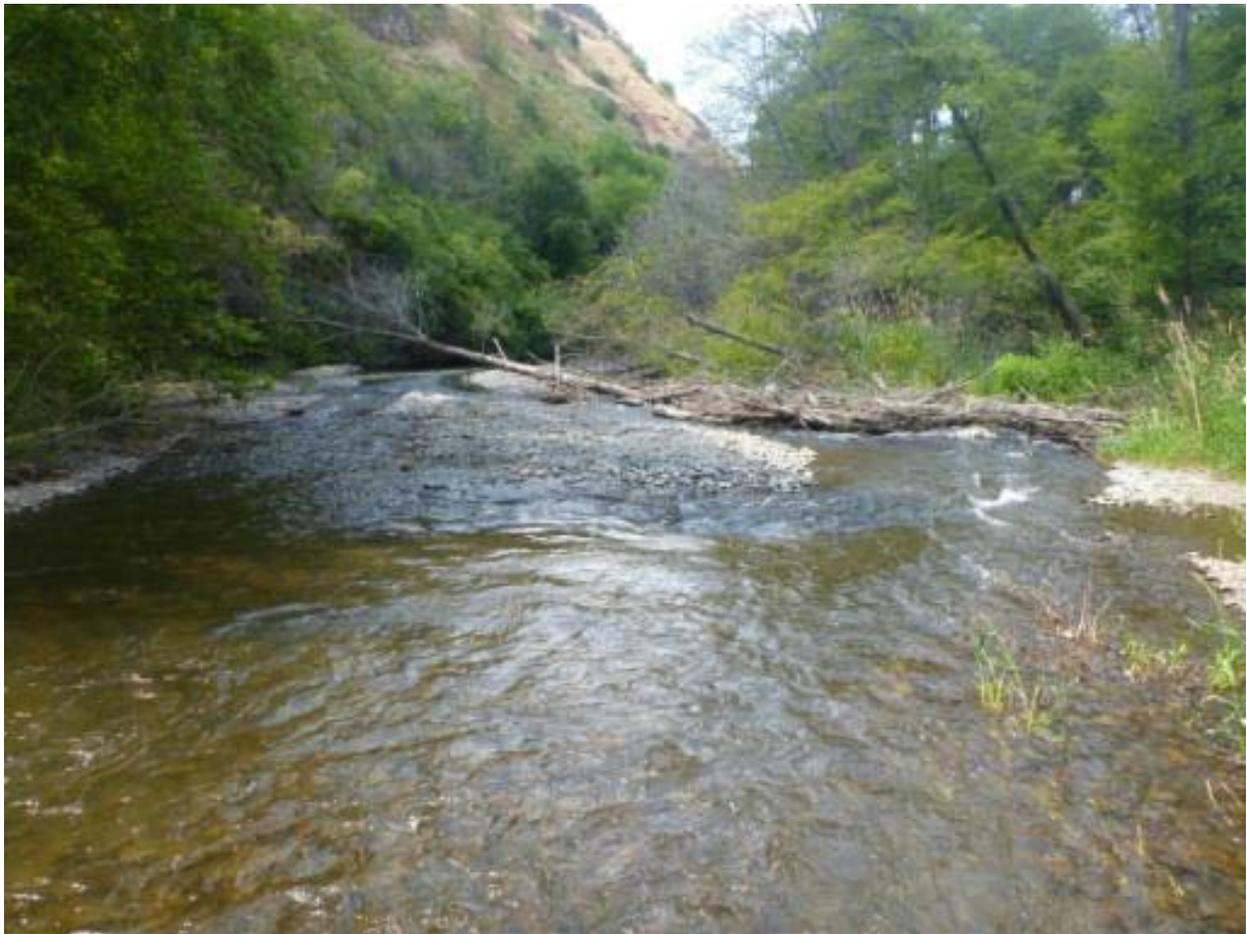
Photograph 8-2b

An unconfined, aggrading section of the channel near RM 24.5

sediment deposition. The river makes a tight bend around a resistant fine-grained deposit at RM 25.0 and is confined against the valley wall by a levee to RM 24.85. Between RM 24.85 and 24.3, the main channel flows parallel to the valley wall but has a wide, aggrading active channel area. Moderate to high LWD is present in this section where wood is being recruited as the channel expands (Photograph 8-2b). Several deep alcove pools are present along the margins of the channel, as well as pools that have scoured out at fallen LWD and root masses of standing trees. Some short sections of riprap were observed within this portion of the channel at RM 24.8 and 24.6. At RM 24.6, the river flowed through the riprap into a low area on the opposite side.

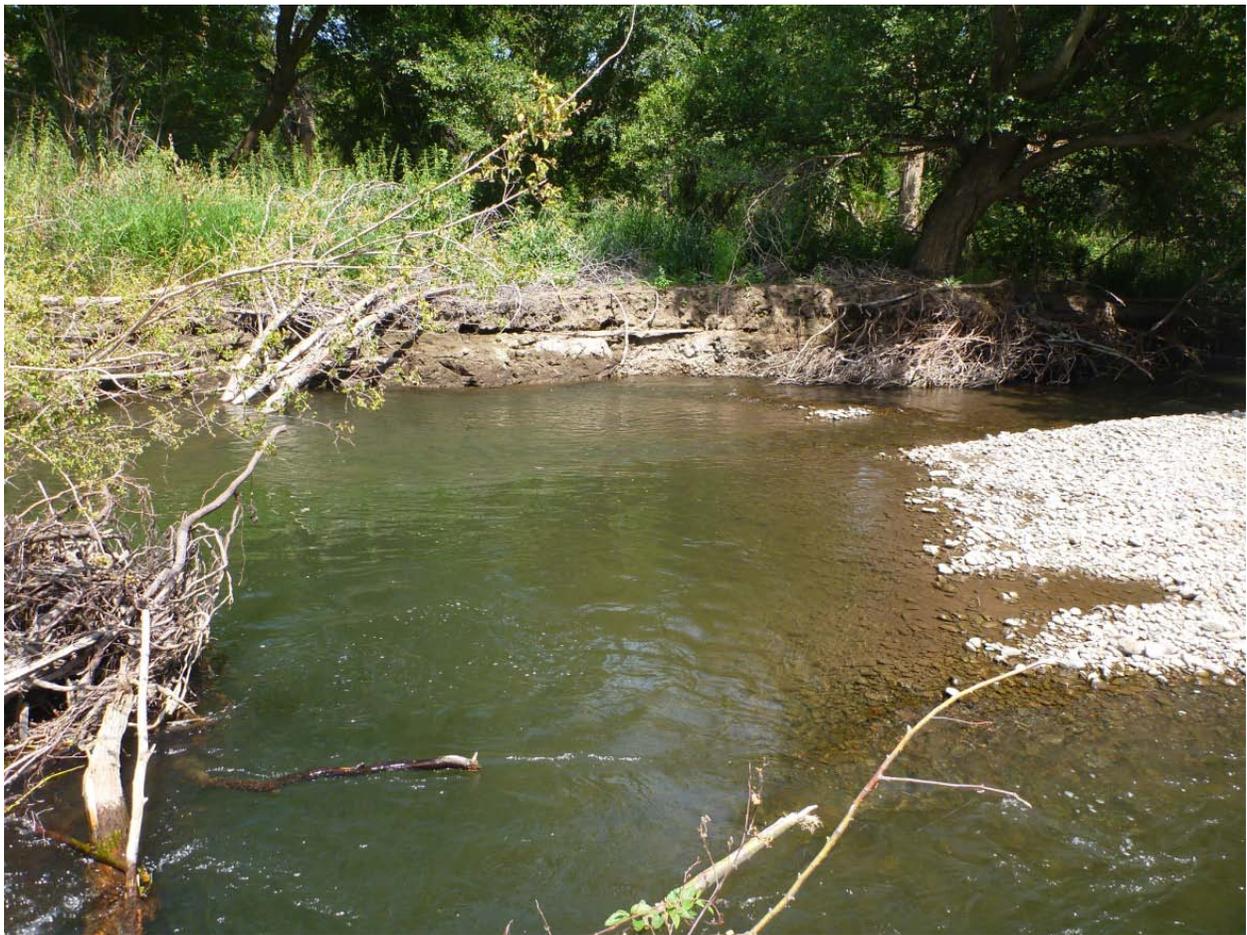
Photograph 8-2c

A deep pool and recruited tree along the outside of a meander bend near RM 24.1

Between RM 24.2 and 23.65, the river is characterized as a highly dynamic, meandering, forced pool-riffle channel. The channel has multiple secondary flow paths and side channels and contains many deep pools at LWD and along the outside of meander bends (Photograph 8-2c). Remnant alluvial fans and terraces that are relatively resistant to erosion compared to the recent alluvium in the active channel create tight bends in the channel planform. A pump and short armored levee are located along the left bank at approximately RM 23.8.

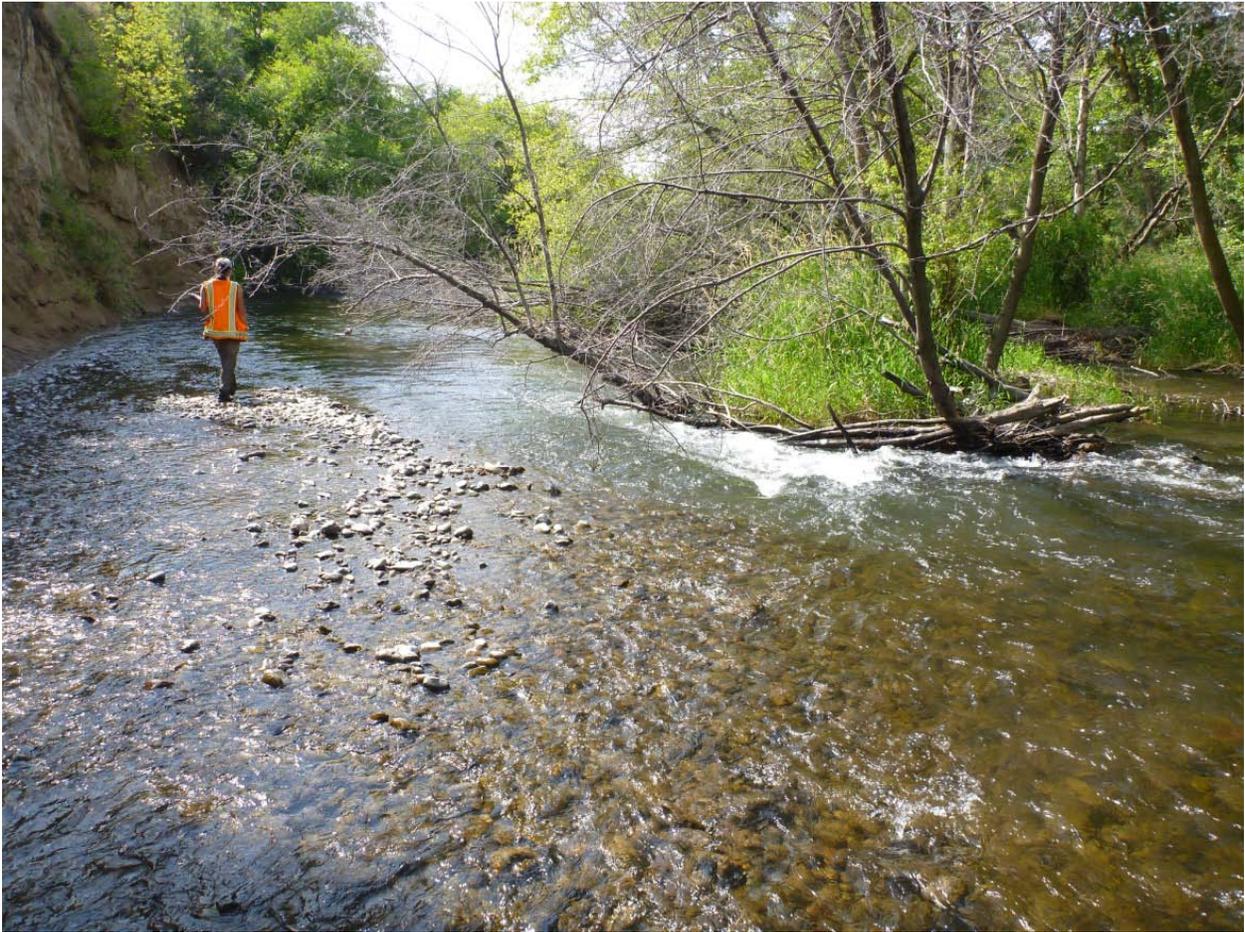
Photograph 8-3

A deep pool formed at a tree root and at a resistant bank near RM 23.1

The channel through PA-27 is characterized as a single-thread, plane-bed channel in the upper end of the project area between approximately RM 23.65 and 23.4. Downstream of RM 23.4, the river contains downed trees and resistant fine-grained banks that force deep pools and some small side channels (Photograph 8-3). One rock habitat structure along the right bank near RM 22.95 also created a deep pool. Some evidence of channel migration and expansion was observed, such as within the area shown in Photograph 8-3. Riprap and levees are located in some portions of the project area, along with possible historic spoil piles that could not be verified upon observation. Riprap along the left bank at the approach to King Grade results in a steep, straight channel bank that showed some signs of undercutting of the riprap and tree roots along the toe of the bank. The upstream end of the project area contained no available off-channel habitat at the time of observation. The middle to lower project area between RM 23.4 and King Grade contained some short sections of side channels and slow-moving backwater alcoves, such as at RM 23.25.
