CONCEPTUAL RESTORATION PLAN, REACHES 6 TO 10 TUCANNON RIVER PHASE II

Columbia Conservation District
202 South 2nd Street, U.S. Post Office Building
Dayton, Washington 99328

Anchor QEA, LLC
1605 Cornwall Avenue
Bellingham, Washington 98225

November 2011

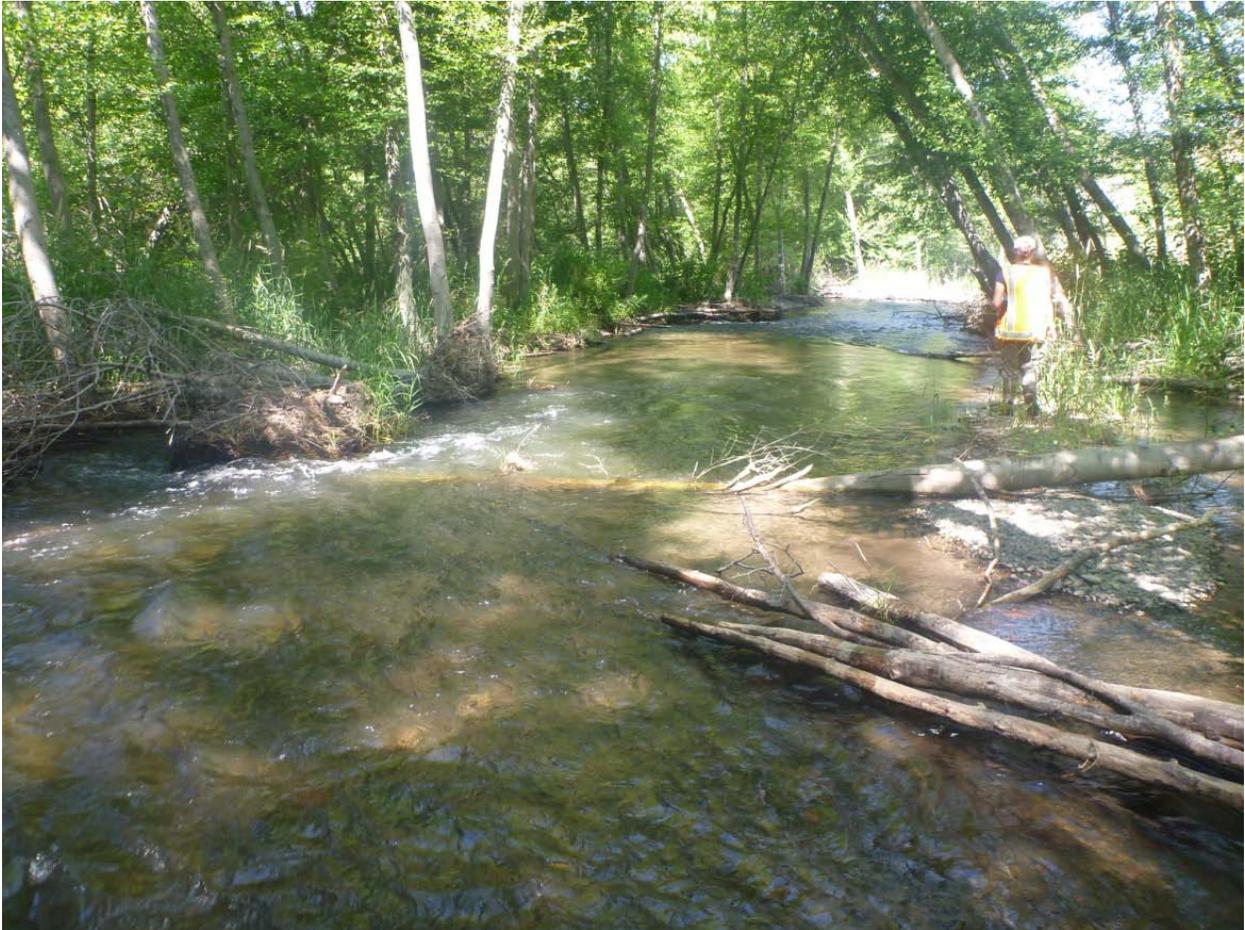
Photograph 8-4a
Forced pools and riffles near RM 22.5

The channel through PA-28 contains primarily a dynamic, multiple-thread channel with forced pools, riffles, and rapid sections (Photograph 8-4a). Some portions of the project area contain a relatively straight and single-thread channel with little complexity; these areas are typically influenced by the presence of infrastructure. From King Grade to RM 22.1, the channel is actively migrating and aggrading. Several recently recruited trees and newly formed side channels were observed throughout this area, along with a high volume of temporary sediment storage in the form of gravel point bars and islands. Deep pools were observed at rootwad logs, larger log jams, and along the outside of meander bends. One ELJ was observed at RM 22.6 that contained a very large pool and ample cover that many fish were utilizing. This section of the project area did not contain any significant bank armoring, but some remnant spoil piles or pushup levees were present in the floodplain.

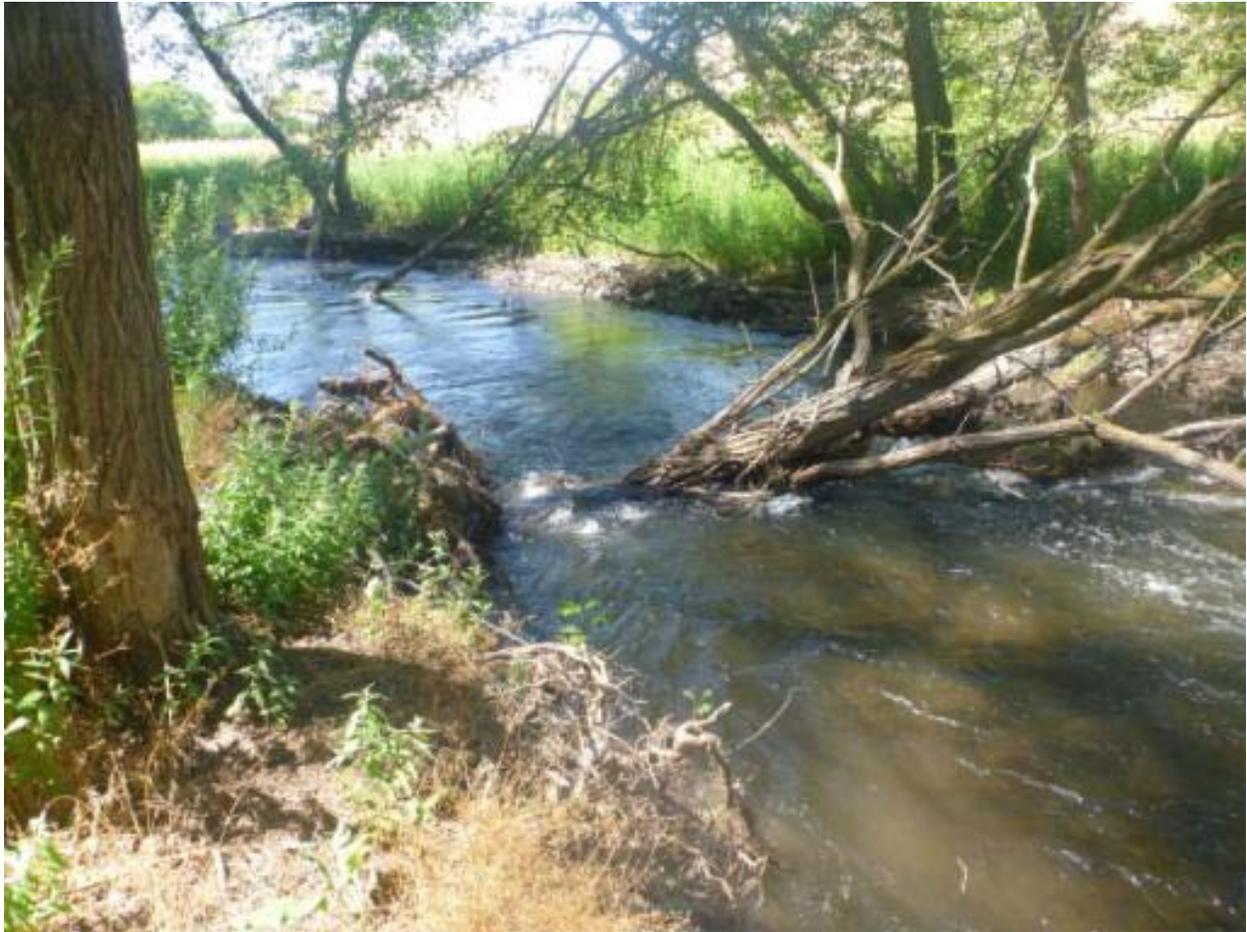
Photograph 8-4b

A recent avulsion of the main channel to a position adjacent to an agricultural field near RM 21.35

Between RM 21.7 and 20.35, the river transitions back to a dynamic channel with signs of aggradation and migration throughout. A relatively recent channel avulsion was observed at RM 21.4 that resulted in the main channel flowing adjacent to an open field for approximately 1,000 feet (Photograph 8-4b). Bank armoring and spoil piles are present throughout this section. Some of this infrastructure influences channel process, but many have been damaged and mobilized by channel migration. The most significant infrastructure that affects the channel is located along the right bank adjacent to the field between RM 21.0 and 20.9, as well as an armored levee along the left bank that is associated with a power line crossing at RM 20.6.

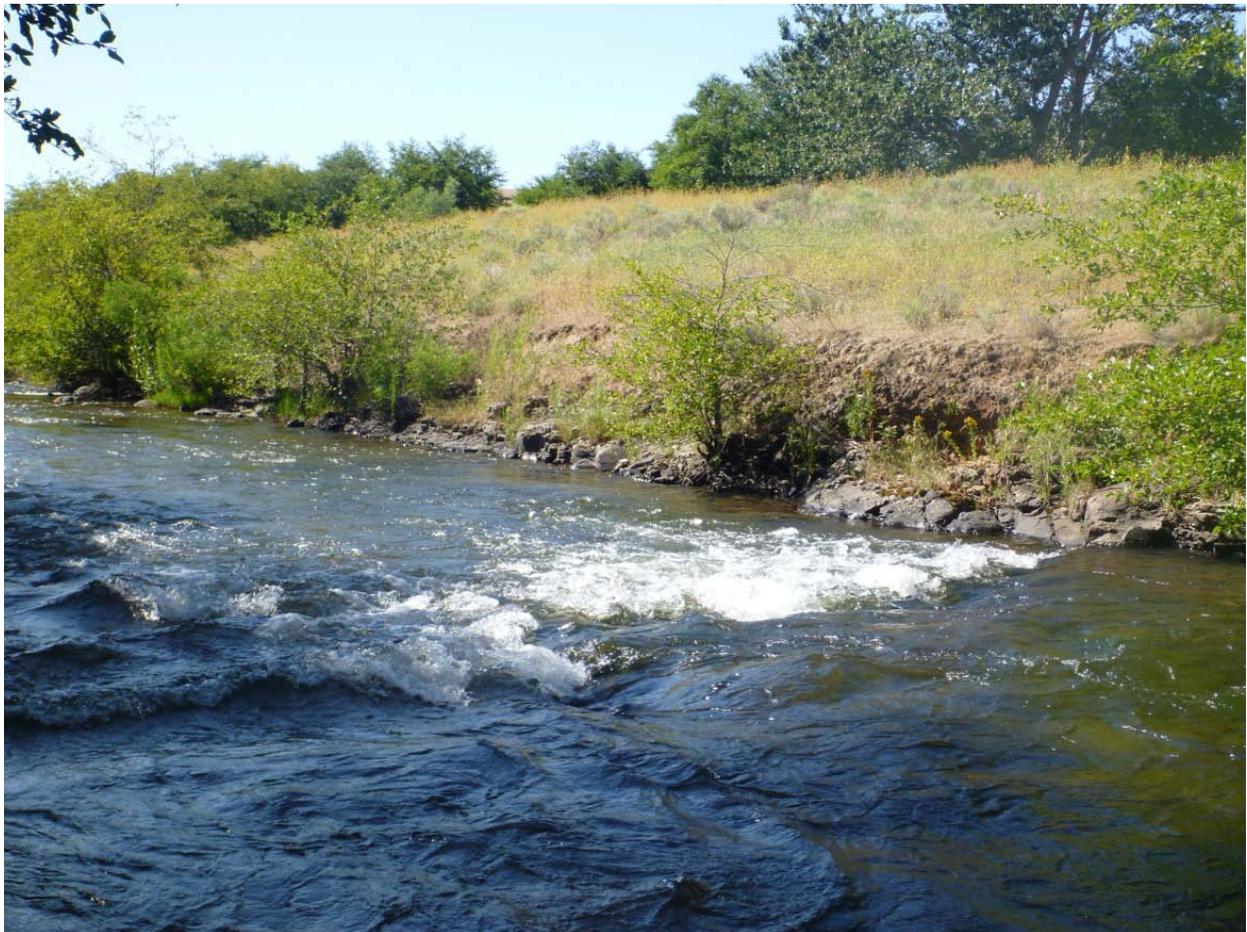
Photograph 8-4c

Bedrock in the channel and along the right bank where the channel flows through a bedrock knob near RM 20.15

The channel between RM 20.35 and 20.0 is relatively straight with a wide, plane-bed section with multiple rapid sections created by bedrock in the channel. The rock weir located at RM 20.35 and the bedrock in the channel throughout much of the remainder of the project area hold the channel grade. Between RM 20.15 and 20.1, the channel is located through a knob of bedrock (Photograph 8-4c); this likely was the result of a historic management action to place the channel against the valley wall because of the multiple-channel pathways that are located through the floodplain north of the bedrock. A levee is located off the downstream end of the bedrock between RM 20.1 and 20.05. A steep drop in the channel grade at a bedrock protrusion is present adjacent to the levee.

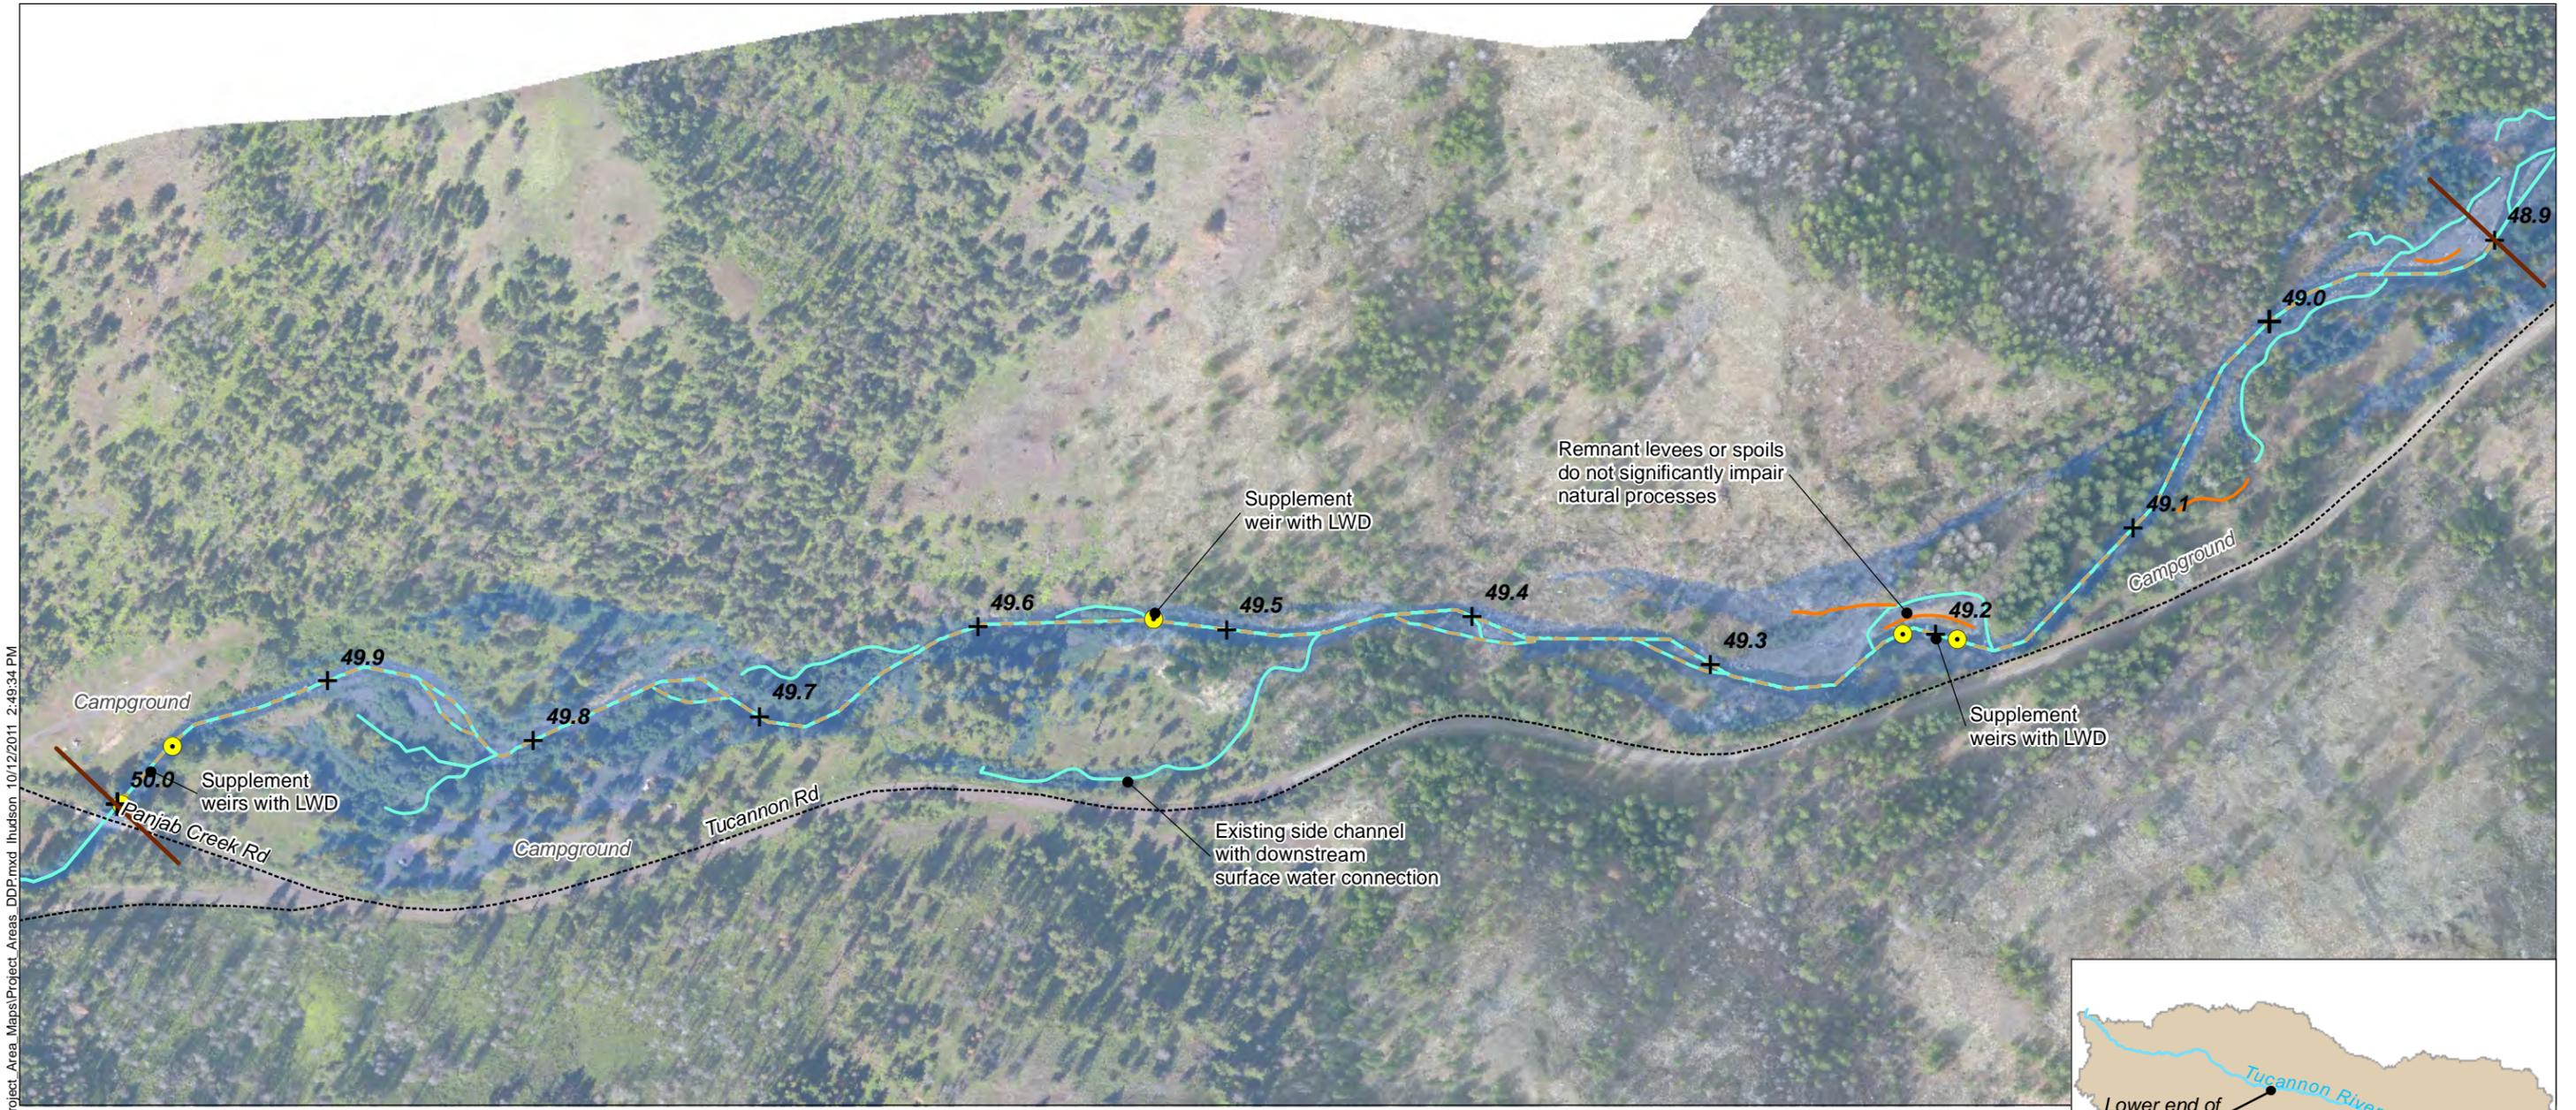
Figure B-1
 Project Area 1, River Mile 50.0 to 48.9
 Tucannon River Habitat Restoration Design, Preliminary Project Areas Memorandum
 Columbia Conservation District
