SITE NUMBER: B-235R-02 (was B-R4-03)

LOCAL NAME: Dahlgren Springs

NORTH COAST OFF CHANNEL SITE INVENTORY DATA

RIVER SYSTEM: Bogachiel

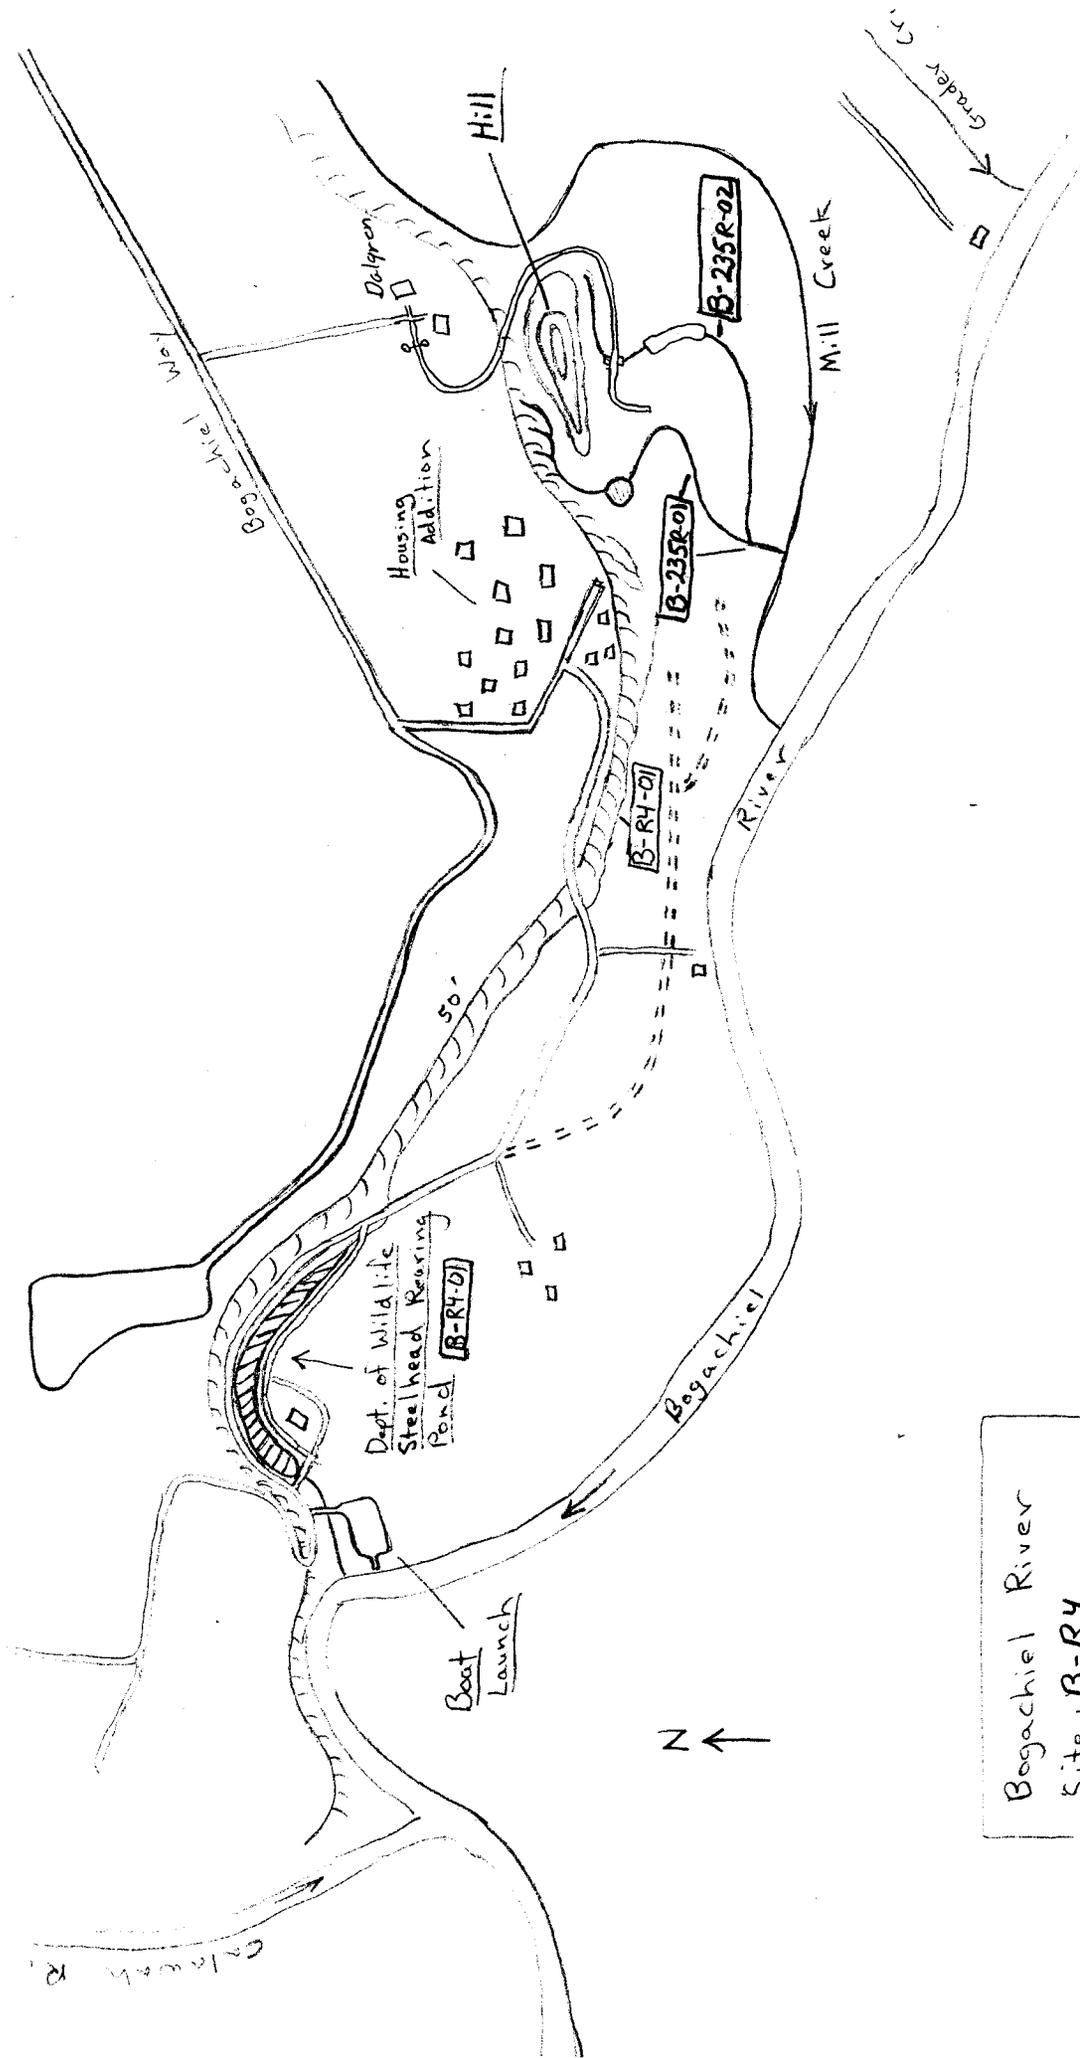
Bogachiel River
 Site: B-R4
 Overview Map
 Revised 4/97

Bogachiel River

site: B-R4

Site map
