**SITE NUMBER:** CW-R6-01  
**LOCAL NAME:** Christmas Cr.#1  
**WRIA:**

**NORTH COAST OFF CHANNEL SITE INVENTORY DATA**

**CHANNEL TYPE:** Terrace tributary

**TRIBUTARY TO:** Christmas Creek (21.0065)

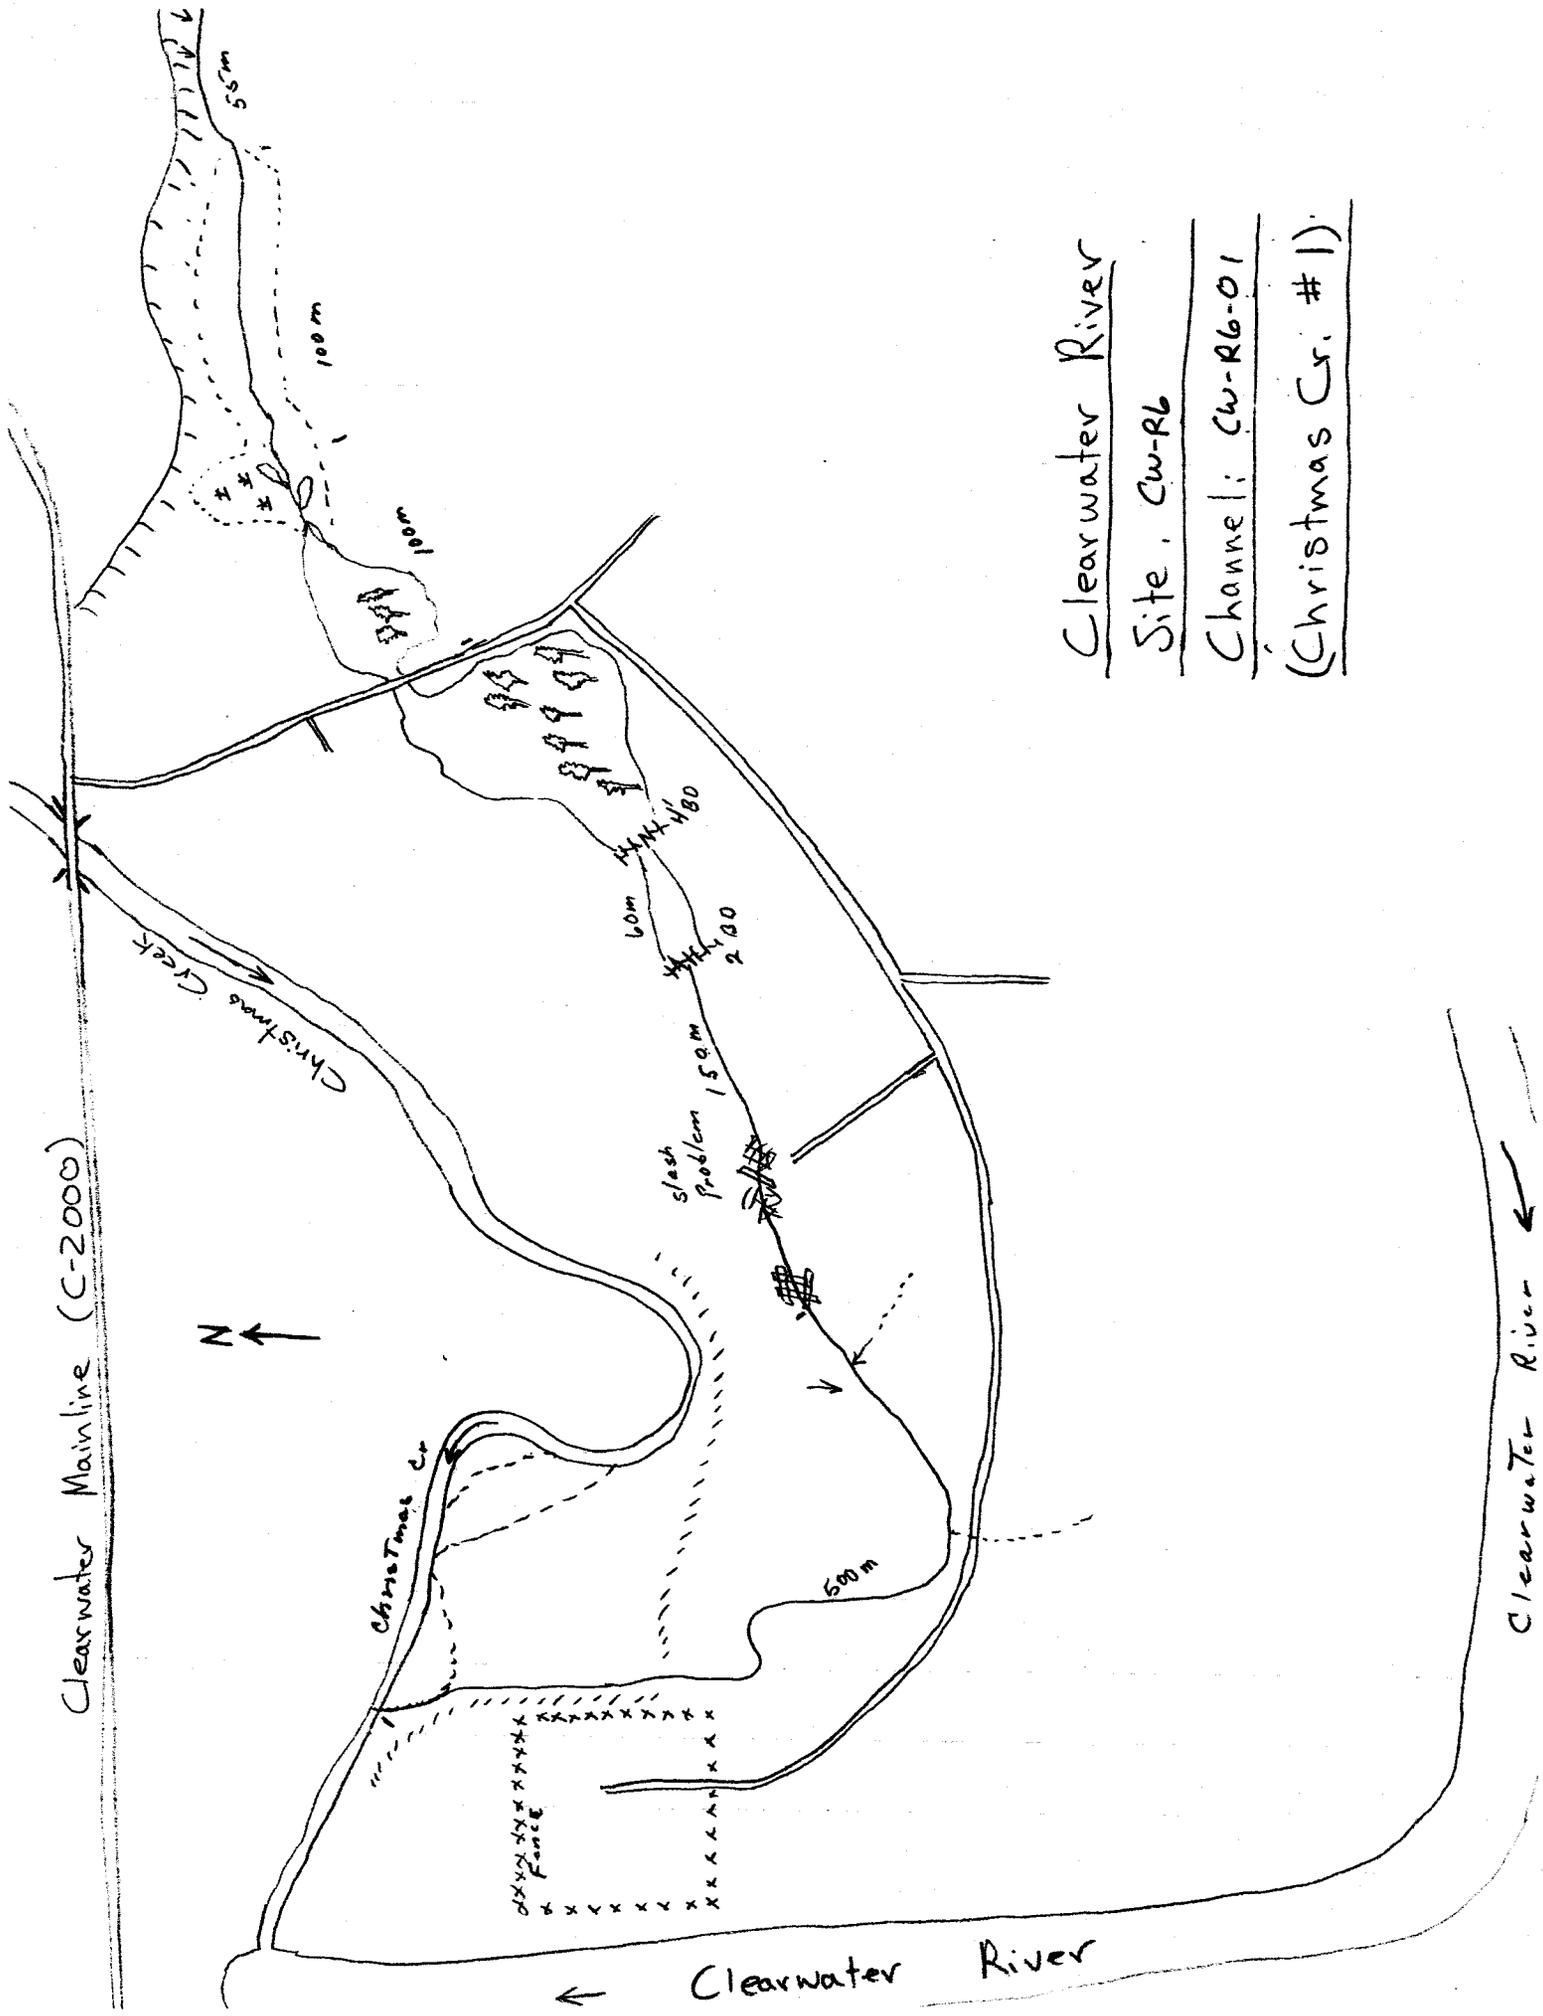
Site: Cw-R6

Channel: Cw-R6-01

(Christmas Cr. #1)

**COMMENTS & RECOMMENDATIONS:** CW-R6-01 should be a valuable winter rearing site for juvenile coho. The lower 80 to 100 m of the channel lies within the active floodplain of Christmas Cr. The next 400 m above the floodplain is relatively free of debris and could be developed as a beaded channel.
