SITE NUMBER: D-R2-05
LOCAL NAME: Elkhorn Pond
WRIA: 20.0104C

NORTH COAST OFF CHANNEL SITE INVENTORY DATA

RIVER SYSTEM: Dickey **DATE:** 12/12/90 **OBSERVER:** Nettnin

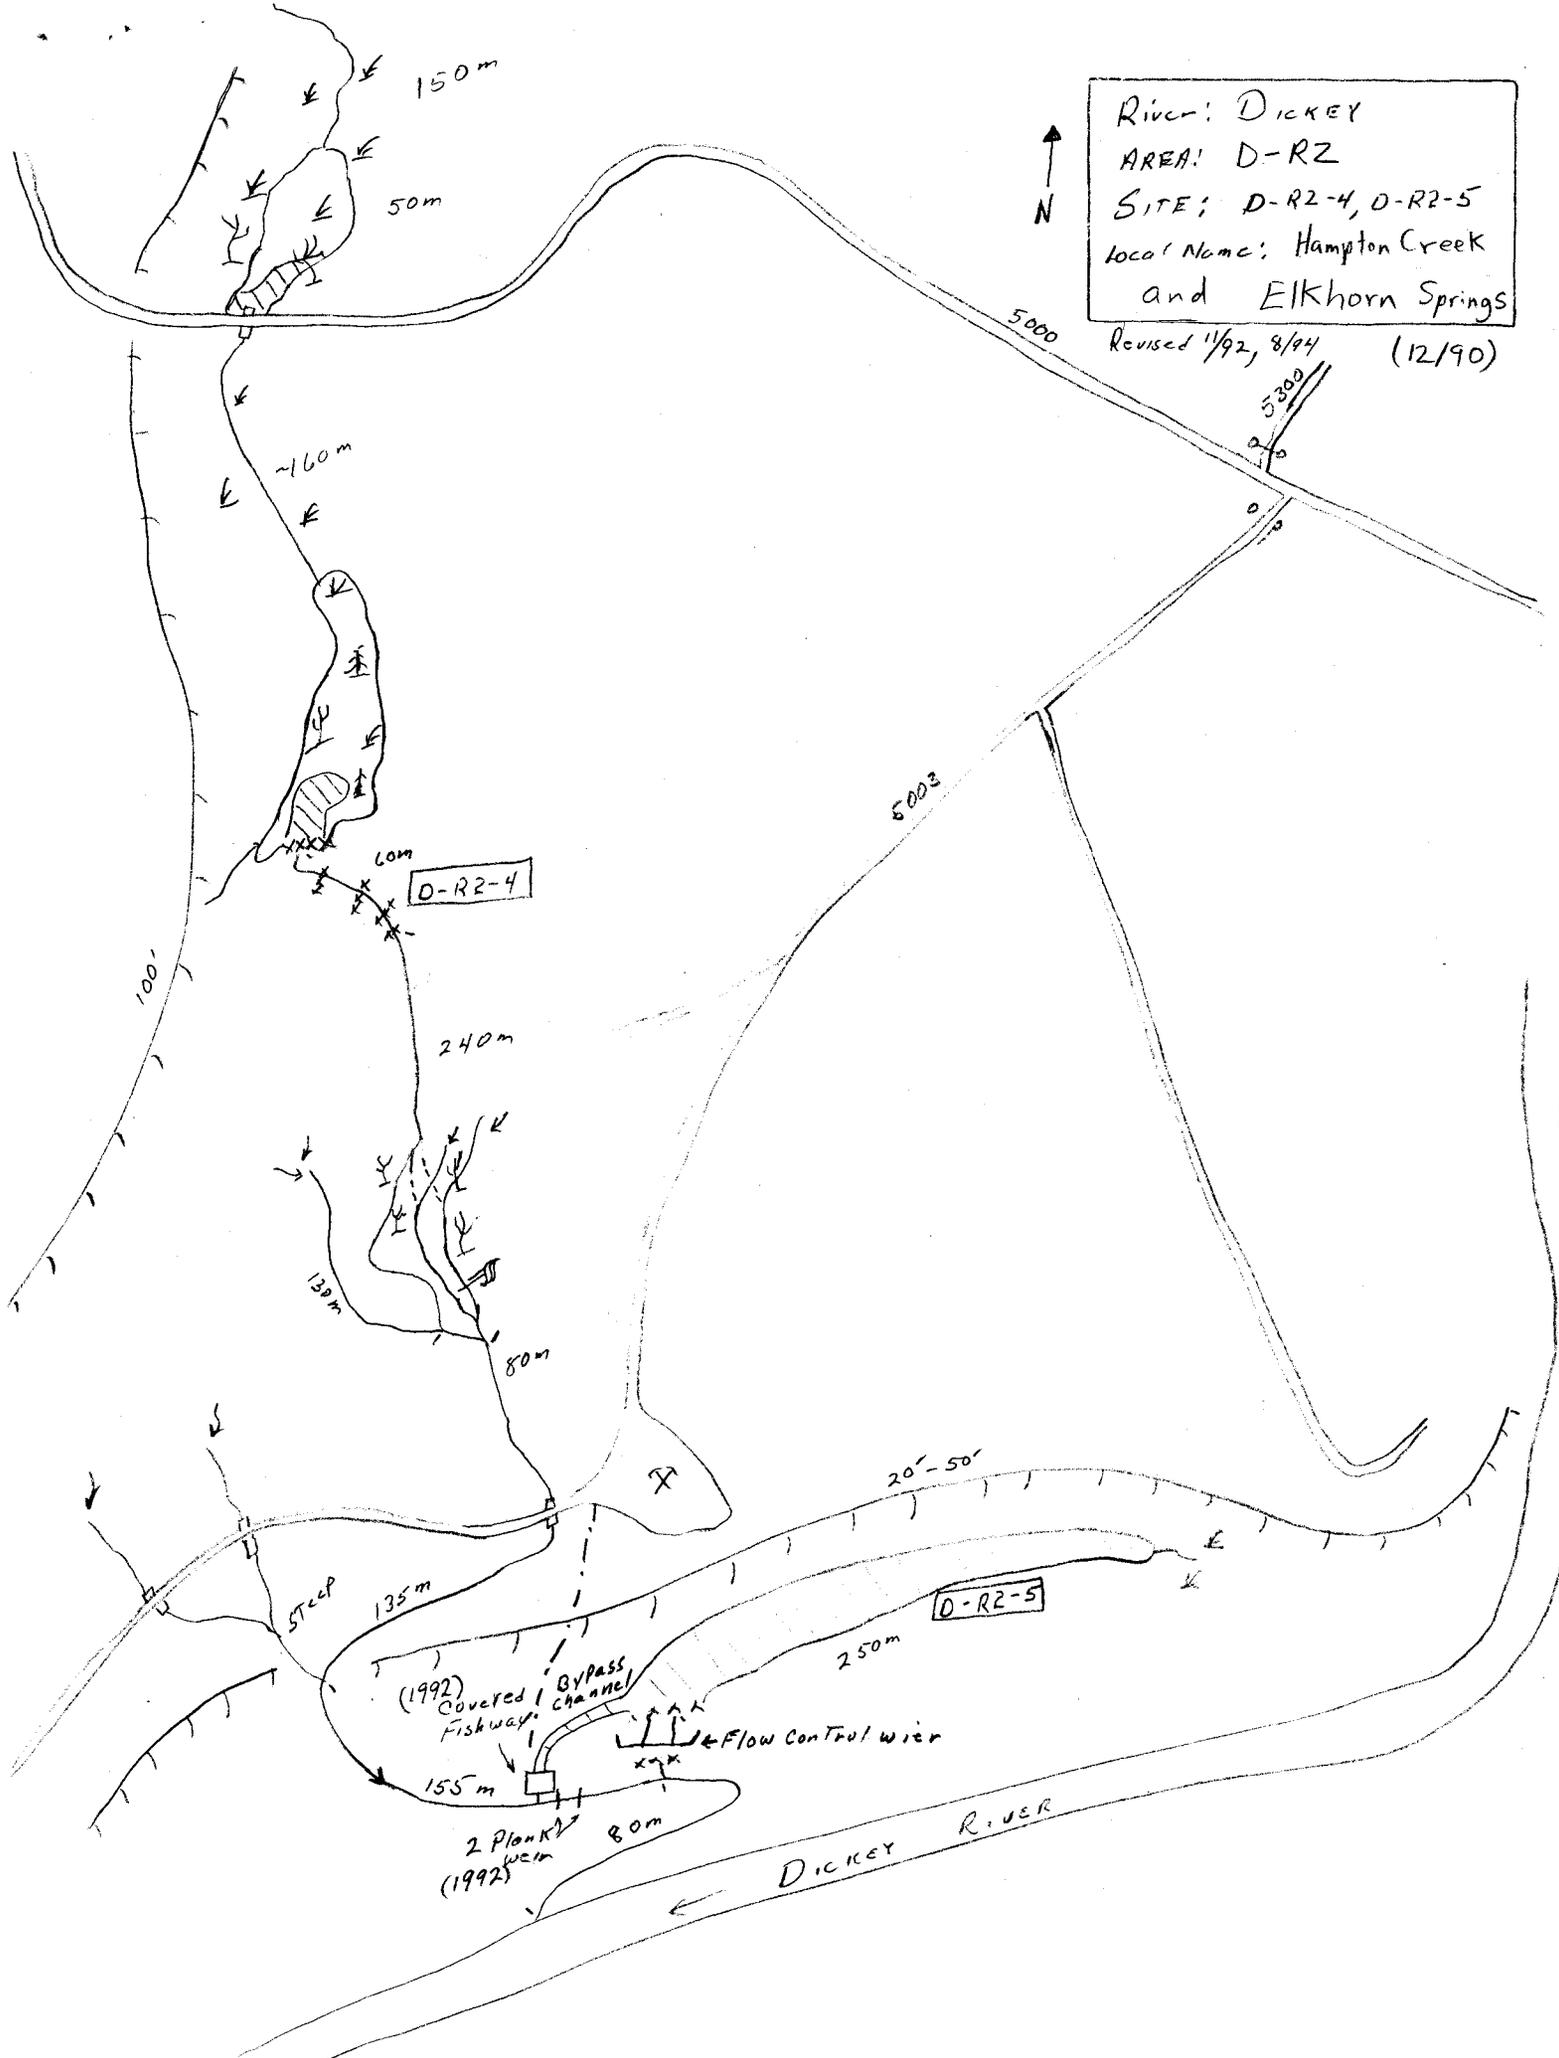
River: DICKEY
AREA: D-RZ
SITE: D-R2-4, D-R2-5
Local Name: Hampton Creek
and Elkhorn Springs

Revised 1/92, 8/94 (12/90)
