SITE NUMBER: ED-L4-08

LOCAL NAME: Trash Cr.

NORTH COAST OFF CHANNEL SITE INVENTORY DATA

CHANNEL TYPE: Terrace tributary (wall-based)

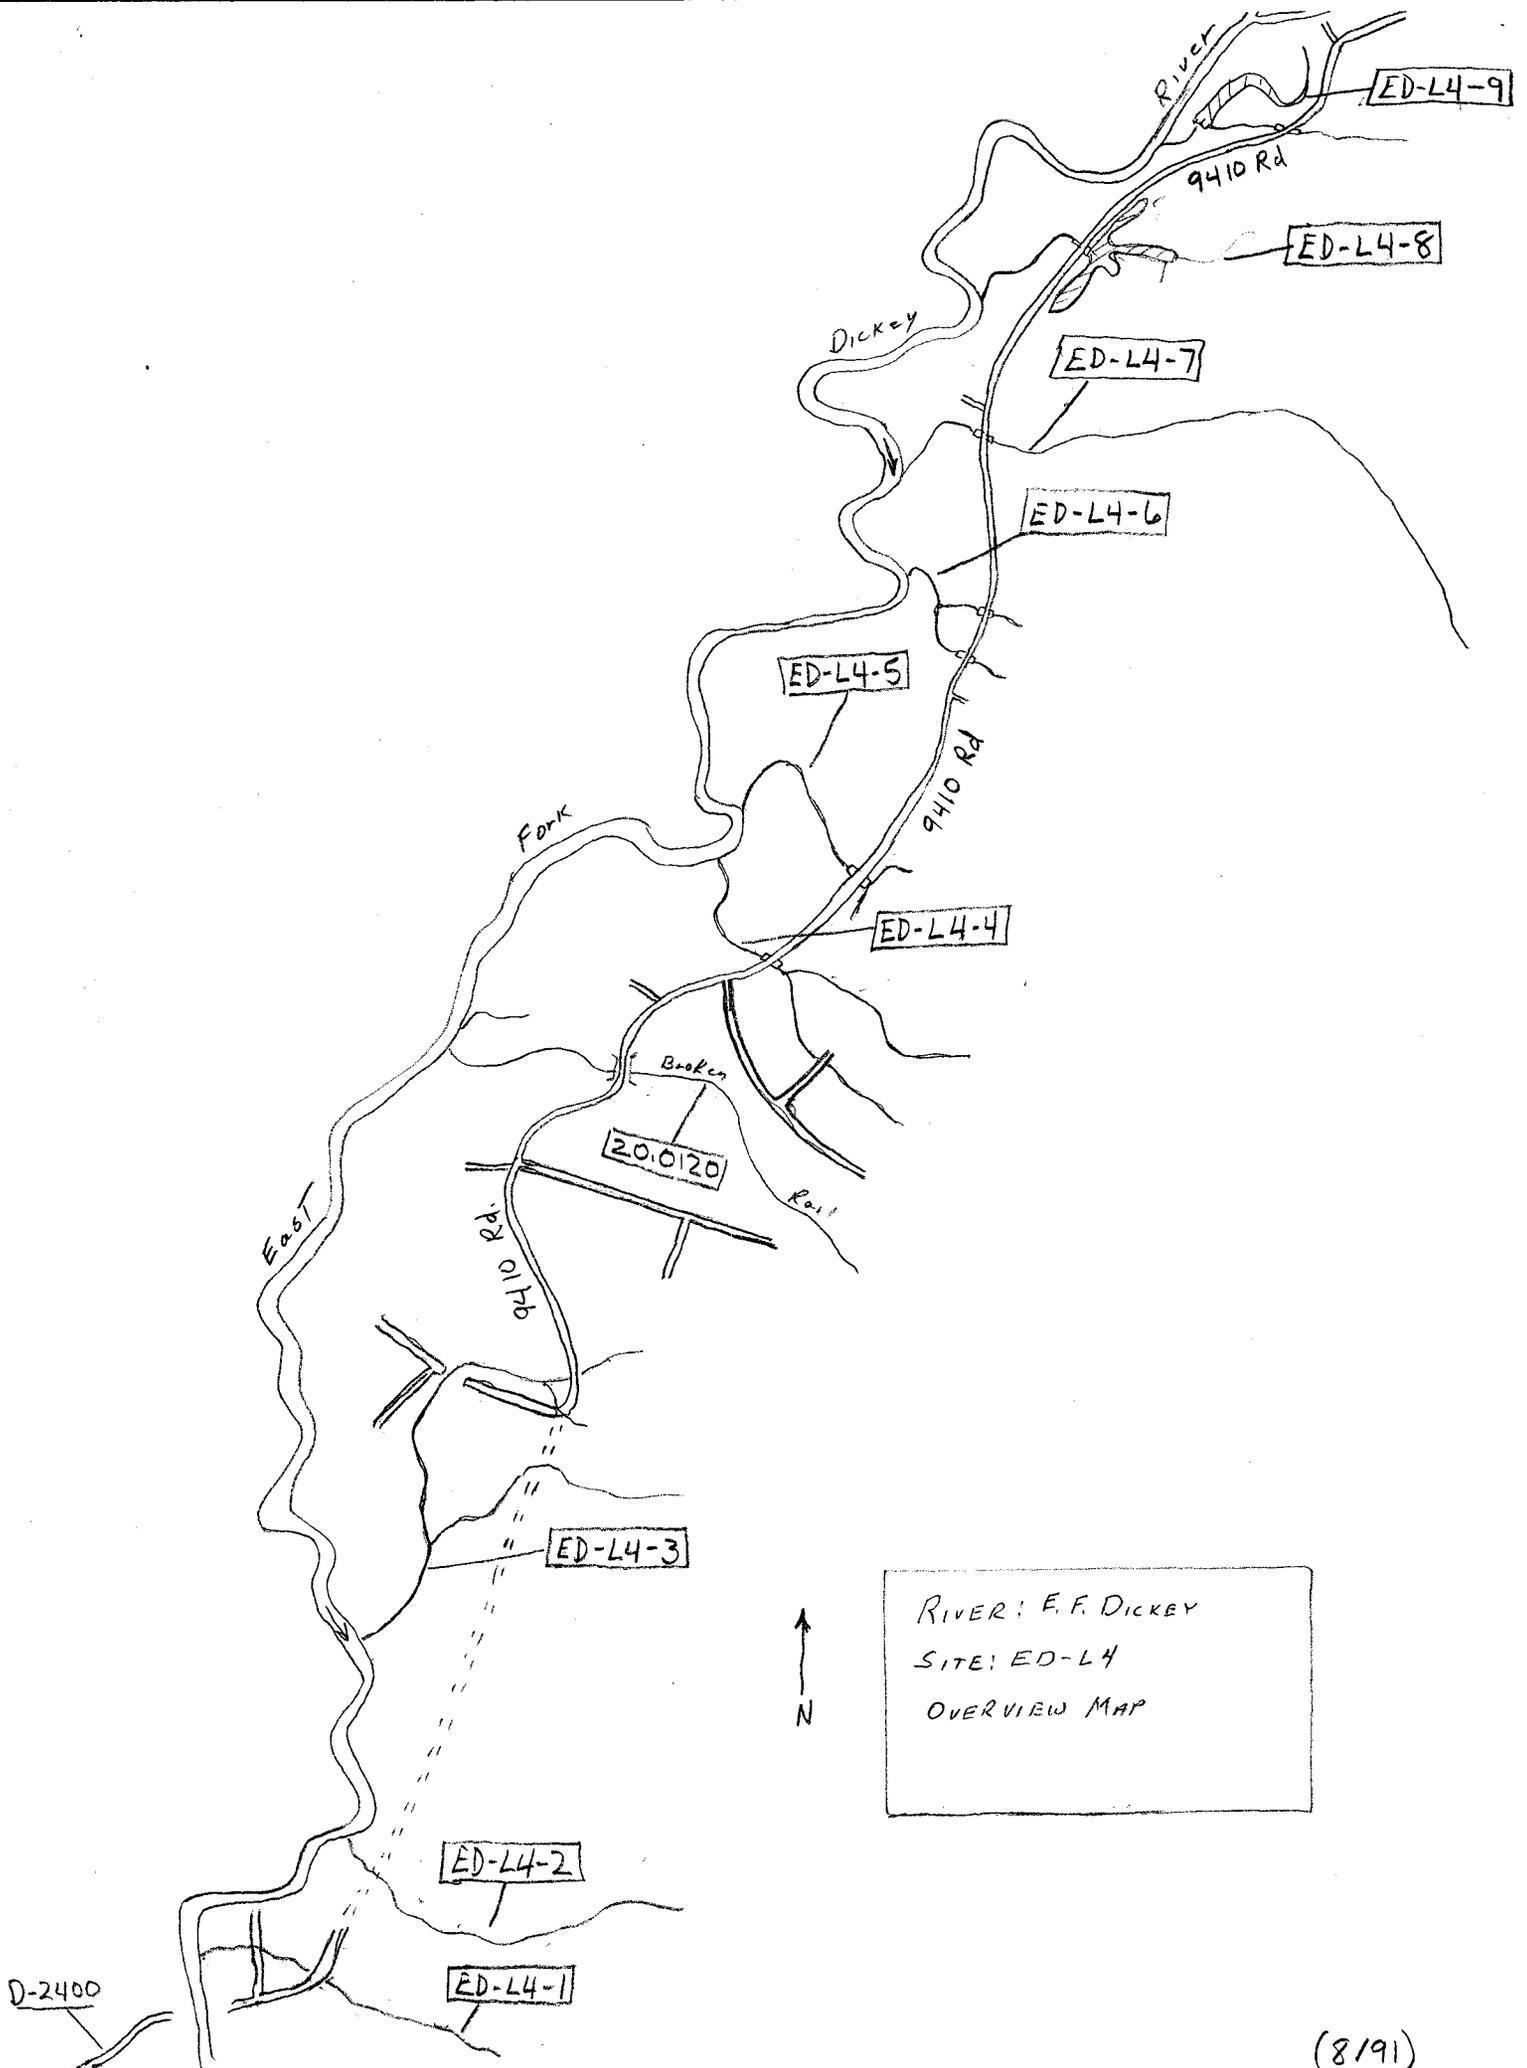
AREA: ED-L4
SITE: ED-L4-08
WRIA: 20.0120J
NAME: Trash Creek

RIVER: E.F. DICKEY

REV. DATE: 7/97

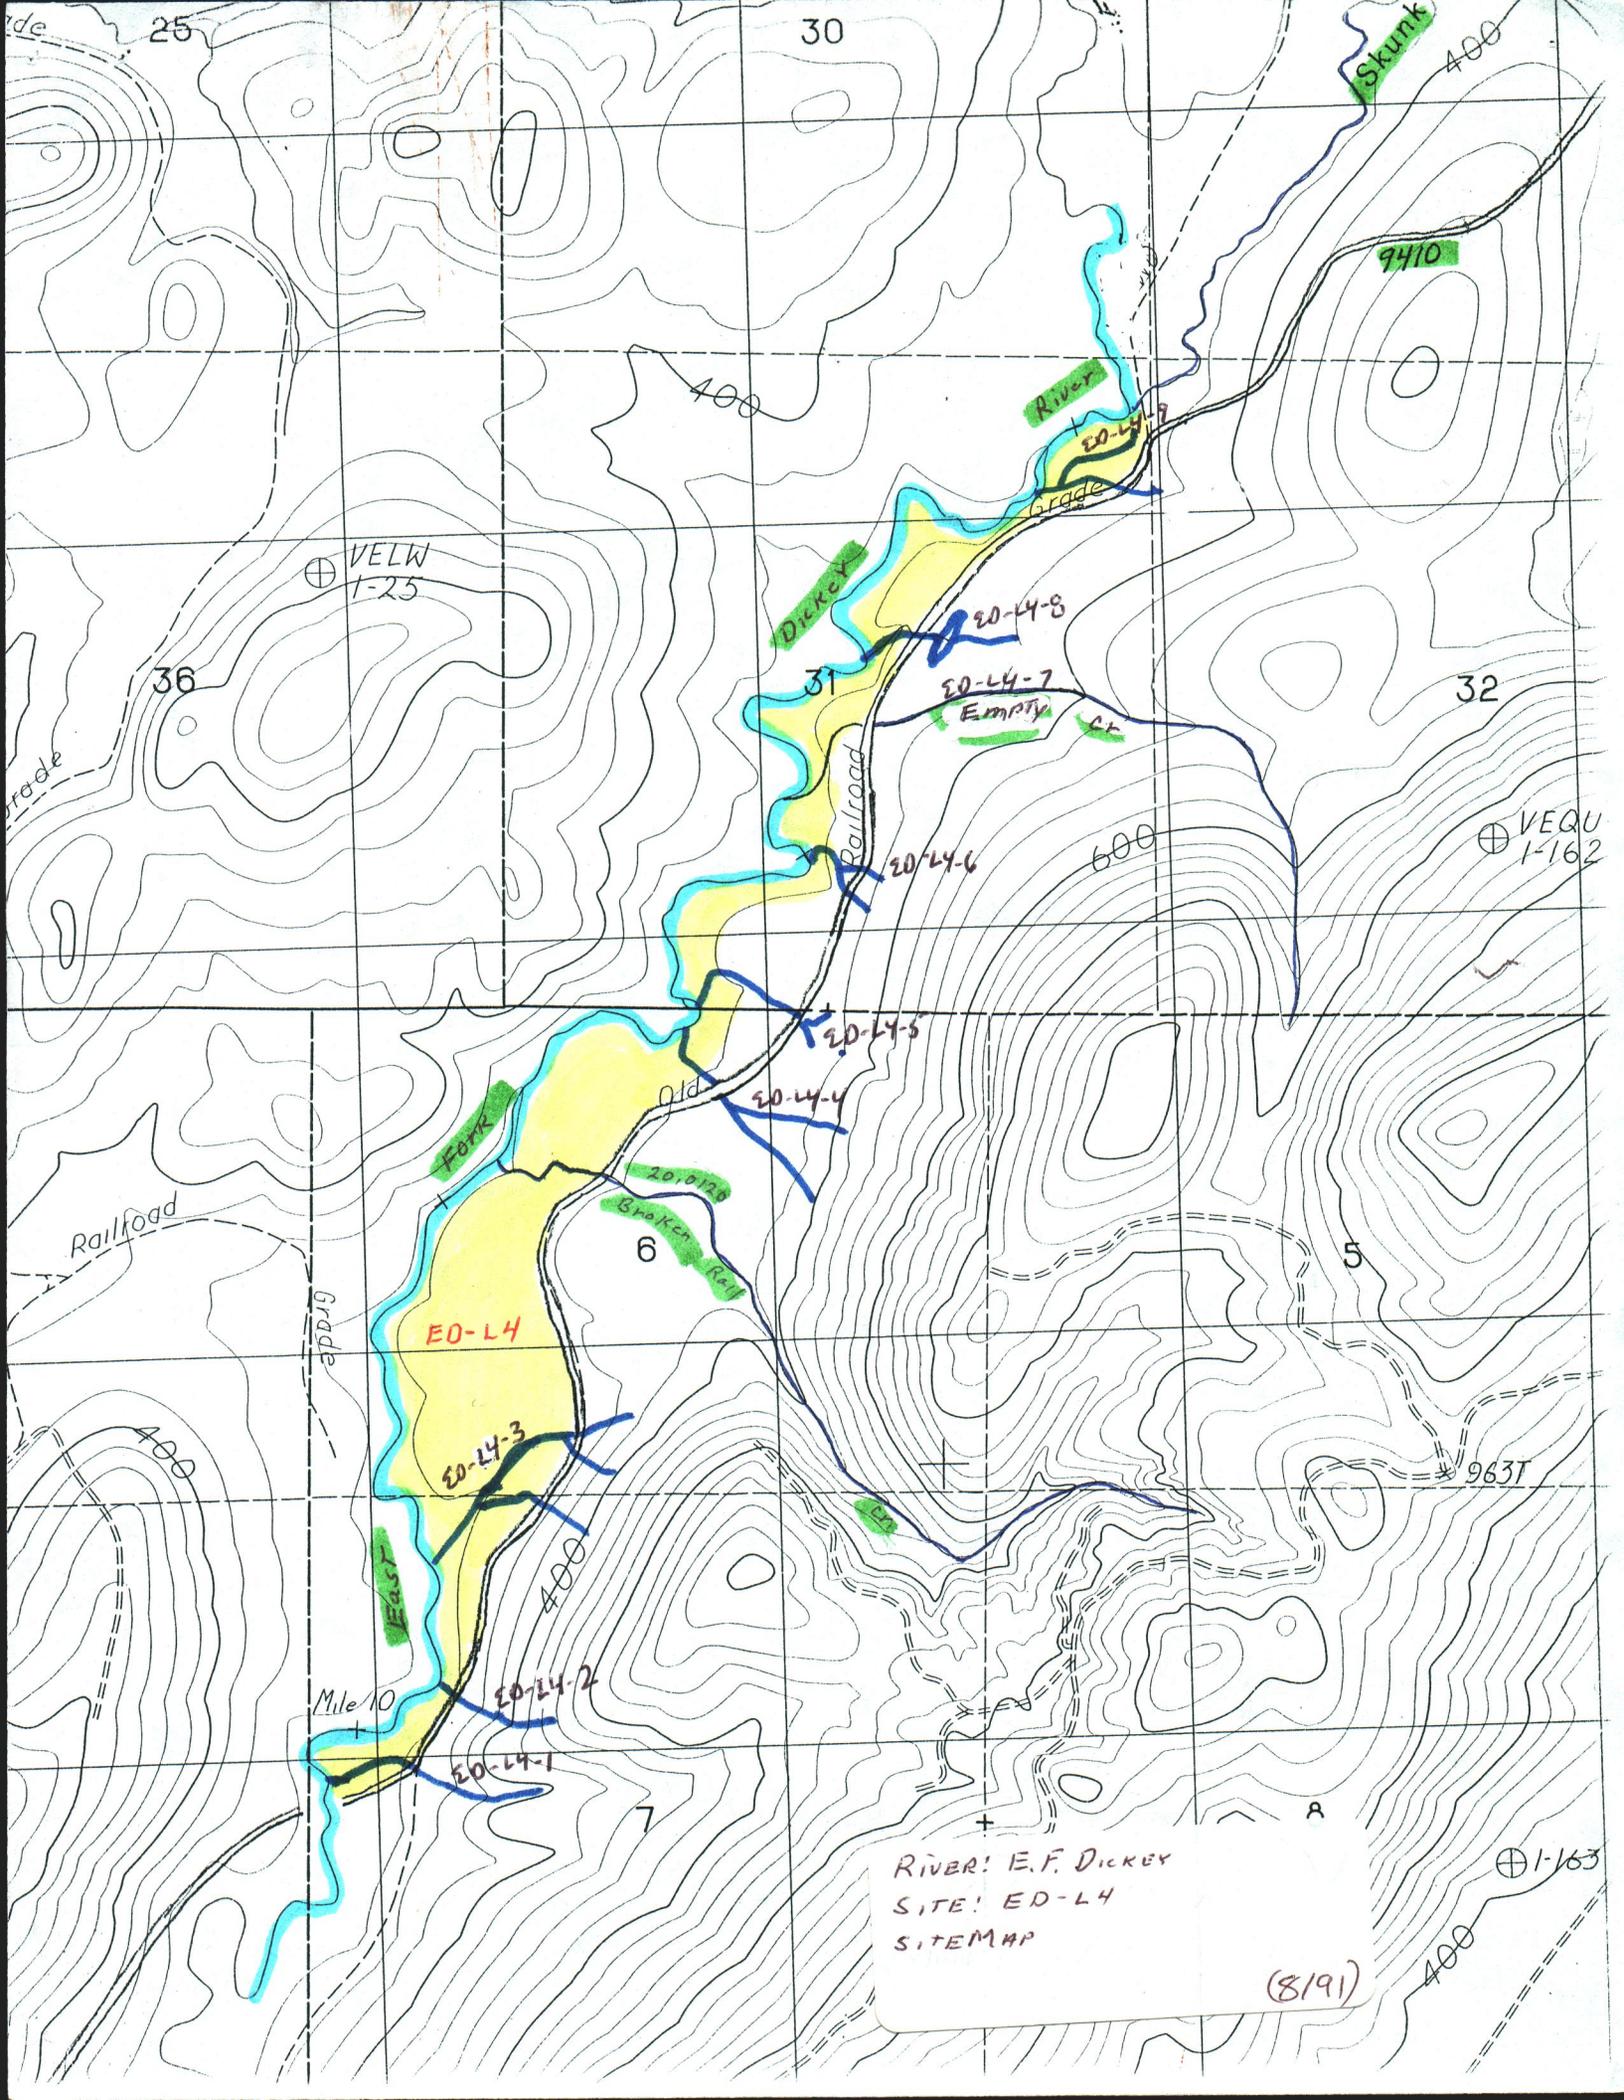
RIVER: E.F. DICKEY
SITE: EO-L4
SITEMAP

(8/91)
