SITE NUMBER: H-457L-01 (was H-R9-02)

LOCAL NAME: Peterson Pond

NORTH COAST OFF CHANNEL SITE INVENTORY DATA

RIVER SYSTEM: Hoh **DATE:** 9/2/87 **OBSERVER:** Young/Nettnin

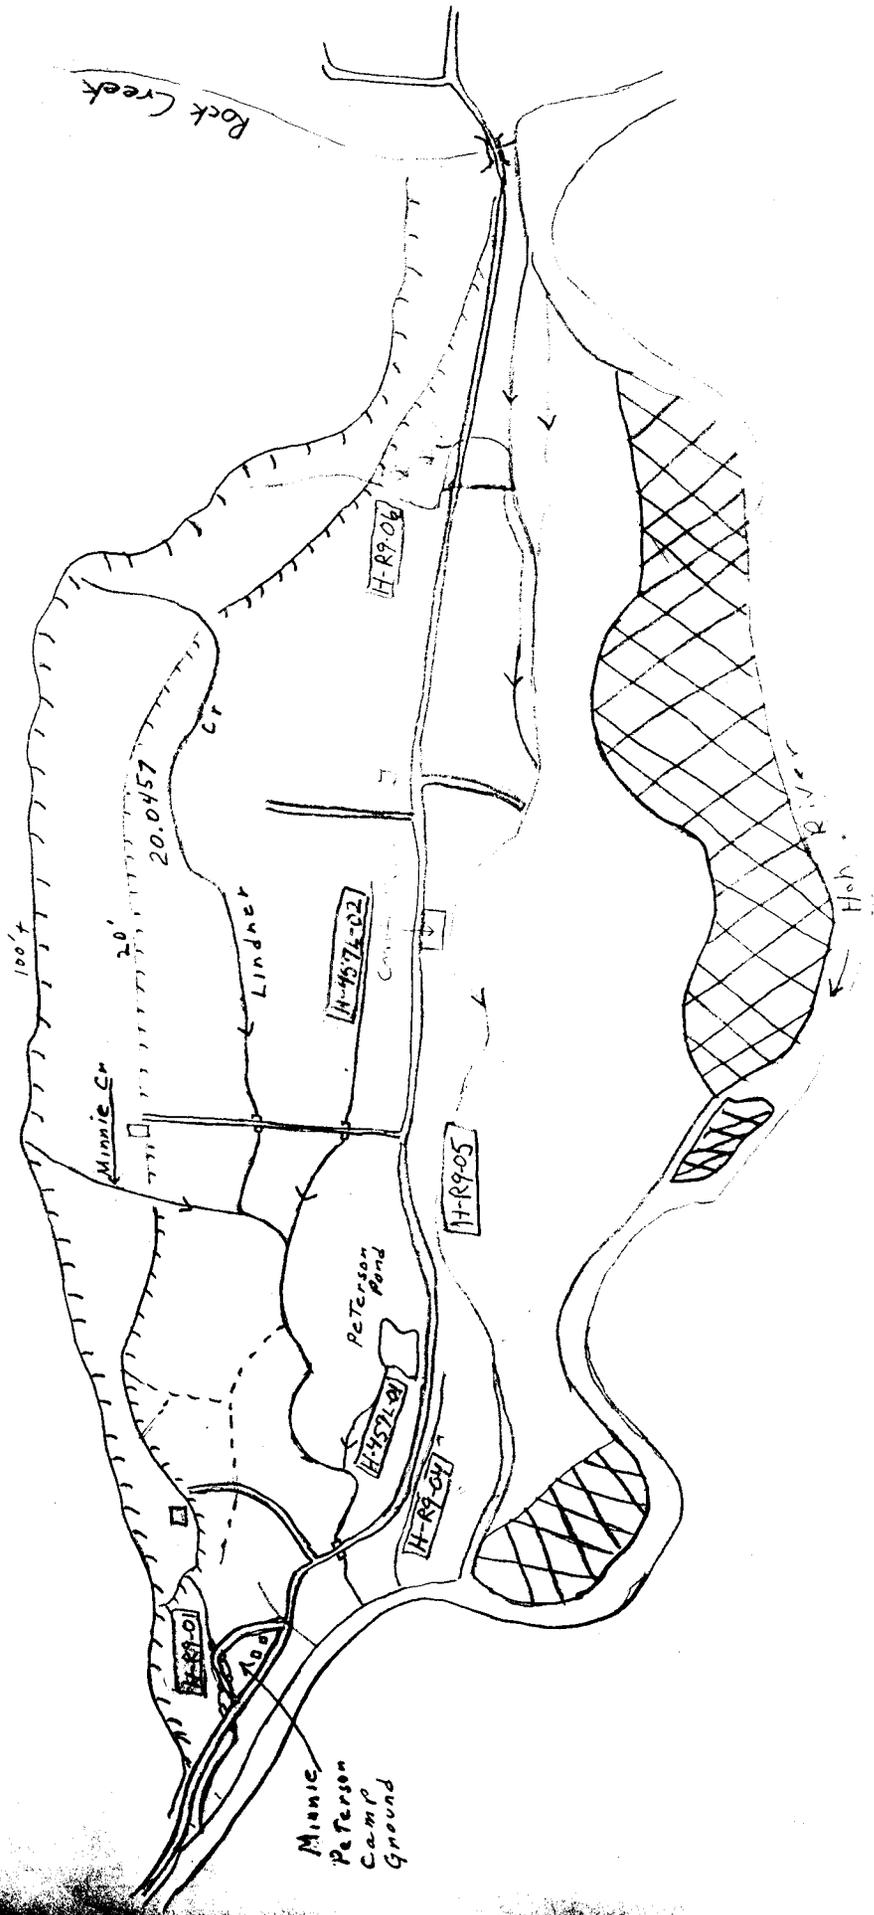
Hoh River
 Site: H-R9
 Overview Map
 Map Date: 9/87
 Revised: 1/90
 11/97

SITE H-R9-02 WAS CHANGED TO H-457L-01
 H-R9-03 WAS CHANGED TO H-457L-02
