**SITE NUMBER:** H-461R-01 (was H-R12-02)

**LOCAL NAME:** Hoh Springs

**NORTH COAST OFF CHANNEL SITE INVENTORY DATA**

**RIVER SYSTEM:** Hoh

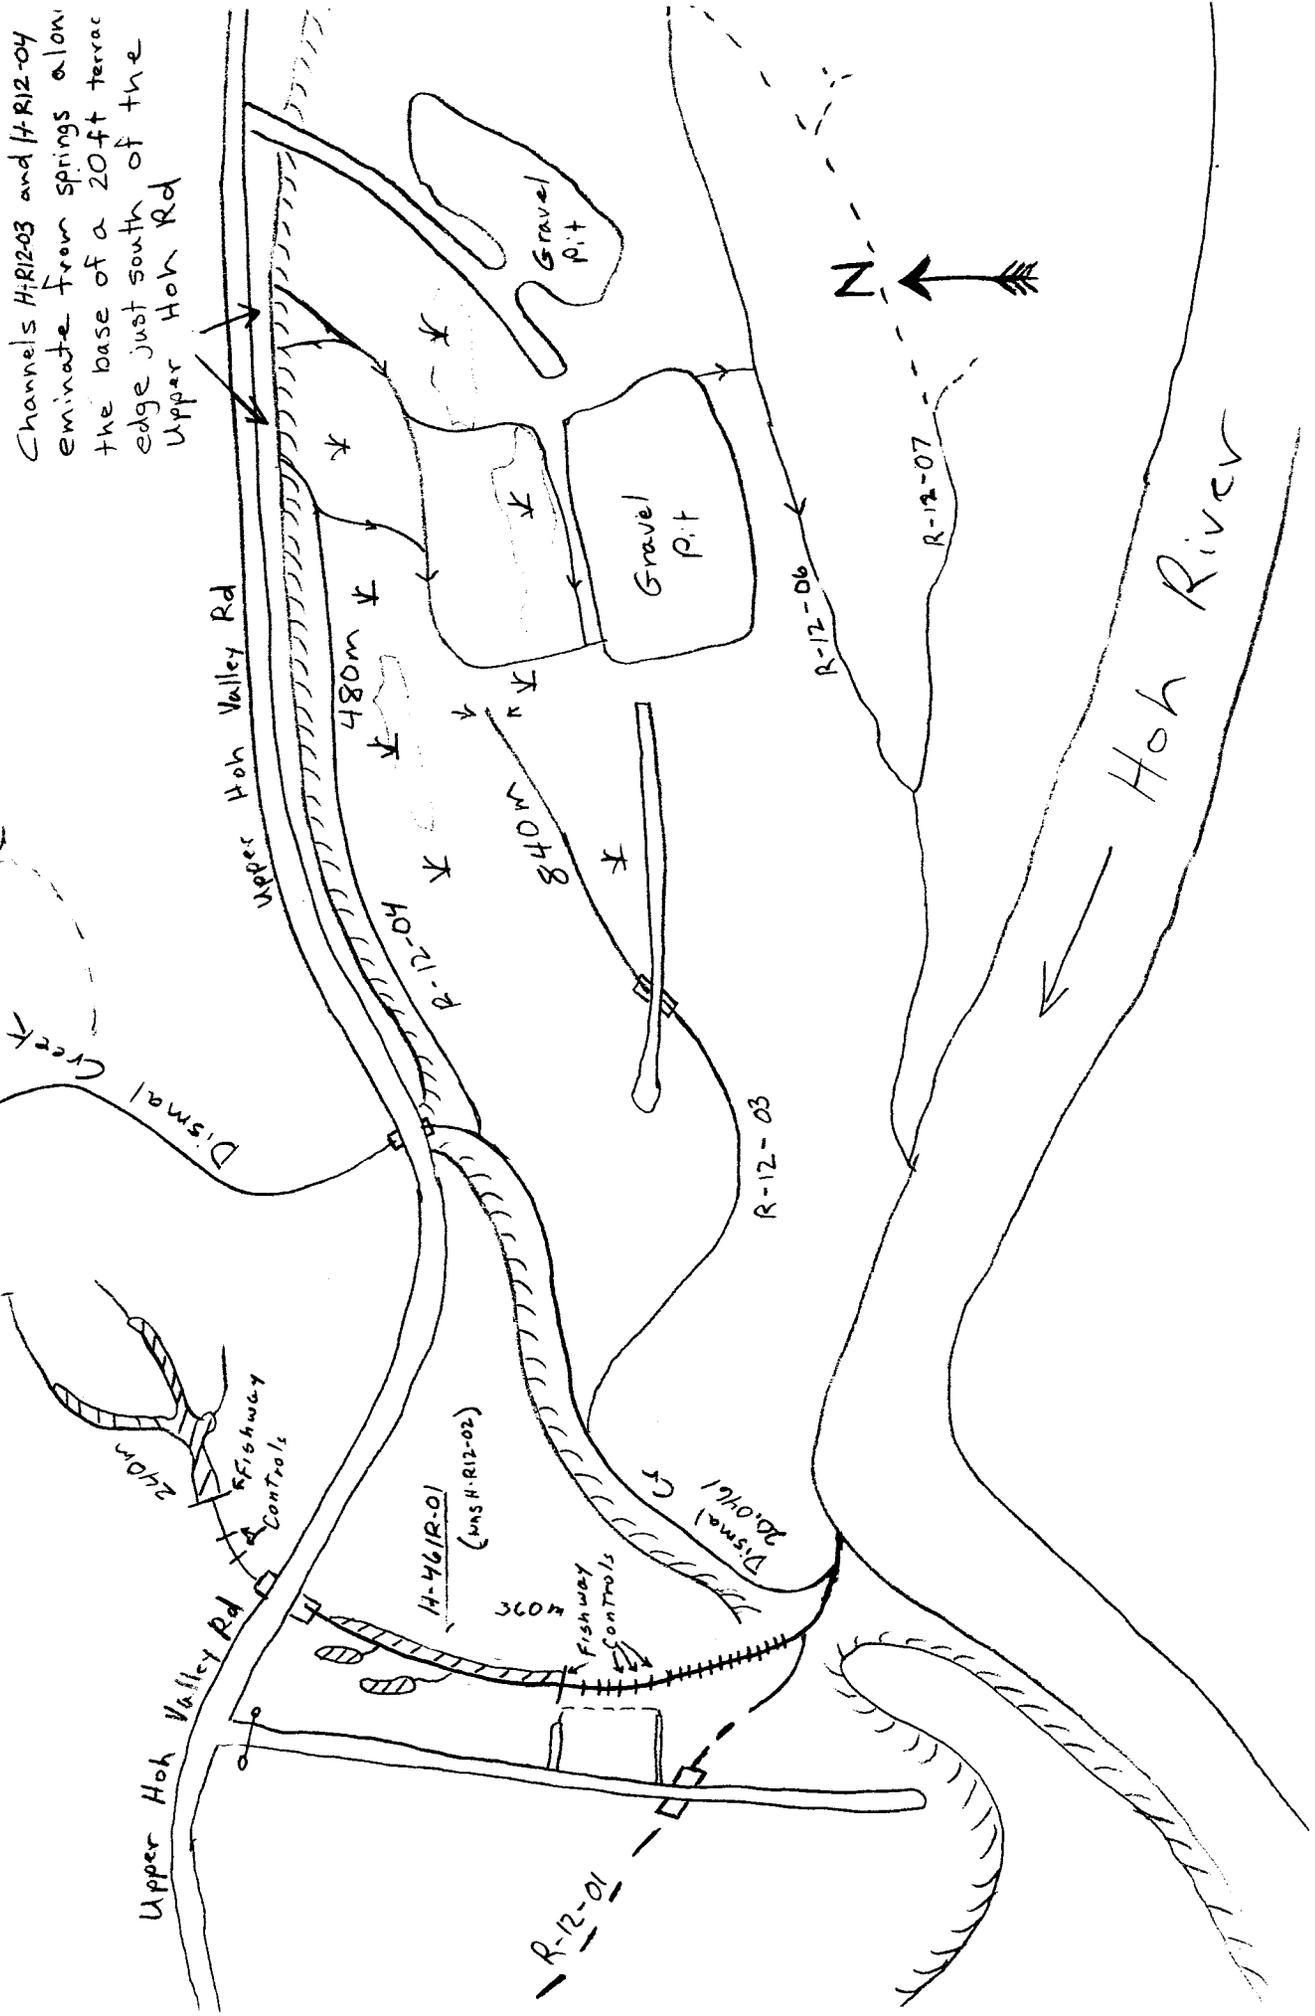
Channels 1, 2, 3, 4

Revised 10/9, 8/93, 7/94, 11/97

Channels H-12-03 and H-12-04  
emanate from springs along  
the base of a 20ft terrac  
edge just south of the  
Upper Hoh Rd
