SITE NUMBER: H-L3-01
LOCAL NAME: Nolan Channel
WRIA: 20.0436L

NORTH COAST OFF CHANNEL SITE INVENTORY DATA

RIVER SYSTEM: Hoh River **DATE:** 7/7/87 **OBSERVER:** Young/Nettlin

CHANNEL TYPE: Overflow

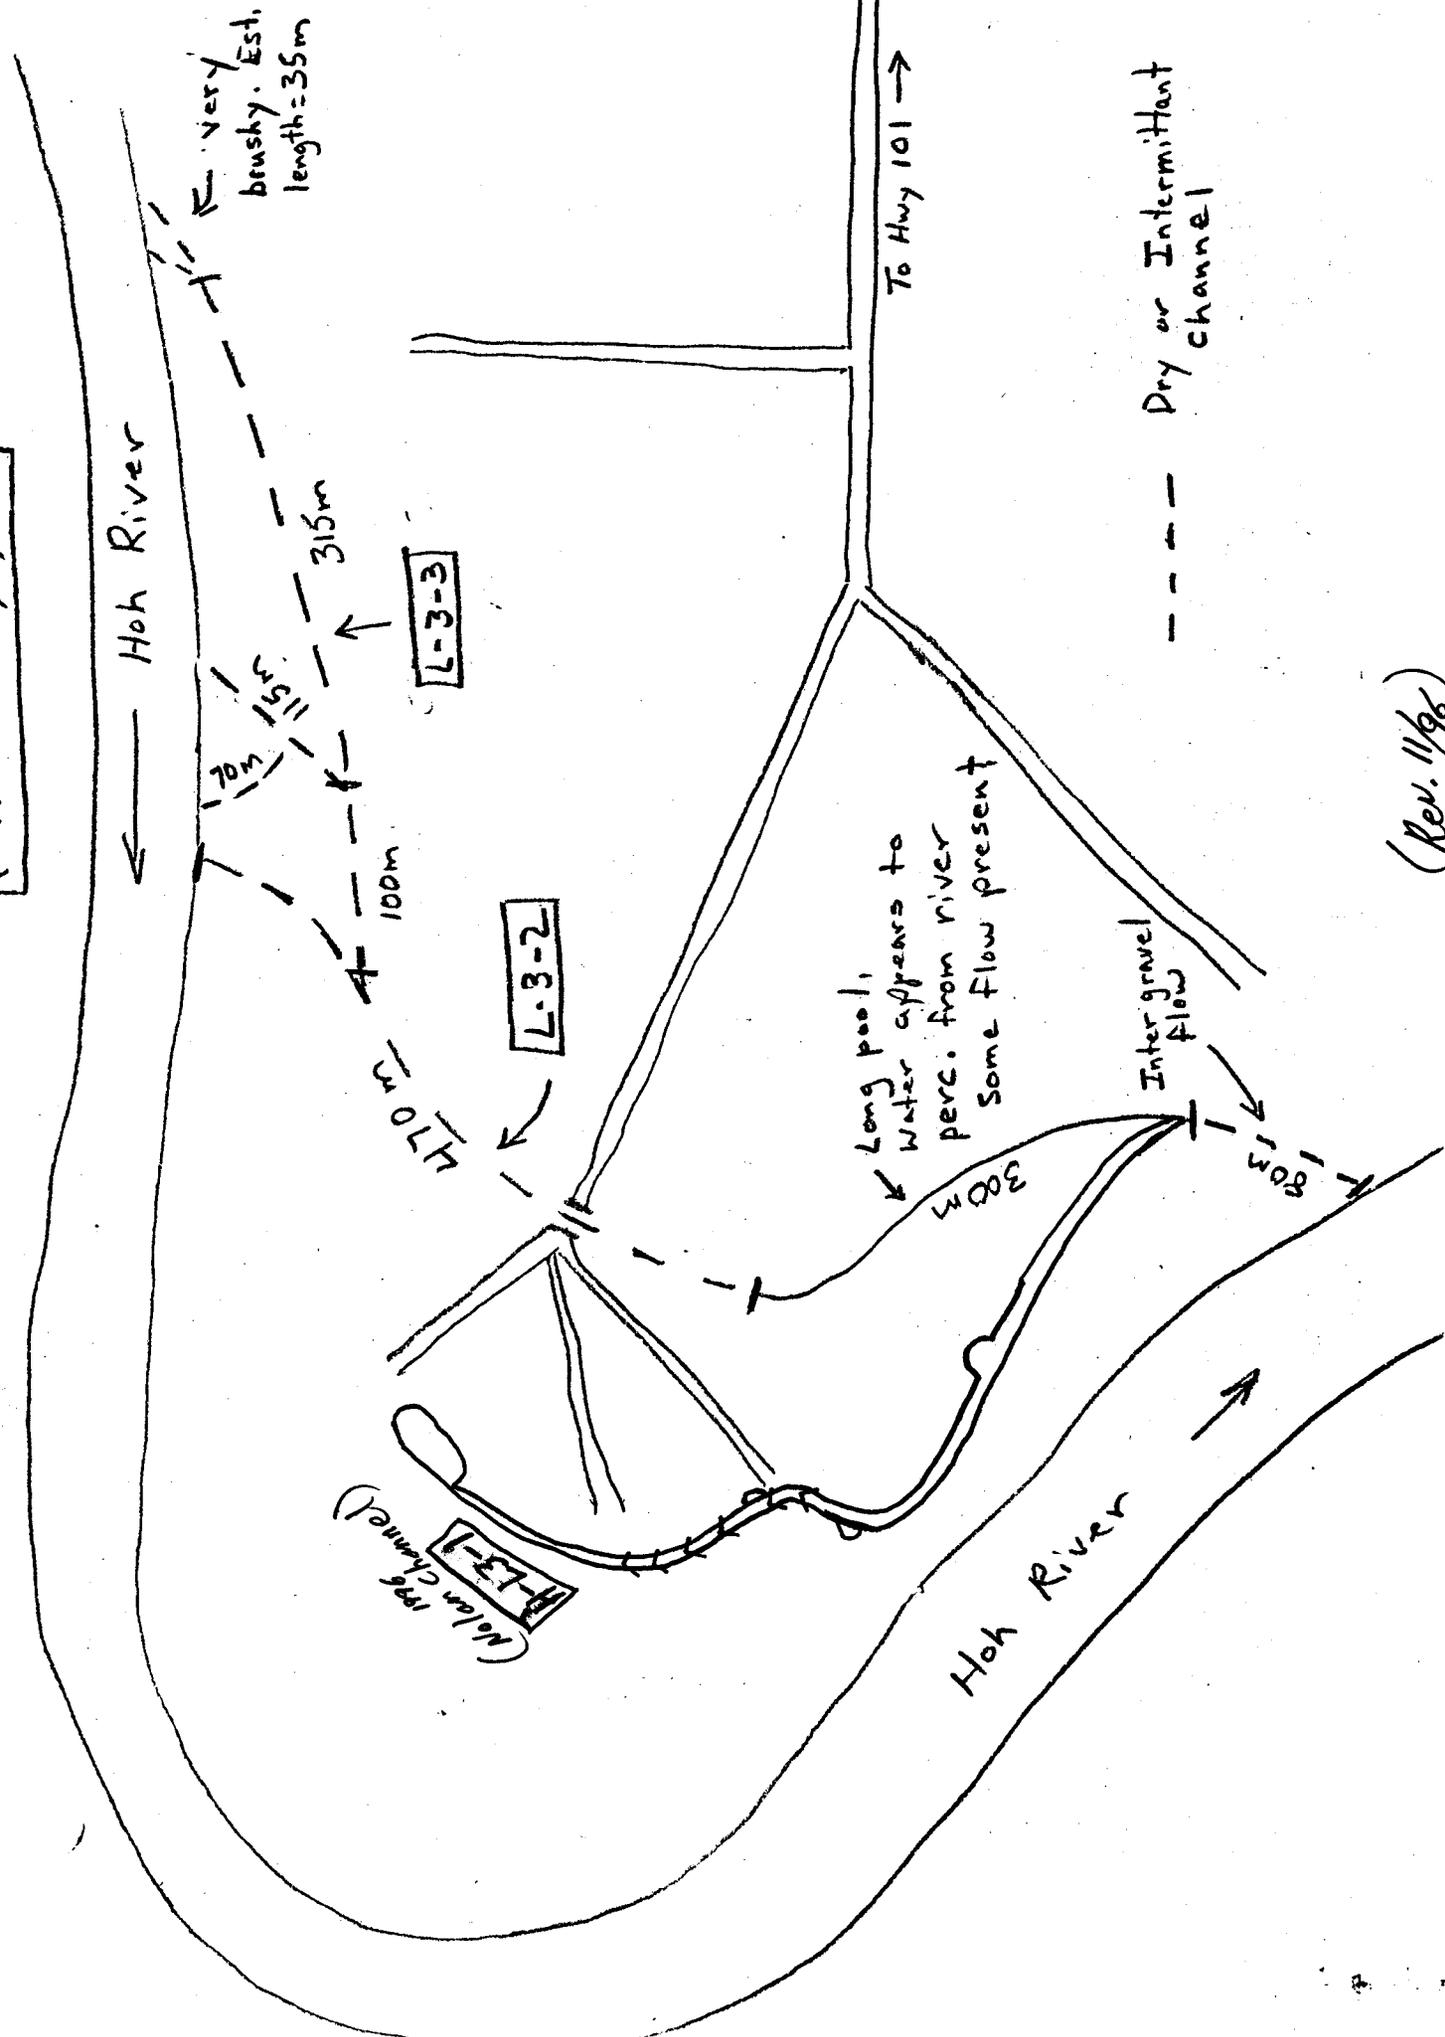
Site: H-L-3
(Channels 1, 2, 3)

(Revised 11/96)

During the Summer of 1996, WDFW's Habitat Enhancement Section constructed a groundwater-fed spawning and rearing channel. Approximately 1900 feet of this channel was deepened below the surrounding groundwater table and connected to H-L3-02 about 500 feet from its mouth. Six log stream bed controls were installed in the upper channel and a small pond was created at the very upper end. Three side refuge bays were constructed along the channel and spawning gravel was added upstream from each log control. Stumps and small spruce trees were loaded into the channel and anchored. A small berm was constructed across the swale upstream from the upper end of the project to give some added protection from flood flows. At this time, water was not flowing out of the channel into the Hoh river. Not much flow over log controls especially the upper 3 controls.

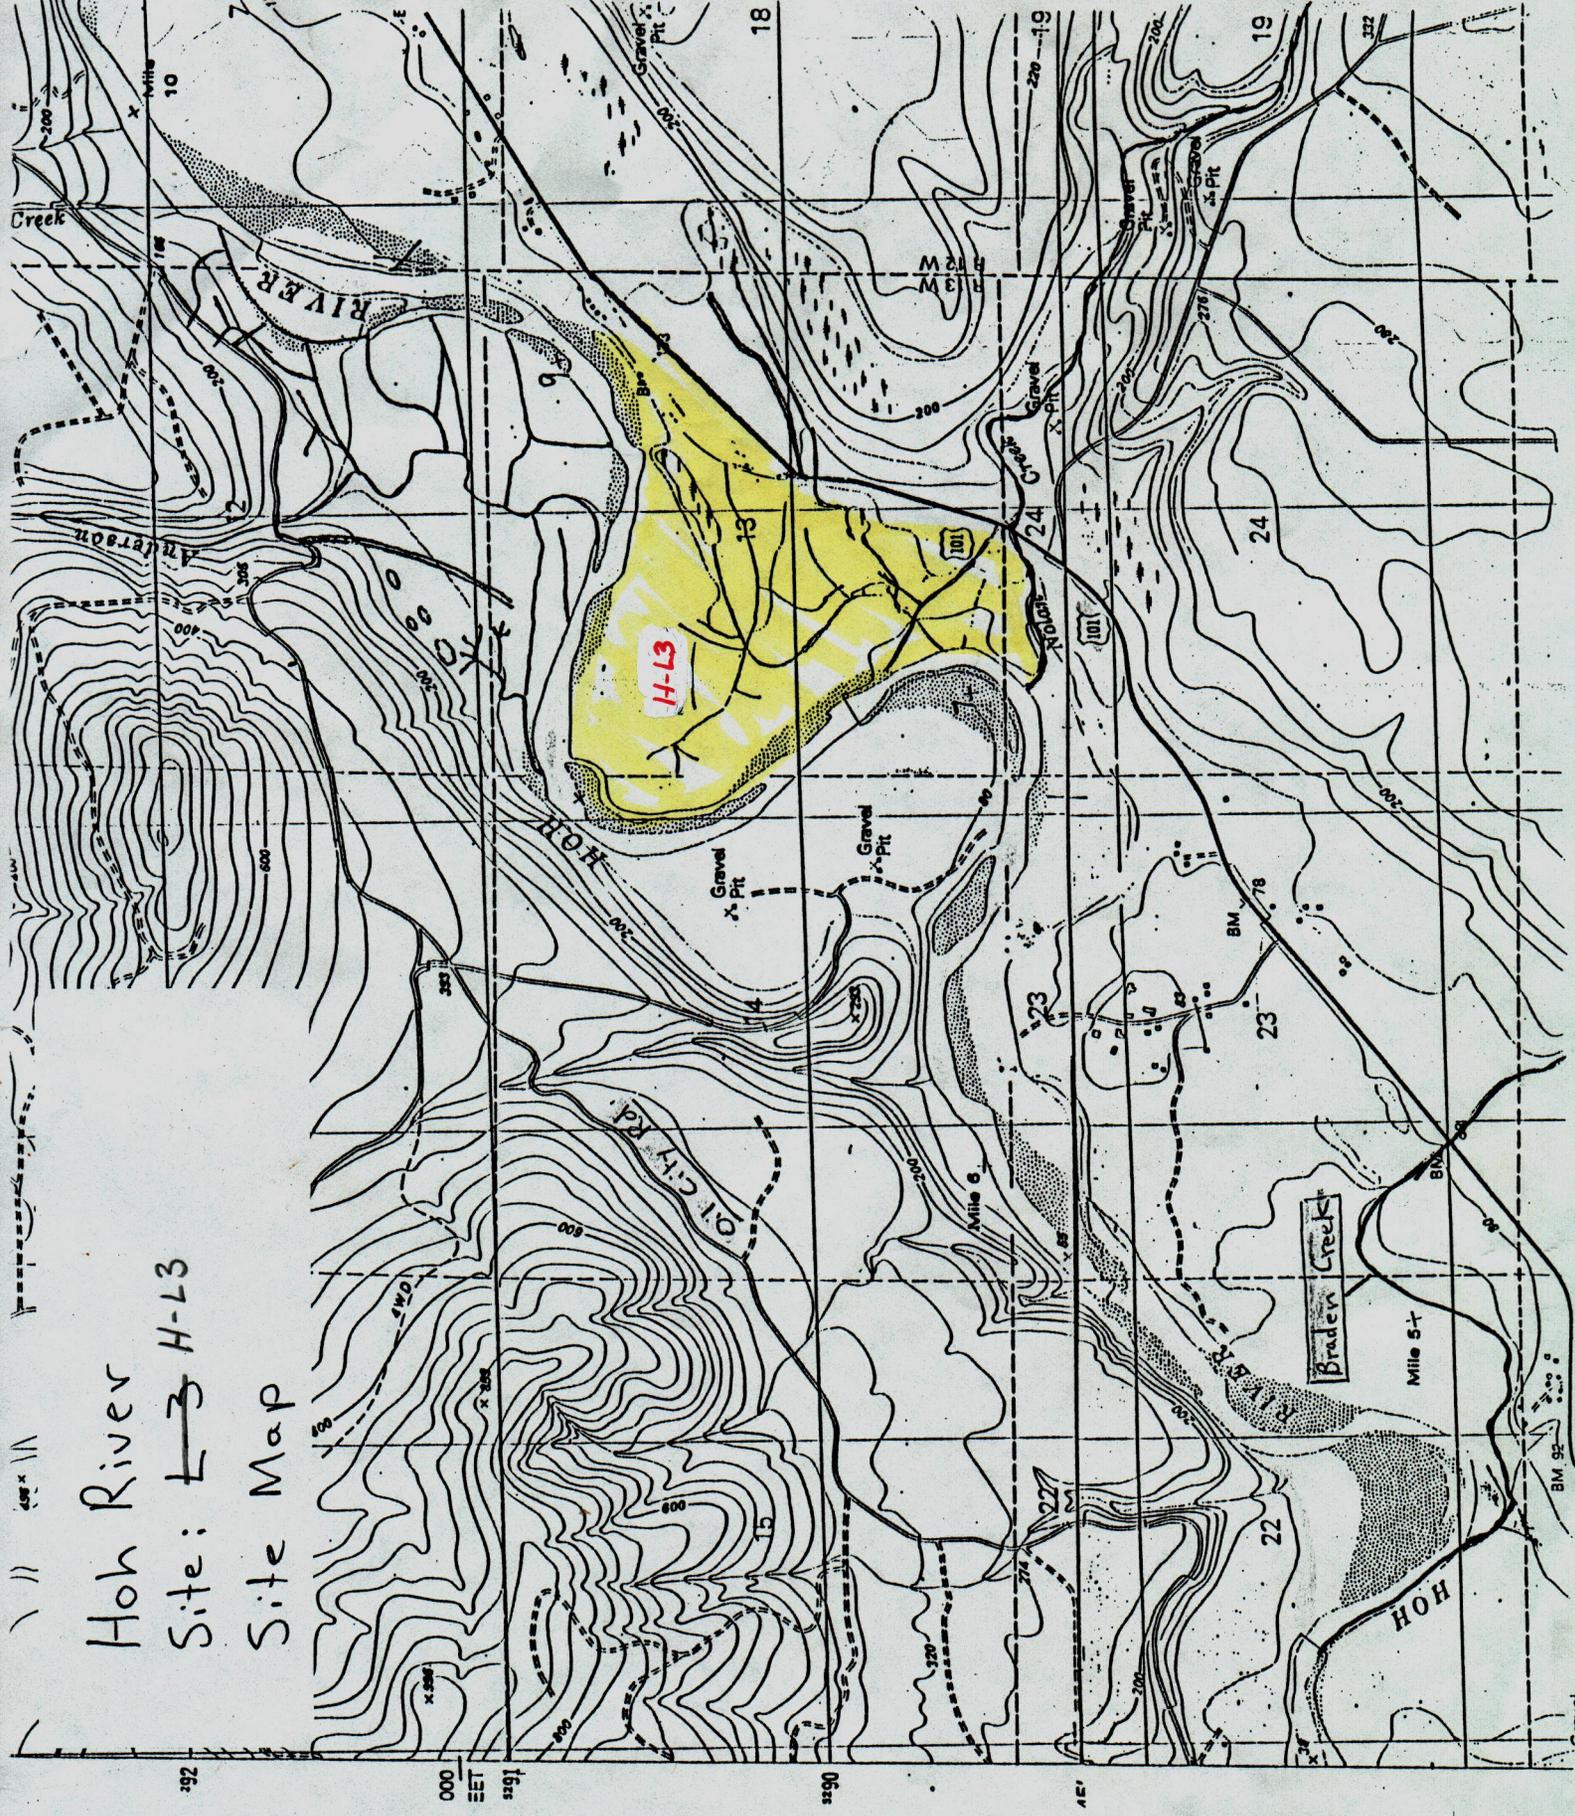
Hoh River
Site: ~~L-3~~ H-13
Site Map

(Rev. 11/96)
