Anderson Ponds
 Hoh River
 H-R6-04
 Ponds 1, 2+3 - 1988
 Pond 4 - 1989
 Pond 3 deepened - 1989
 Marsh Channels deepened - 1989

Hoh River
 SITE: H-RC
 Over view map
 Anderson Ranch
 Revised 1989 2/5/89

Site: H-R6

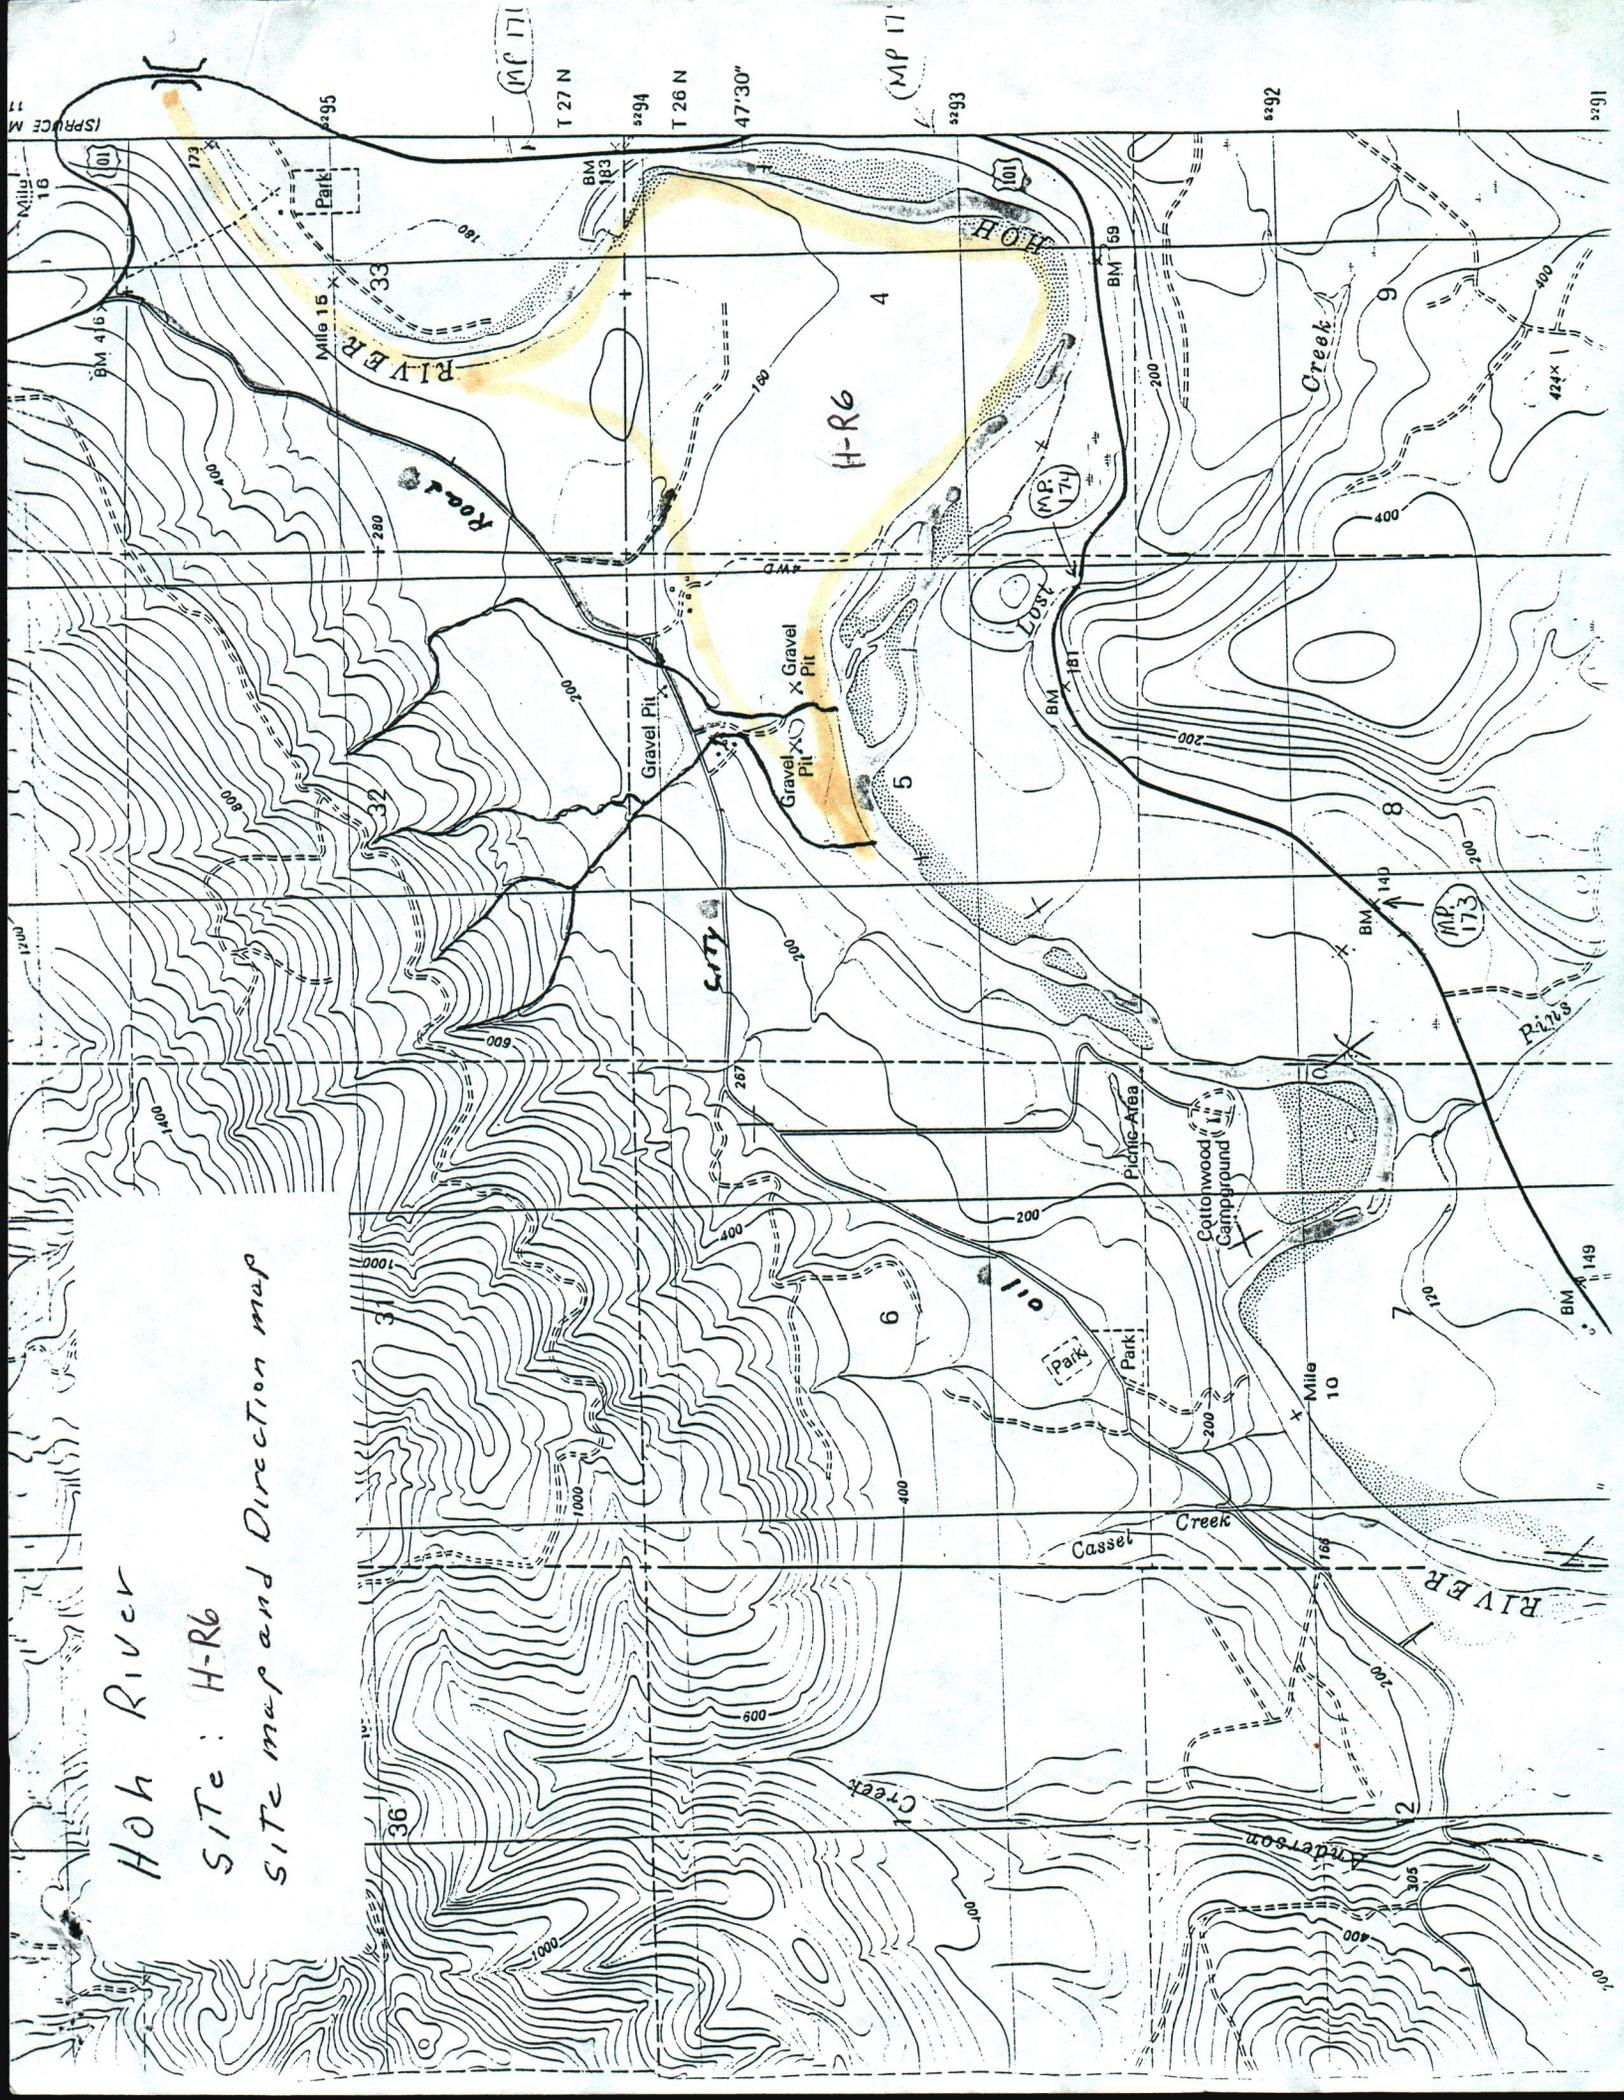
Site map and Direction map

Hoh River
