ENHANCEMENT OPPORTUNITIES: Culvert replacement under old 99 would provide additional spawning and rearing habitat. The culverts under I-5 are also impassable but access above this point prior to the construction of I-5 is suspect. The dam forming the pond is a partial barrier and is poorly constructed.

Project type: Culvert replacement, Pond removal

Site id. code: PIIRBS
 Site name:
 Scale: 1" = 65 m
 Observer(s): B. Barkdull
 Legal location: SE23, T32, R4E

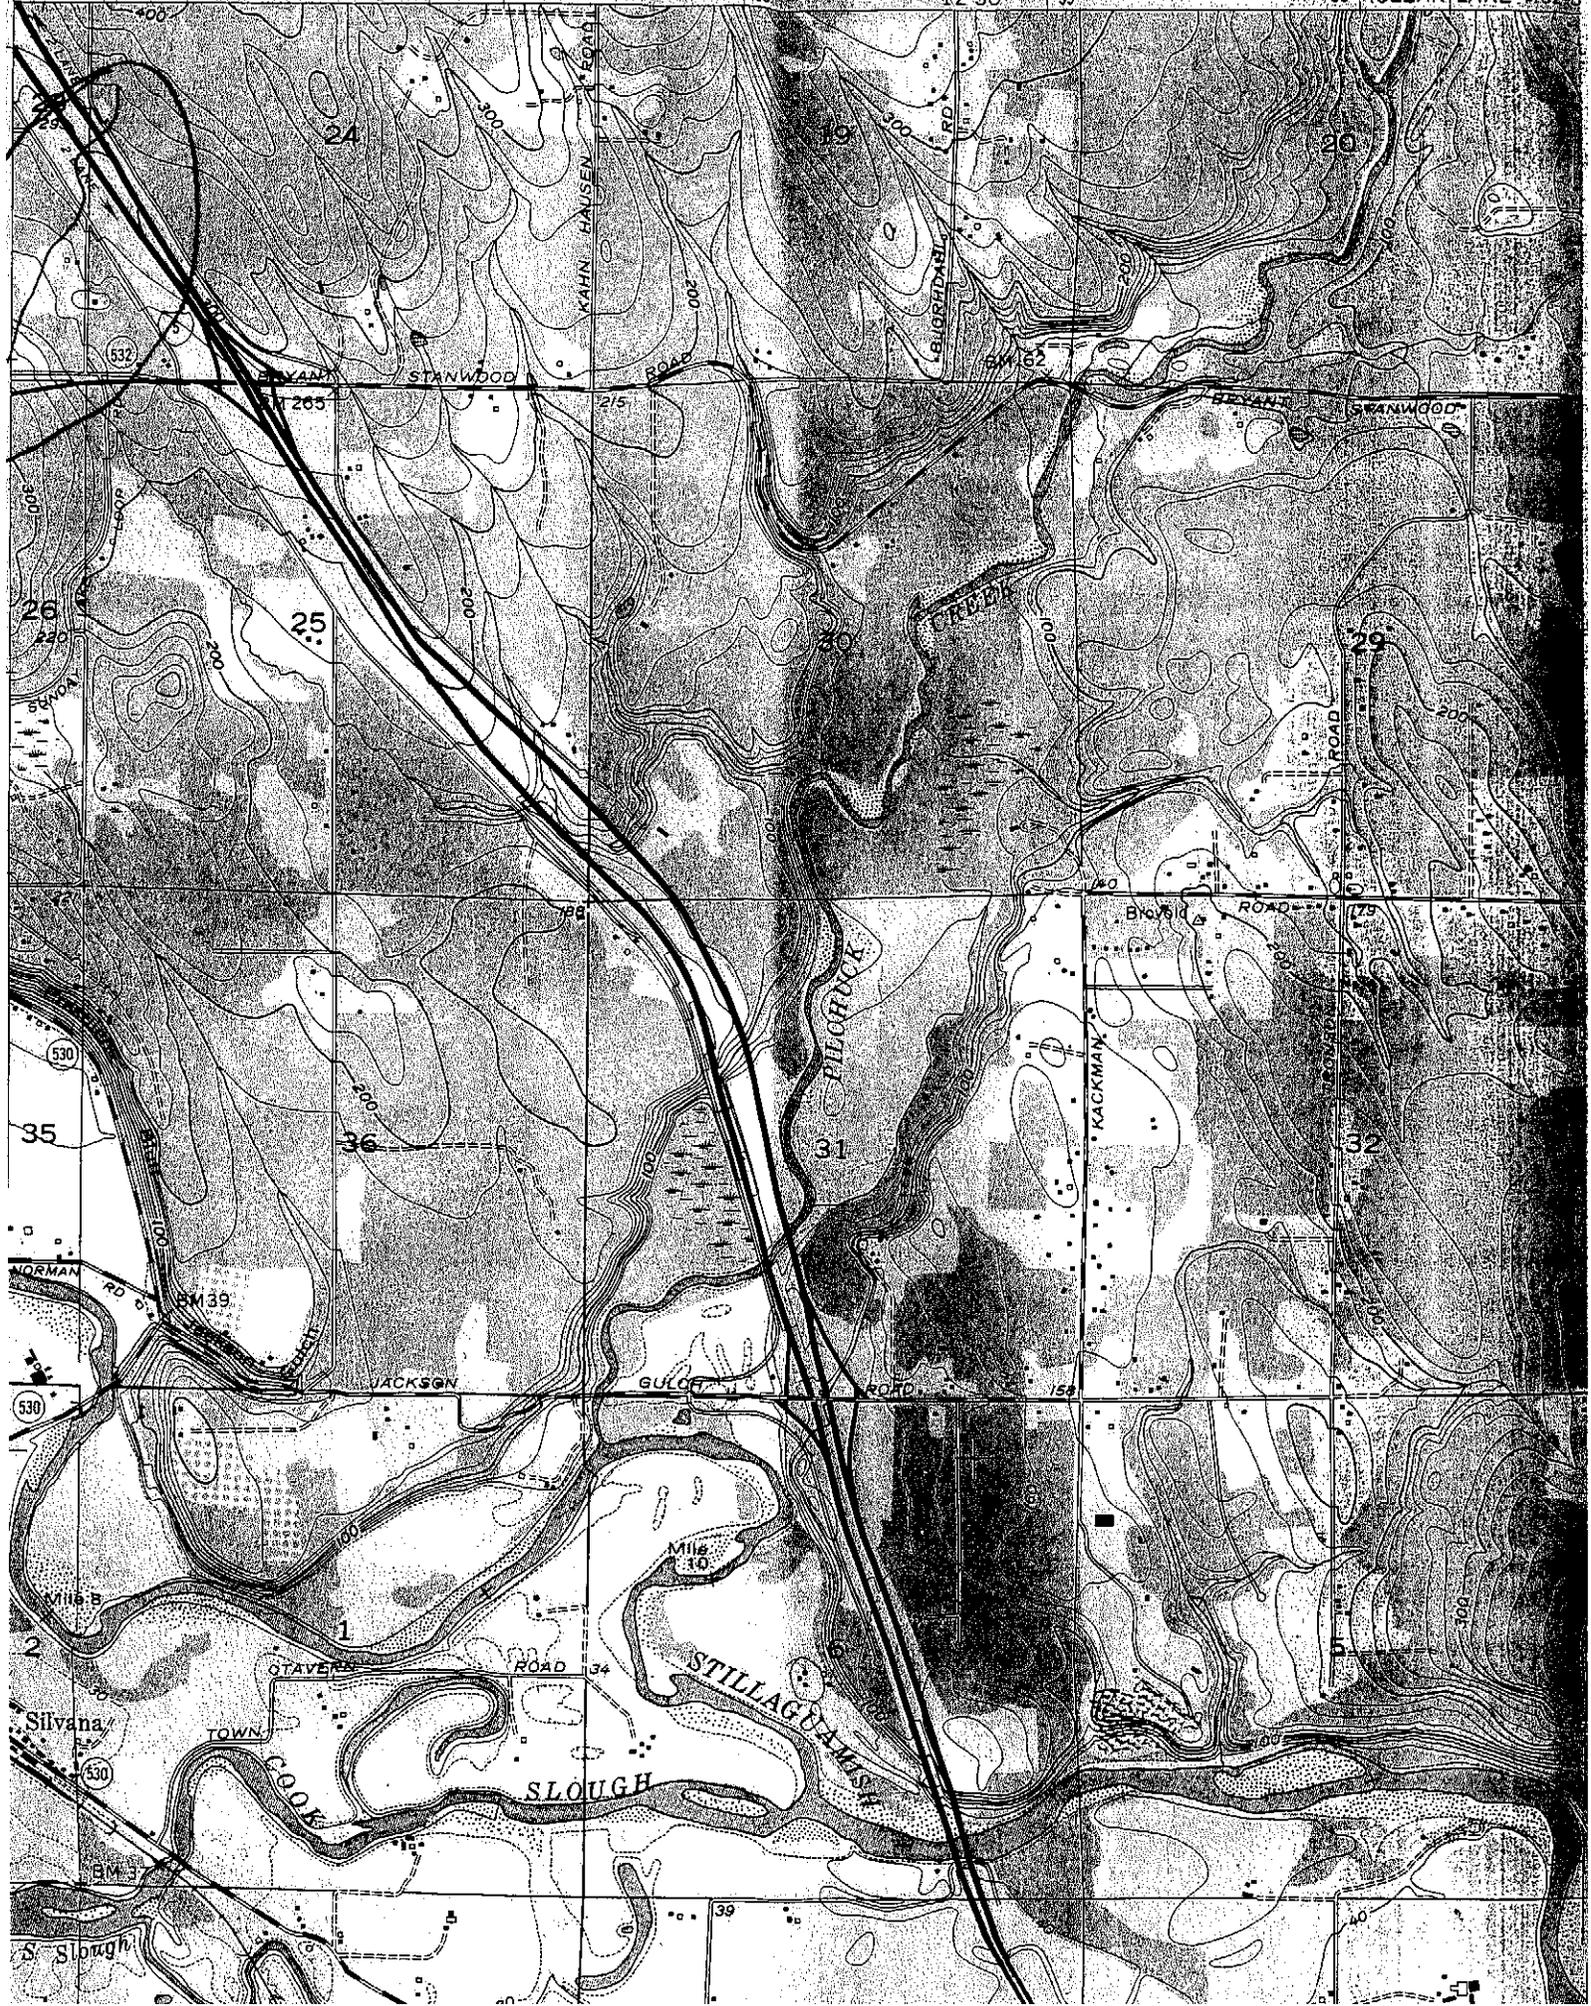
TOPOGRAPHICAL SURVEY

2° 15' 556000m E 57 R. 4 E. R. 5 E 58 12' 30" 59 60 CLEAR LAKE 1580 1625
