STATE OF WASHINGTON
DEPARTMENT OF FISH & WILDLIFE
LANDS AND RESTORATION SERVICES PROGRAM
Salmonid Screening, Habitat Enhancement &
Restoration Division (SSHEAR)

OFF-CHANNEL SITE INVENTORY DATA

Region: North Coast	Observer(s): Nettnin
River System: Sol Duc	Date: 1/8/97
Site Identifier: S-304L-03	WRIA: 20.0304 H (Proposed)
River Mile Location: 1.6	RB/LB: LB
Local Name: Luken Marsh	Trib. to: E.F. Gunderson Cr. 20.0304 A
Legal Description: NE¼ Sec 20 T29N R13W	County: Clallam

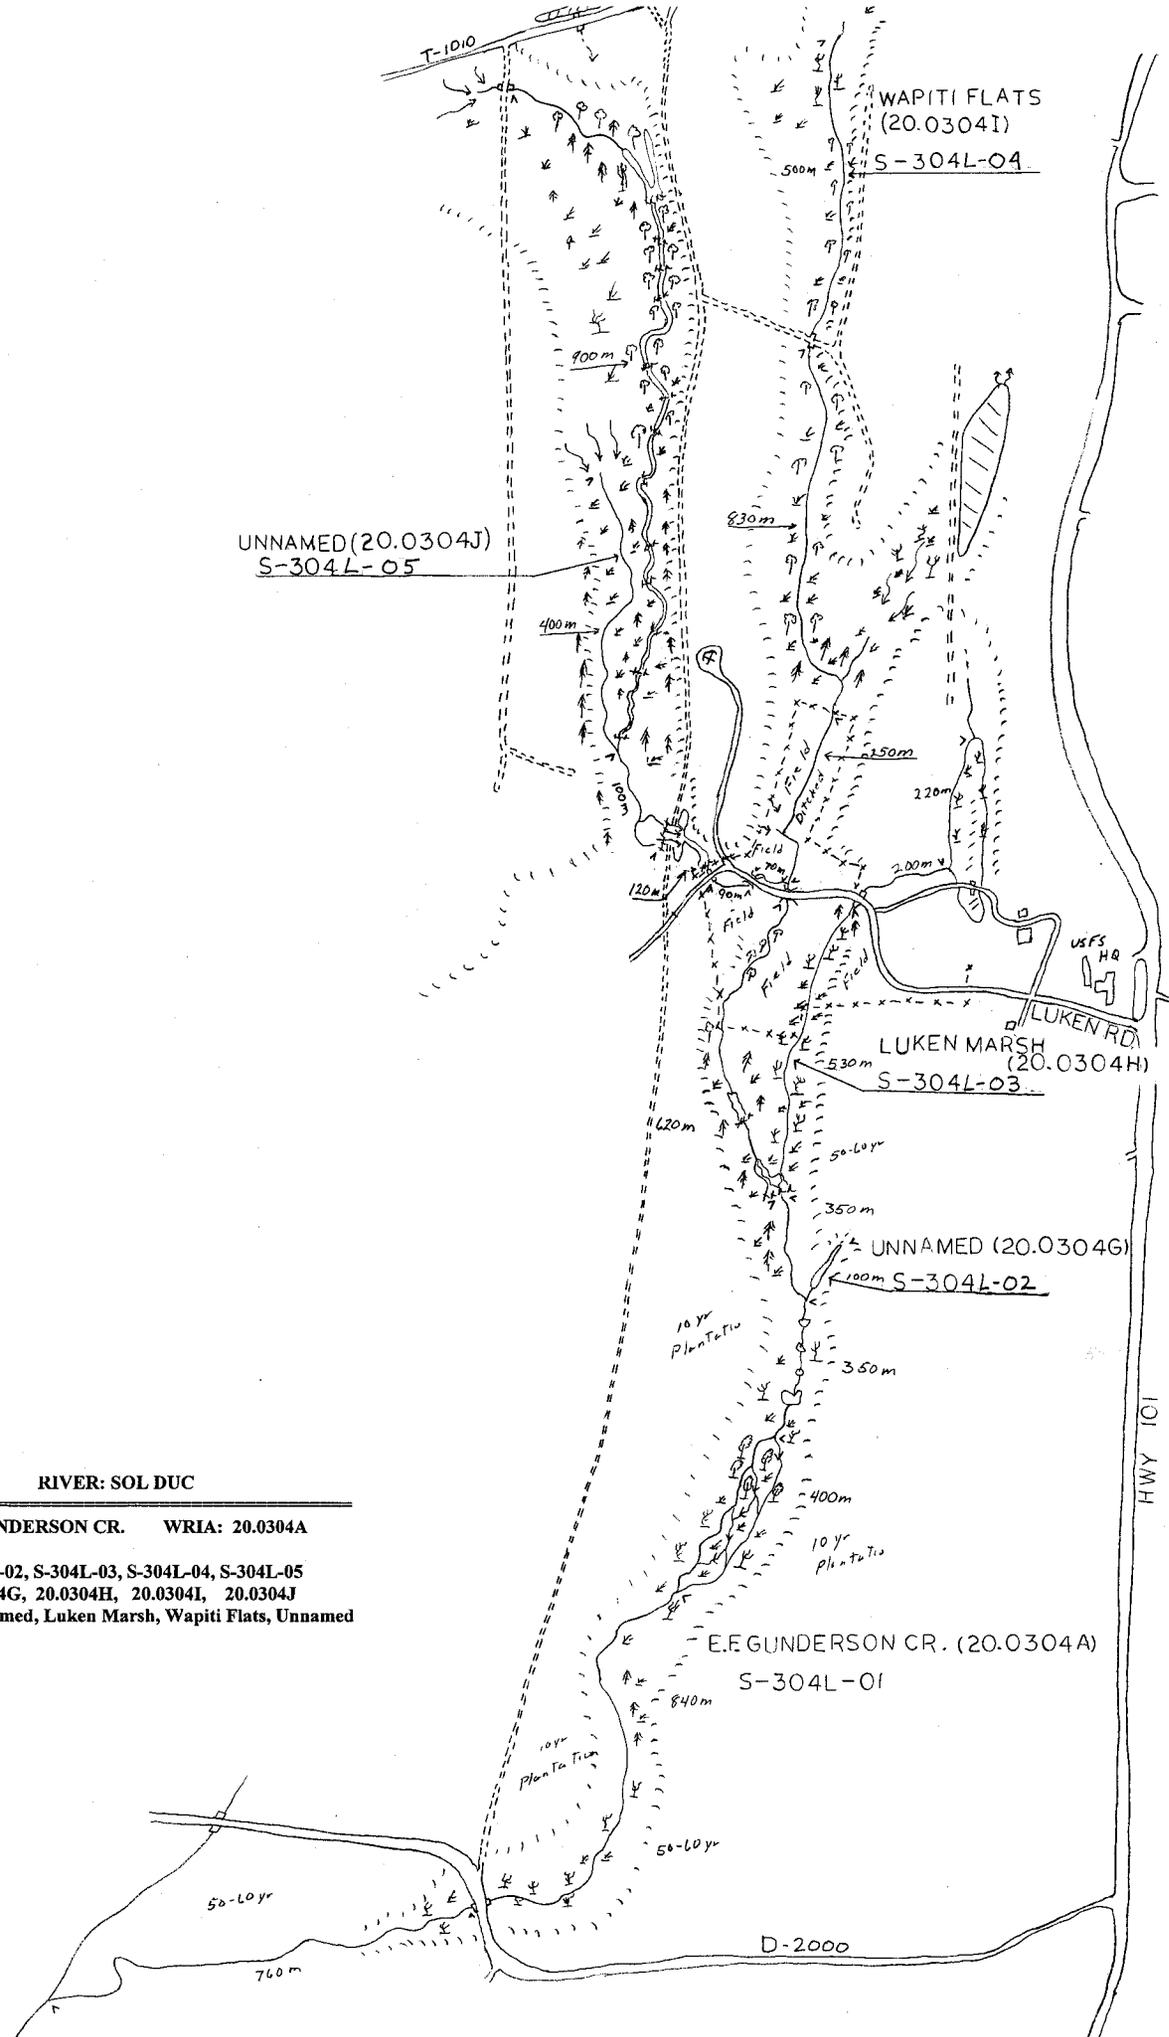
RIVER: SOL DUC

TRIB: E.F.GUNDERSON CR. WRIA: 20.0304A
 AREA: S-304L
 SITES: S-304L-02, S-304L-03, S-304L-04, S-304L-05
 WRIA: 20.0304G, 20.0304H, 20.0304I, 20.0304J
 NAMES: Unnamed, Luken Marsh, Wapiti Flats, Unnamed

DATE: 1/97
