STATE OF WASHINGTON  
**DEPARTMENT OF FISH & WILDLIFE**  
**LANDS AND RESTORATION SERVICES PROGRAM**  
Salmonid Screening, Habitat Enhancement &  
Restoration Division (SSHEAR)

**OFF-CHANNEL SITE INVENTORY DATA**

<b>Region:</b> North Coast	<b>Observer(s):</b> Nettin
<b>River System:</b> Sol Duc	<b>Date:</b> 3/20/98
<b>Site Identifier:</b> S-313L-07	<b>WRIA:</b> 20.0313MM (P)
<b>River Mile Location:</b> 4.8	<b>RB/LB:</b> LS (Left Shore)
<b>Local Name:</b> Bone Slough	<b>Trib. to:</b> Lake Pleasant
<b>Legal Description:</b> SE¼ Sec24 T30N R13W	<b>County:</b> Clallam
<b>Habitat Type:</b> Terrace Tributary	
<b>Landowner:</b> <input type="checkbox"/> Federal <input checked="" type="checkbox"/> State <input type="checkbox"/> County <input type="checkbox"/> Other Government <input checked="" type="checkbox"/> Private - Possibly Rayonier Timber Operations Company - Possibly Department of Natural Resources

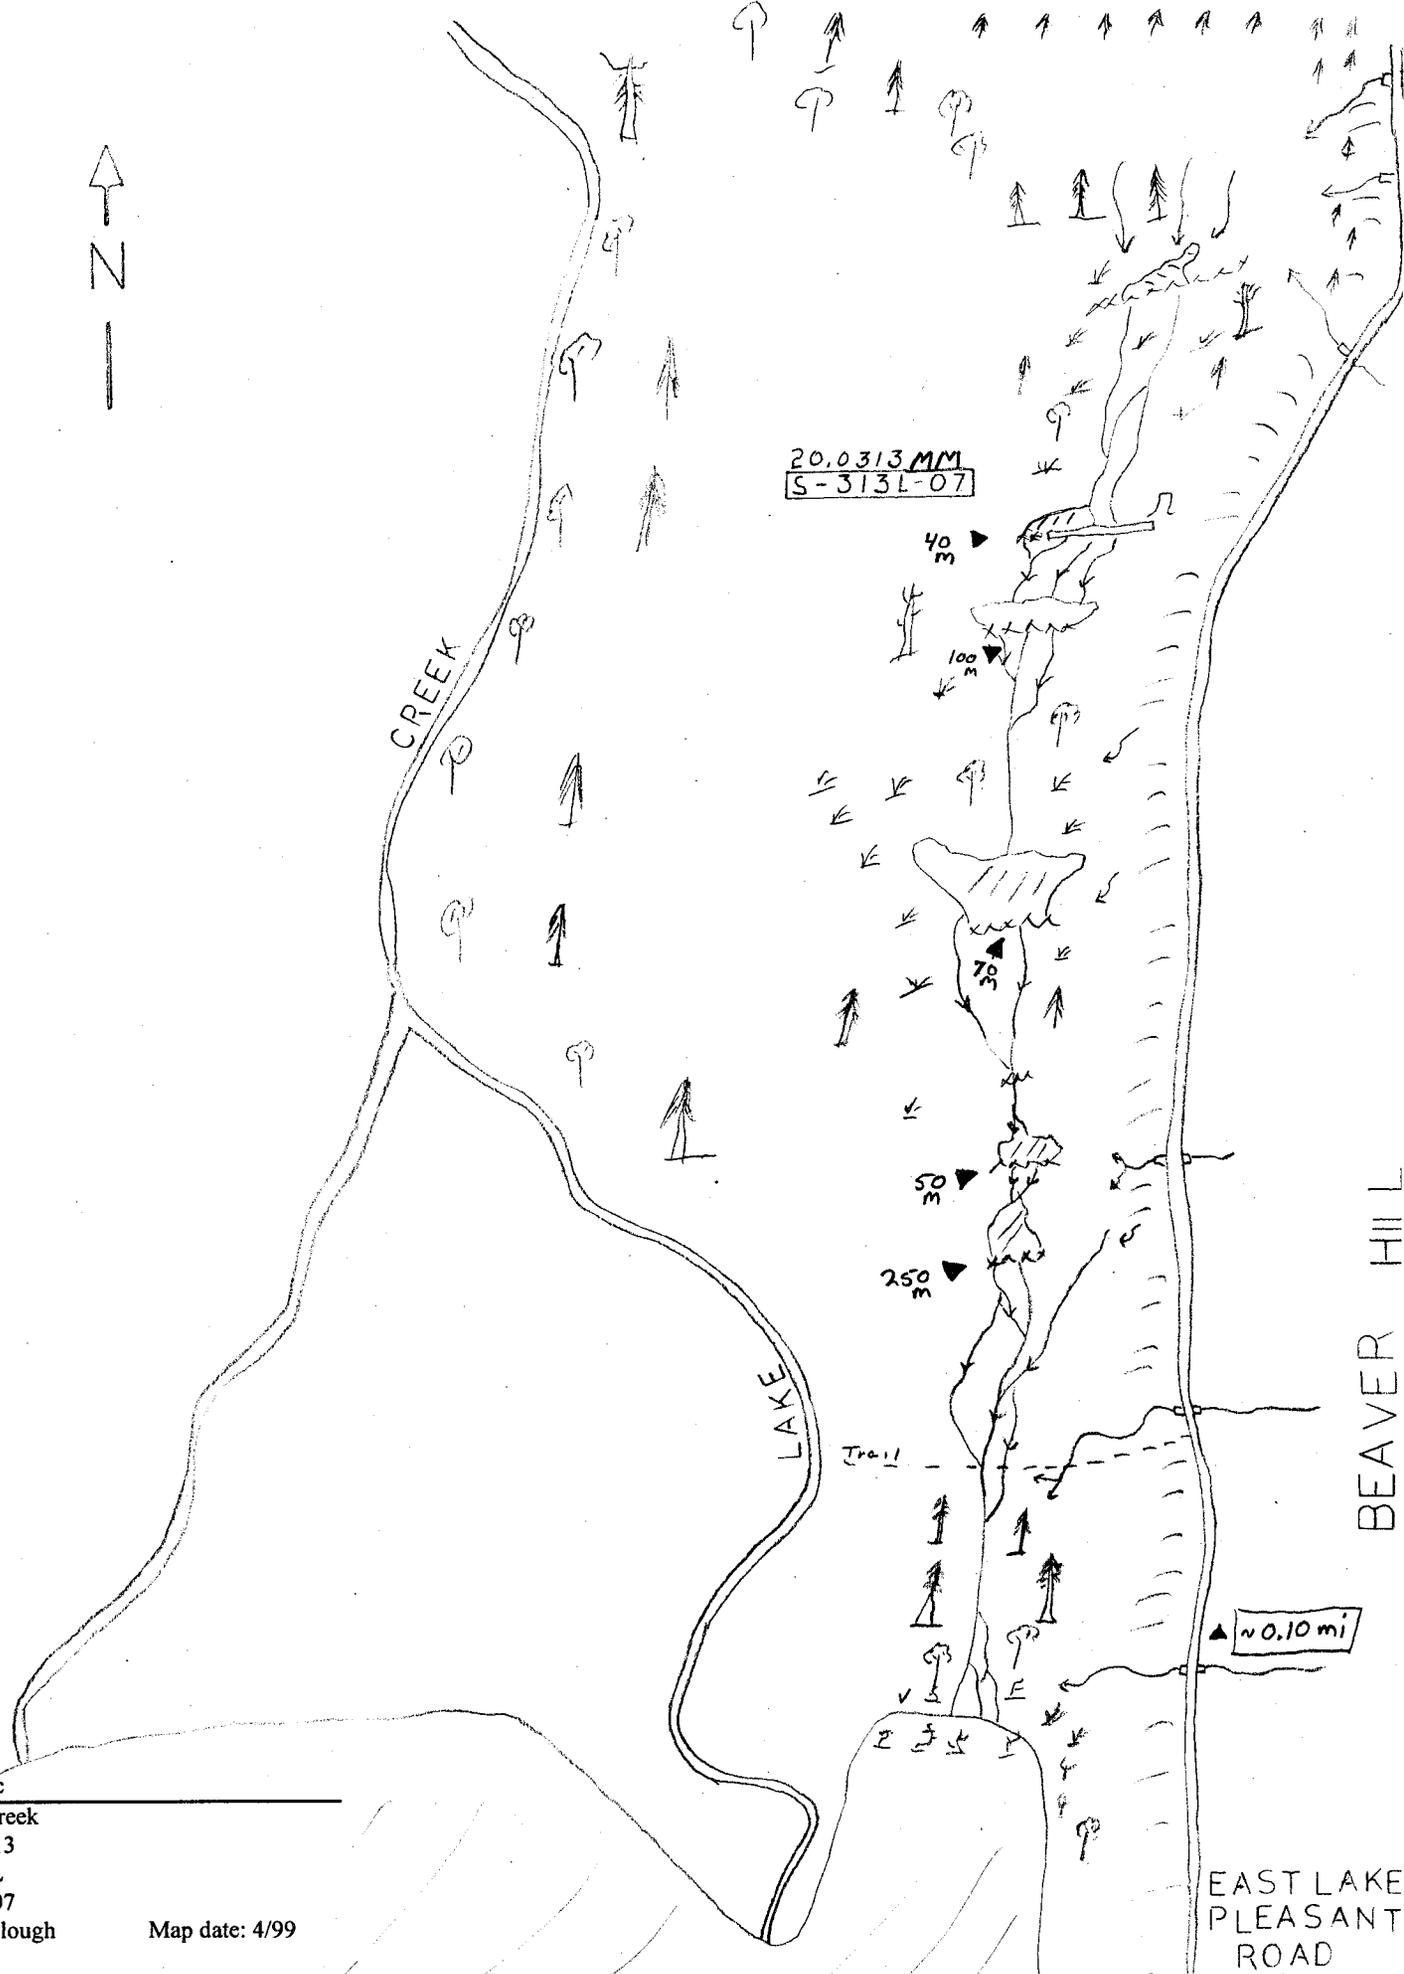
LAKE PLEASANT

Map date: 4/99

North from Forks (Hwy 101) to MP 202, turn left onto East Lake Pleasant Road and then 1.5 mi. to the end of the county road. A gate will be encountered. The key can be obtained at the Rayonier Timber Operations Company office in Forks. About a tenth of a mile beyond the gate, there is a trail off to the left (marked with flagging). Follow the trail to the valley floor past the large spruce trees until S-313L-07 is encountered.

This terrace tributary flows between Lake Creek and the toe of the valley wall. It is low gradient and is characterized as marshy. There are numerous beaver dams, however, most of them are old and inactive. There is an adequate RMZ that provides shade for about 80% of the channel. Large numbers of 0+ coho fry were observed in the lower reach. This appears to be an excellent off channel, over winter rearing area for coho.
