STATE OF WASHINGTON
DEPARTMENT OF FISH & WILDLIFE
LANDS AND RESTORATION SERVICES PROGRAM
Salmonid Screening, Habitat Enhancement &
Restoration Division (SSHEAR)

OFF-CHANNEL SITE INVENTORY DATA

Region: North Coast	Observer(s): Nettrin
River System: Sol Duc	Date: 4/22/99
Site Identifier: S-324L-04	WRIA: 20.0324K (P)
River Mile Location: 1.2	RB/LB: LB
Local Name: Garbage Dump Slough	Trib. to: Beaver Cr. 20.0324
Legal Description: NW¼ Sec 29 T30N R12W	County: Clallam
Habitat Type: Wall based channel	
Landowner: <input type="checkbox"/> Federal <input type="checkbox"/> State <input type="checkbox"/> County <input type="checkbox"/> Other Government <input checked="" type="checkbox"/> Private - Rayonier Timber Operations Company - Possible other private individuals

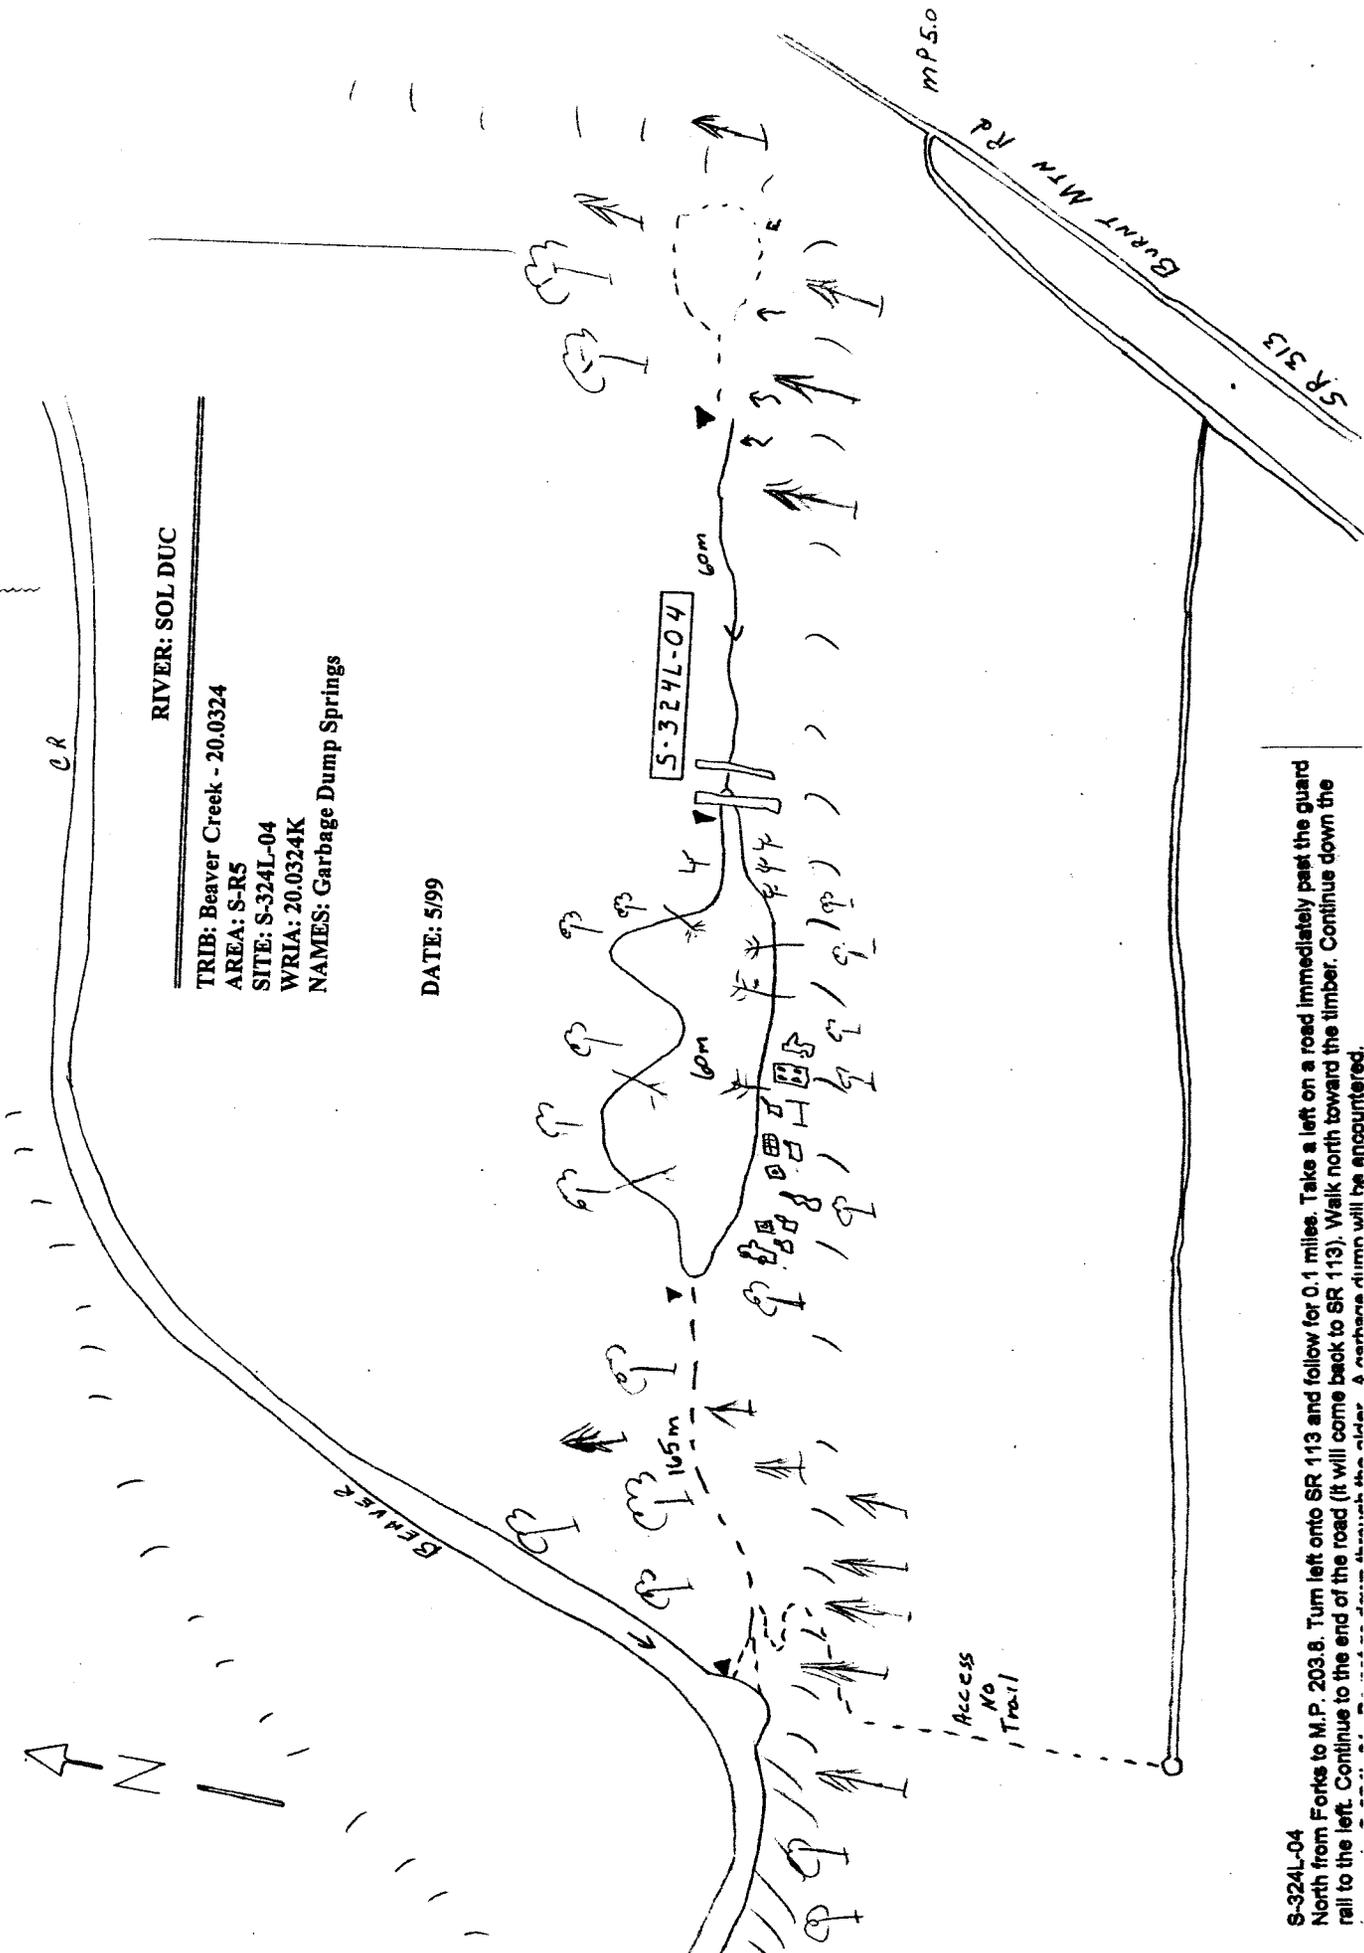
TRIB: Beaver Creek - 20.0324
AREA: S-R5
SITE: S-324L-04
WRIA: 20.0324K
NAMES: Garbage Dump Springs

S-324L-04
 North from Forks to M.P. 203.8. Turn left onto SR 113 and follow for 0.1 miles. Take a left on a road immediately past the guard rail to the left. Continue to the end of the road (it will come back to SR 113). Walk north toward the timber. Continue down the road through the timber. A northern dike will be encountered.

This is a typical wall base channel. Springs emanate along the base of the terrace, pooling in the middle reach. The lower reach however, is dry except during high flows. The uppermost reach is in mature timber. The middle reach is in a younger alder stand and is somewhat open. The lower reach of the impounded area is impacted by an old garbage dump.
