OF WASHINGTON
DEPARTMENT OF FISH & WILDLIFE
LANDS AND RESTORATION SERVICES PROGRAM
Salmonid Screening, Habitat Enhancement &
Restoration Division (SSHEAR)

OFF-CHANNEL SITE INVENTORY DATA

Region: North Coast	Observer(s): Nettnin
River System: Sol Duc	Date: 2/1/00 and 2/15/00
Site Identifier: S-324R-06	WRIA: 20.0324B
River Mile Location: 2.6	RB/LB: RB
Local Name: Boot Creek	Trib. to: Beaver Cr. (20.0324)
Legal Description: NW¼ Sec 20 T30N R12W	County: Clallam
Habitat Type: Lower valley wall tributary	
Landowner: <input type="checkbox"/> Federal <input checked="" type="checkbox"/> State <input type="checkbox"/> County <input type="checkbox"/> Other Government <input checked="" type="checkbox"/> Private - Department of Natural Resources - Unknown, possibly some private ownership

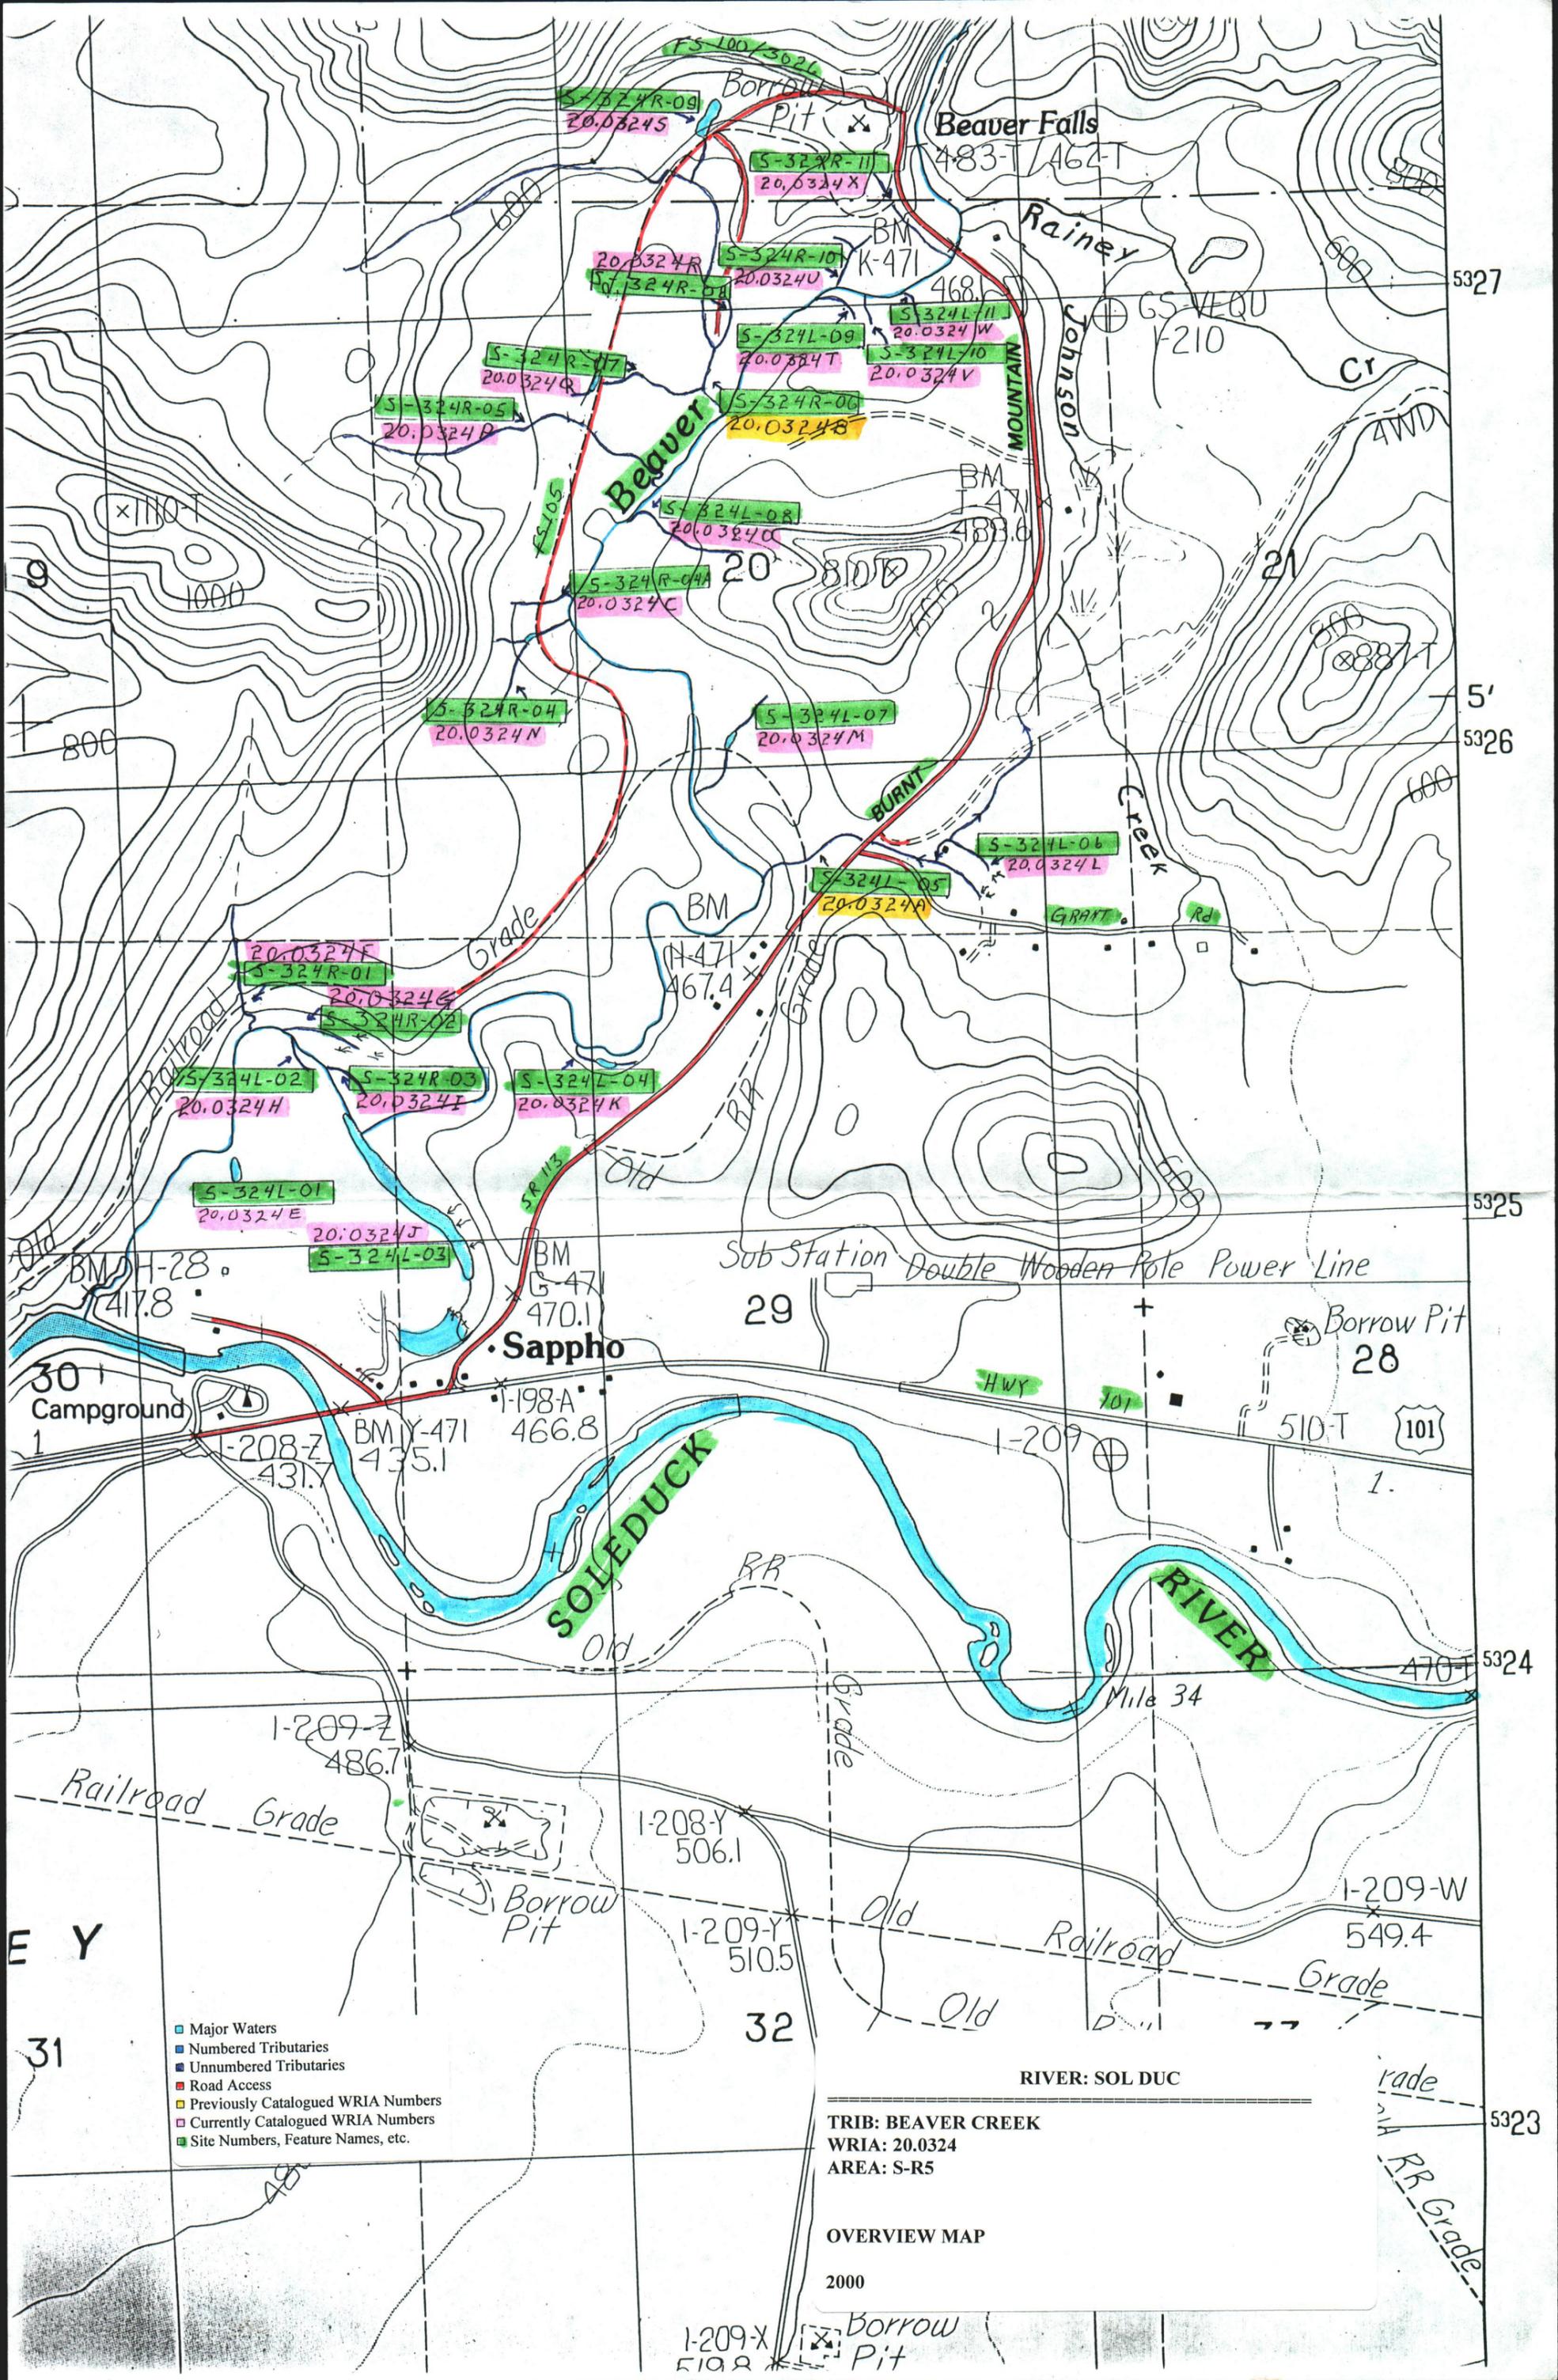
TRIB: Beaver Creek - 20.0324
 AREA: S-R5
 SITE: S-324R-06, S-324R-07, S-324R-08, S-324R-09
 WRIA: 20.0324B, 20.0324Q, 20.0324R, 20.0324S
 NAMES: Boot Cr, Heel Cr, Lace Cr, Arch Cr

- Major Waters
- Numbered Tributaries
- Unnumbered Tributaries
- Road Access
- Previously Catalogued WRIA Numbers
- Currently Catalogued WRIA Numbers
- Site Numbers, Feature Names, etc.
