STATE OF WASHINGTON  
**DEPARTMENT OF FISH & WILDLIFE**  
**LANDS AND RESTORATION SERVICES PROGRAM**  
Salmonid Screening, Habitat Enhancement &  
Restoration Division (SSHEAR)

**OFF-CHANNEL SITE INVENTORY DATA**

<b>Region:</b> North Coast	<b>Observer(s):</b> Nettnin
<b>River System:</b> Sol Duc	<b>Date:</b> 5/8/01
<b>Site Identifier:</b> S-324R-17	<b>WRIA:</b> 20.0324X
<b>River Mile Location:</b> 6.5	<b>RB/LB:</b> RB
<b>Local Name:</b> Unnamed	<b>Trib. to:</b> Beaver Creek (20.0324)
<b>Legal Description:</b> NW ¼, Sec 11, T30N, R12W	<b>County:</b> Clallam

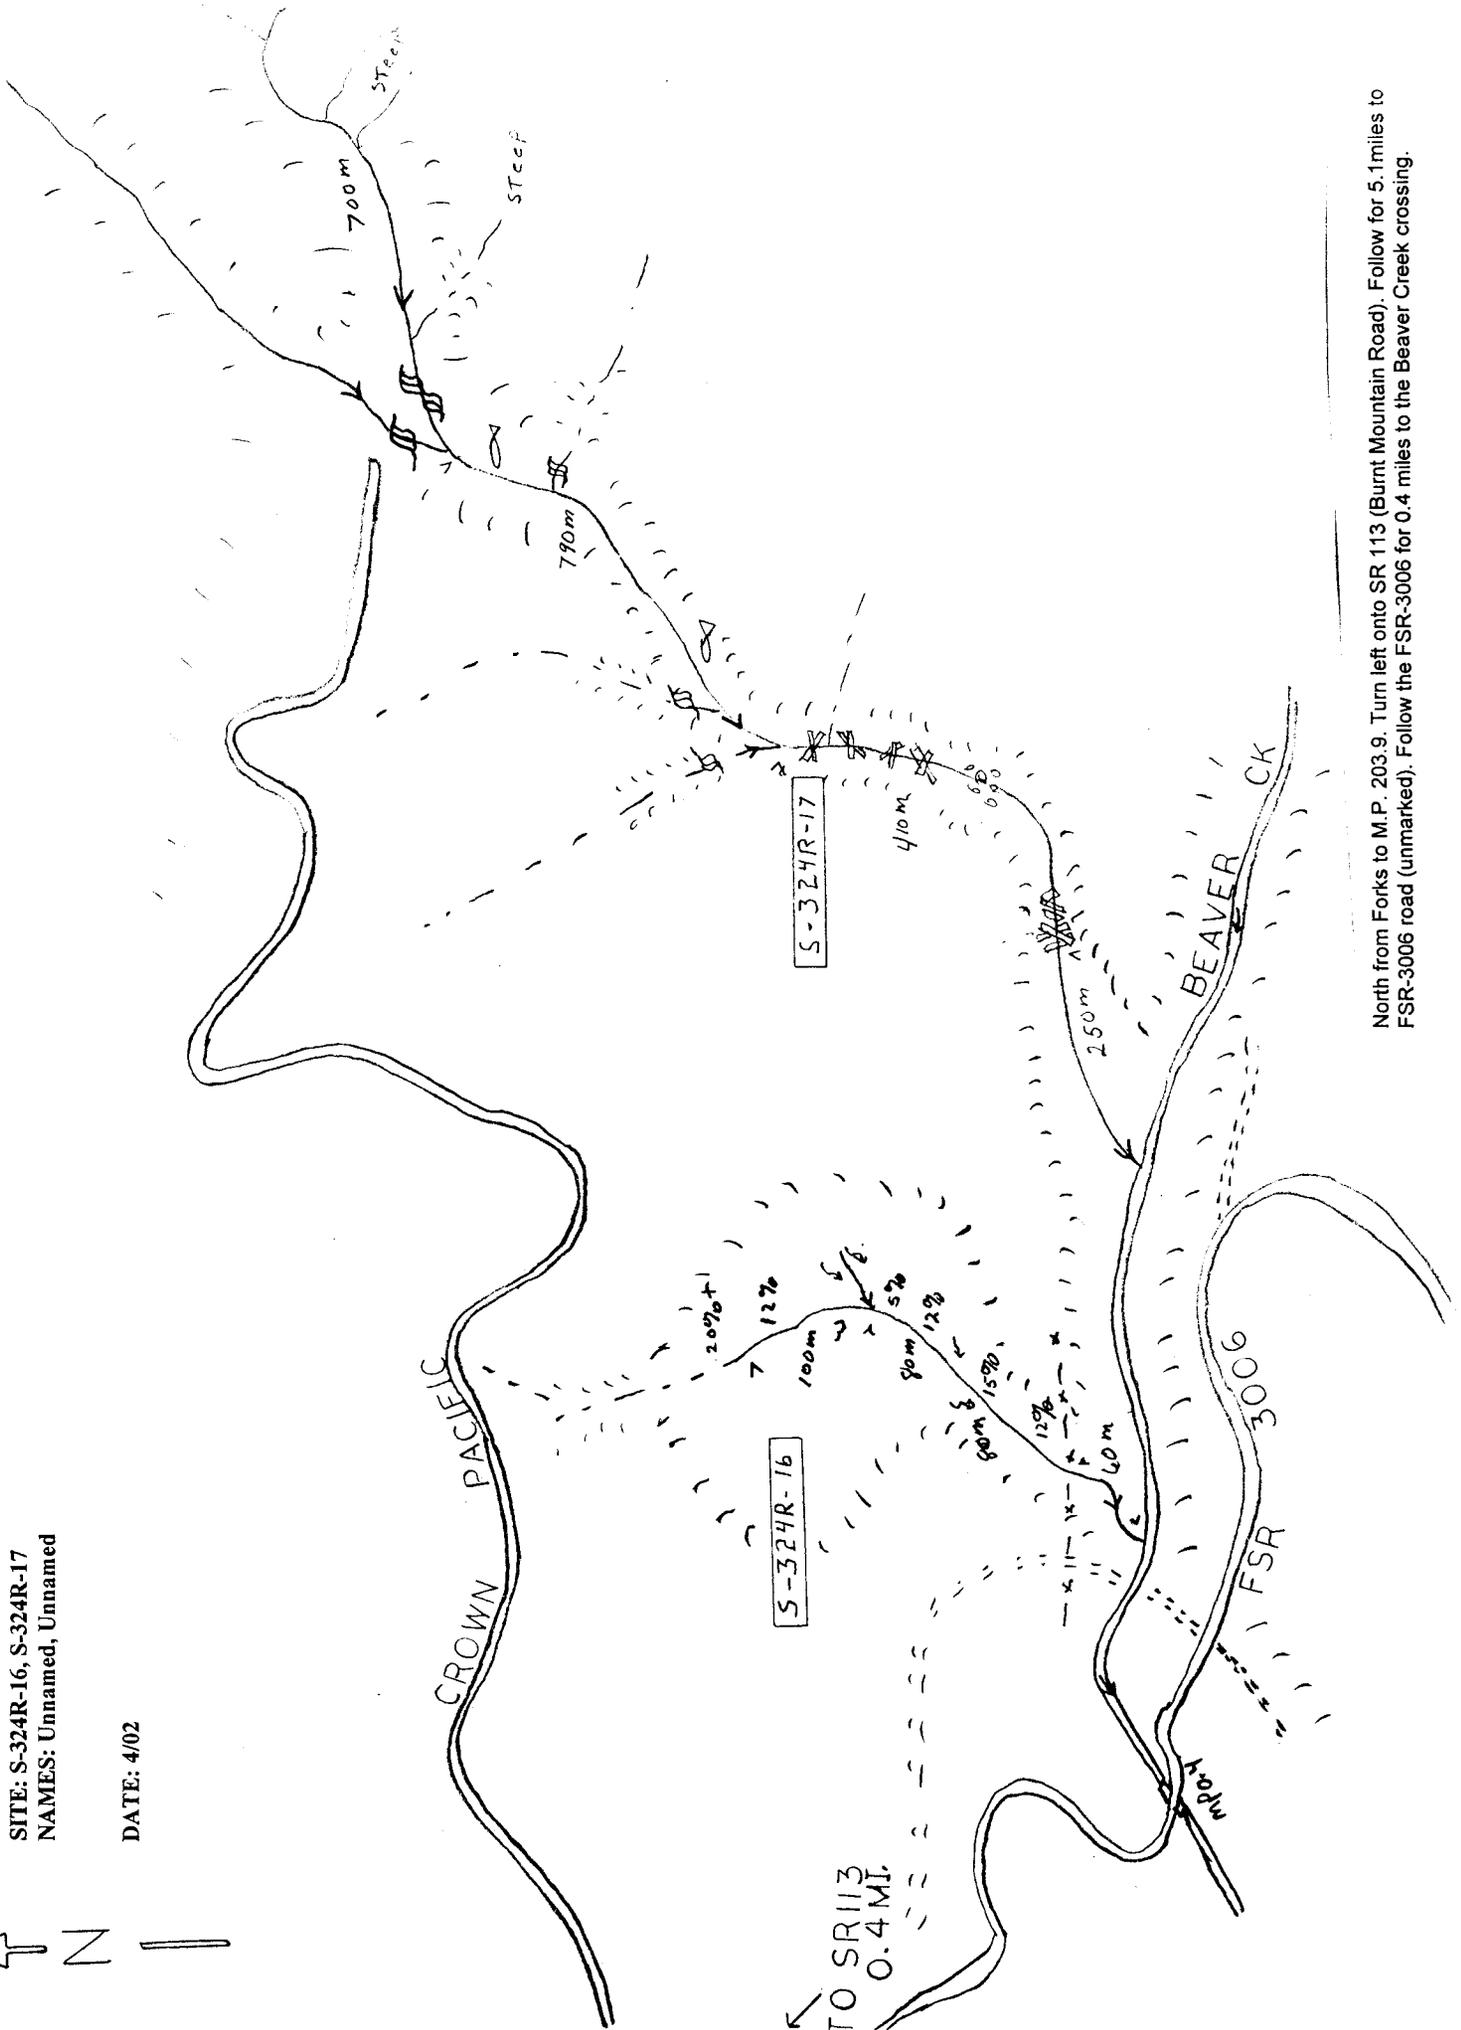
TRIB: Beaver Creek - 20.0324  
AREA: S-R5  
SITE: S-324R-16, S-324R-17  
NAMES: Unnamed, Unnamed

North from Forks to M.P. 203.9. Turn left onto SR 113 (Burrt Mountain Road). Follow for 5.1 miles to FSR-3006 road (unmarked). Follow the FSR-3006 for 0.4 miles to the Beaver Creek crossing.

**Directions to site:** North from Forks to M.P. 203.9. Turn left onto SR 113 (Burnt Mountain Road). Follow for 5.1 miles to FSR-3006 road (unmarked). Follow the FSR-3006 for 0.4 miles to Beaver Creek crossing. Follow the right bank of Beaver Creek upstream for about 470 meters to S-324R-17.
