Fish Passage Effectiveness of Recently Constructed Road Crossing Culverts in the Puget Sound Region of Washington State

Abstract.—Fish passage barriers at road–stream crossings are widely recognized as salmon *Oncorhynchus* spp. habitat restoration priorities in Washington State and throughout the Pacific Northwest of the USA. More than 3,500 fish passage barriers (mostly culverts) have been repaired in Washington streams since 1999, costing more than US\$139 million. We evaluated fish passage at 77 randomly selected culverts (new and repaired) that were issued permits during three time periods (1998, 2003, and 2007). This sample represents approximately 85% of the fish passage culverts permitted in the Puget Sound region of Washington State during the last 10 years. All study culverts were permitted for fish passage under the Washington Department of Fish and Wildlife’s (WDFW) hydraulic project approval (HPA) permitting process and evaluated using physical criteria in the WDFW’s fish passage barrier standard. Our results indicate that 30% of culverts (23 of 77) permitted under the HPA process for fish passage were, in fact, barriers. Culverts permitted as no-slope (one of the mos

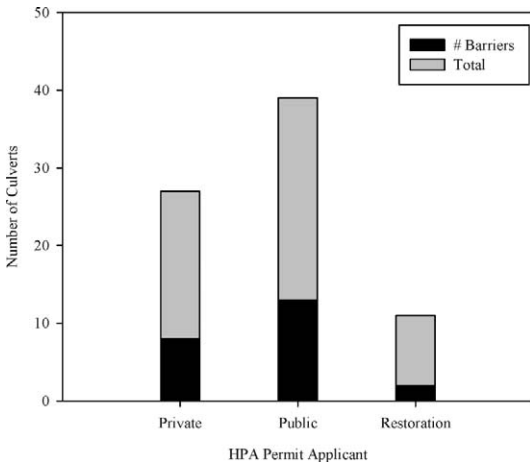
FIGURE 6.—Number of culverts by barrier/nonbarrier status and type of permit applicant.

= 855 d, range = 1,934 d, n = 23) and those not classified as barriers (median = 921 d, range = 2,714 d, n = 54; Figure 5). Likewise, there was no statistical difference in barrier status between culverts installed by restoration sponsors and nonrestoration sponsors (Fisher’s exact test; P = 0.490). Excluding the two culverts that washed out did not change this result (P = 0.266), although the small sample size for restoration sponsors may limit the ability to distinguish among project sponsors (Figure 6).

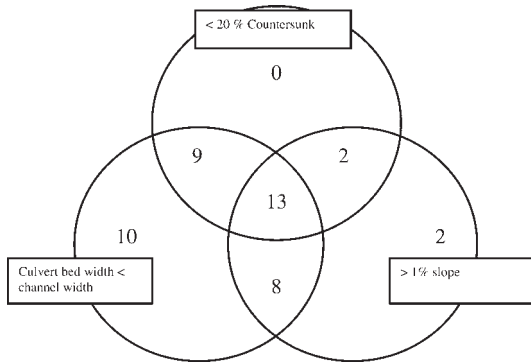
FIGURE 7.—Venn diagram showing the no-slope design criteria thresholds and the ways in which 44 culverts failed to meet the criteria of the no-slope or stream simulation designs in terms of those thresholds.

Culverts identified as no-slope but failing to meet the design criteria for that type (n = 26; Table 7) plus unknown culvert designs (n = 18; Table 7) tended to be narrow relative to channel width. As measured in the field, the mean span-to-bankfull width ratio for stream simulation design culverts was 1.56:1, that for bottomless design culverts was 1.17:1, and that for no-slope and unknown design culverts was 0.72:1. Inadequate countersinking (i.e., <20%) and excessive slope (>1% slope difference) were also common in unknown designs. Culverts never failed to meet design criteria solely because they were inadequately countersunk, and only two failed solely because of excessive slope (Figure 7).

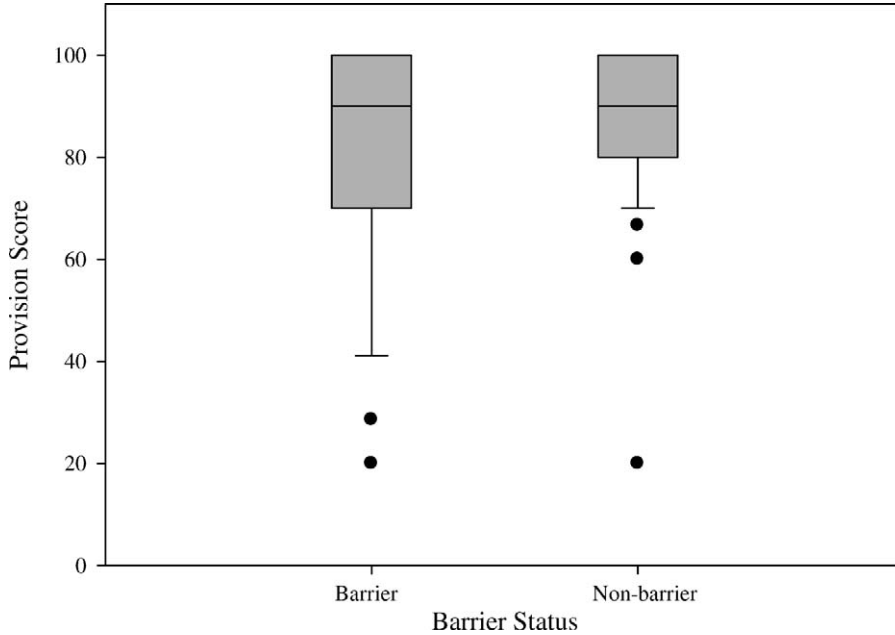
FIGURE 11.—Provision scores (proportion of important provisions contained in an HPA permit) by barrier/nonbarrier status.

The proportion of important provisions contained in an HPA permit (i.e., provision score) among HPA permits ranged from 0 to 100 (median = 90). There was no significant difference in provision scores between barrier and fish-passable culverts (Mann–Whitney $U = 573.0$, $P = 0.560$), although barrier culverts tended to have slightly lower provision scores (Figure 11). Provision scores were significantly different among permit years (Kruskal–Wallis test; $H = 6.967$, $df = 2$, $P < 0.031$). Median provision scores were 80, 100, and
