# Year-One Progress Report

## Implementation and Effectiveness Monitoring of Hydraulic Projects

February 2015

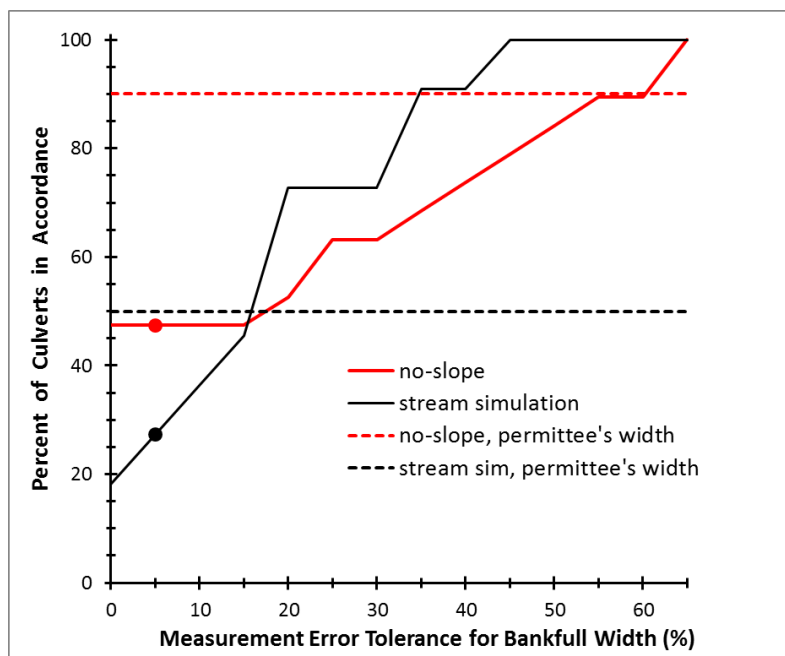
**Figure 2-1.** Sensitivity of accordance rates for no-slope and stream simulation culverts to measurement error tolerance for bankfull width. Dots are accordance rates for culvert width at stream bed for 2013 calculated with 5% error tolerance for BFW measurement. Horizontal dashed lines are mean accordance rates for culvert width at stream bed calculated with the permittees' stream width measurements and a 5% error tolerance (10 no-slope and 6 stream simulation culverts).

Insufficient culvert widths may have been due to mismeasurement of BFW. Permits for six of the stream simulation culverts reported the permittee’s stream channel measurement. The accordance rate for these six culverts based on the permittees’ stream channel measurement was 50% (Figure 2-1). Permits for ten of the no-slope culverts reported the permittee’s stream channel measurement. The accordance rate for these ten culverts based on the permittees’ stream channel measurement is 80%. One of the two culverts that were nonaccordant, did so because it was too long, therefore, the accordance rate for width alone for these 10 culverts was 90%.

The accordance rate for no-slope culverts was 47% (N=19) when we used our channel width measurement but 80% (N=10) when we used the permittees' channel width measurement. Our sensitivity analysis (Figure 2-1) showed that if our estimates of BFW were mistakenly 20% too wide, then the accordance rate for stream simulation culverts changes dramatically from 27% to 73%. Also, we observed that even among staff in WDFW there could be significant disagreement about estimates of mean BFW. Therefore, based on these observations and because a standard procedure for estimating mean BFW does not exist at this time, we question the reliability of accordance rates for culverts in 2013. We do not have the same concern about the calculation of compliance rates.

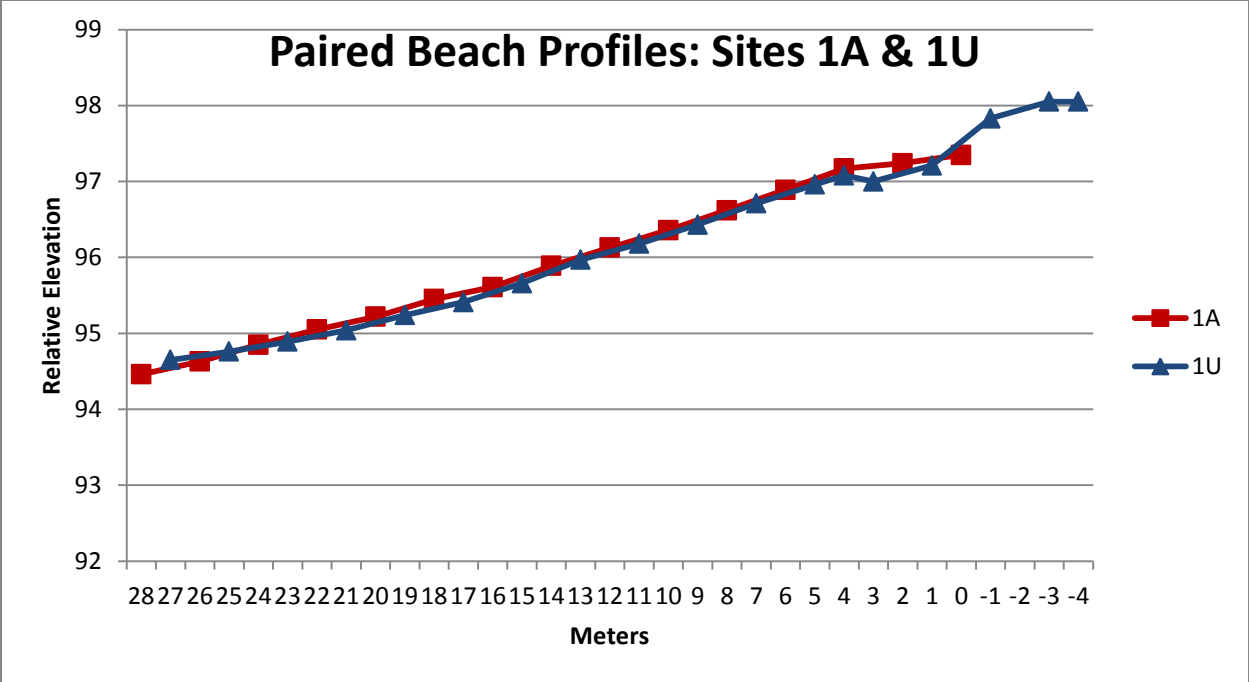
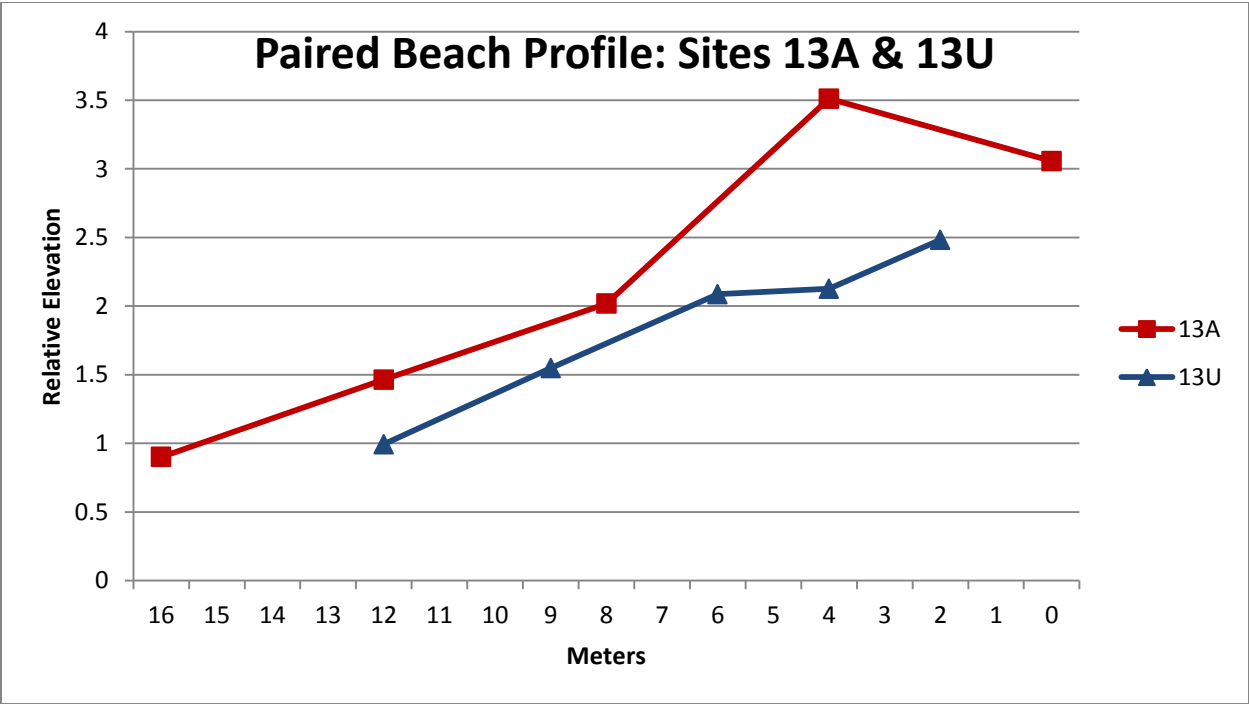
**Figure 3-3.** Comparison of beach profiles for armored (1A and 13A) and unarmored reference sites (1U and 13U). A beach profile represents a cross section of the surface of the beach. The horizontal axis is measured in meters from the approximate toe of the bank or armoring. The vertical axis is the difference in elevation (in meters) relative to a fixed elevation reference.

In addition to the 13 project sites we surveyed in 2013, we also identified and surveyed two potential reference sites, and completed an effectiveness survey at the closest project site to each reference site. Analysis of effectiveness surveys is ongoing. Preliminary results of beach profile and sediment size comparison between neighboring armored and unarmored sites is represented in Figures 3-2 and 3-3.
