Implementation and Effectiveness Monitoring of Hydraulic Projects

Year-Five Progress Report

May 2019

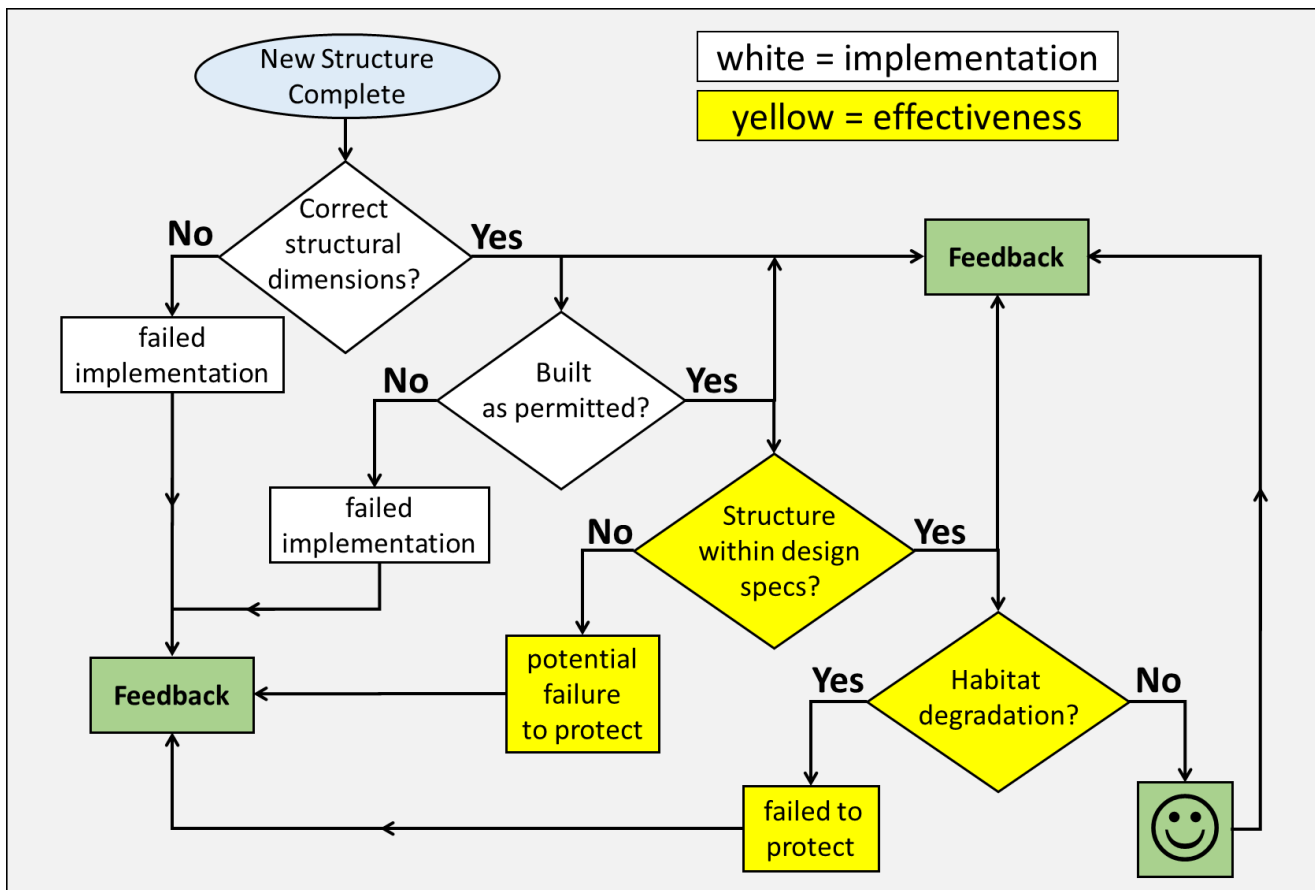
Figure 1.2. Conceptual model depicting relationship between implementation monitoring and effectiveness monitoring of a hydraulic structure. Implementation monitoring occurs once at each hydraulic structure. Effectiveness monitoring occurs many times over time per structure.

Our monitoring framework is hierarchical because the results at one level influence the results at lower levels (Figure 1.2). Implementation monitoring, for instance, determines which management activities will be monitored for effectiveness. Only successfully implemented hydraulic projects, as determined through implementation monitoring, become potential subjects of effectiveness monitoring. Limiting effectiveness monitoring in this way makes efficient use of resources allocated to adaptive management. However, both successes and failures provide feedback for improving implementation.

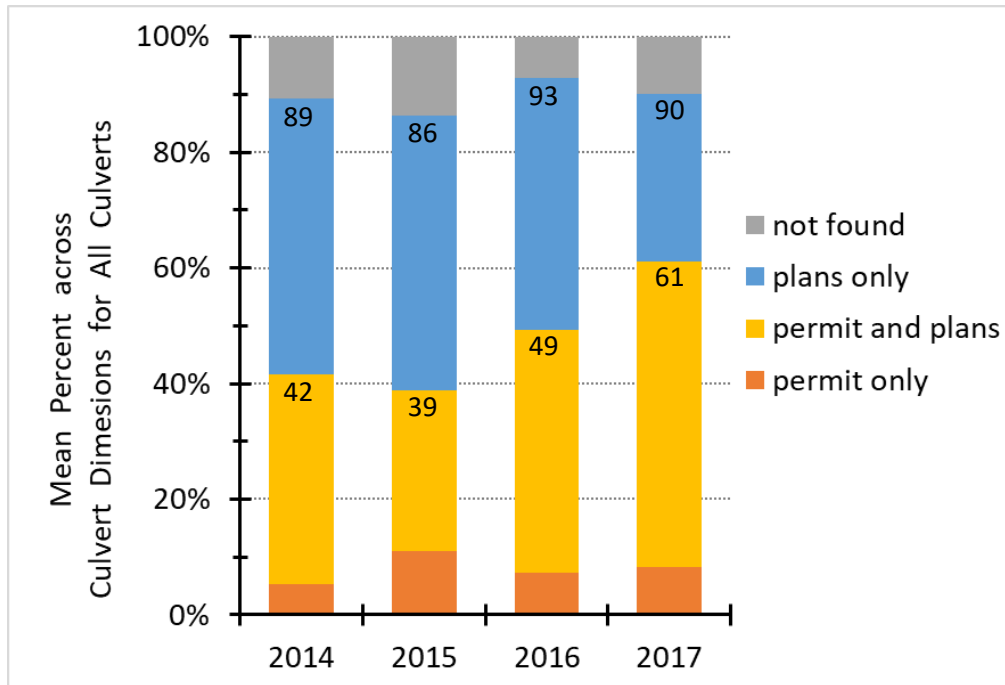
Figure 2.4. Percent of all critical structural dimensions (culvert width at streambed, length, slope, minimum countersink, maximum countersink) for which information could be found on the HPA permit or the project’s plans. Top number in each column is sum of blue, yellow, and orange sections. Bottom number is sum of yellow and orange sections.

An HPA permit should have a specification for every critical structural dimension either on the permit or in the project’s plans. Nearly all permits indirectly included specifications for one or more structural dimensions via a provision such as, “APPROVED PLANS: You must accomplish the work per plans and specifications approved by the Washington Department of Fish and Wildlife . . .” For 2014 through 2017, the combination of permit provisions and project plans resulted in specifications for 89% of critical structural dimensions per year; the minimum of 86% occurred in 2015 (Figure 2.4, Table 2.2).

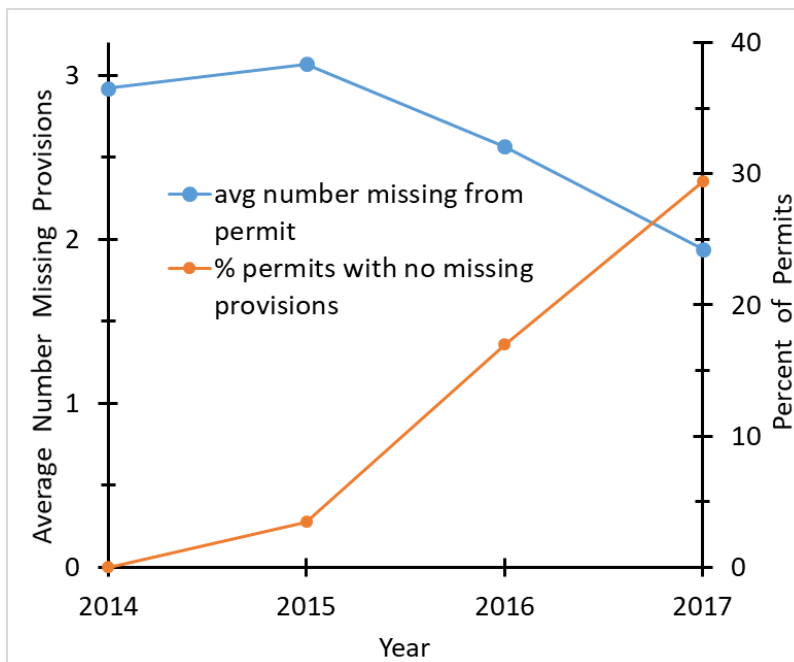
Figure 2.5. Average number per permit of missing provisions for critical structural dimensions, and percent of permits with no missing provisions for critical structural dimensions. Both trends are statistically significant, the former for $p < 0.10$ and the latter for $p < 0.05$.

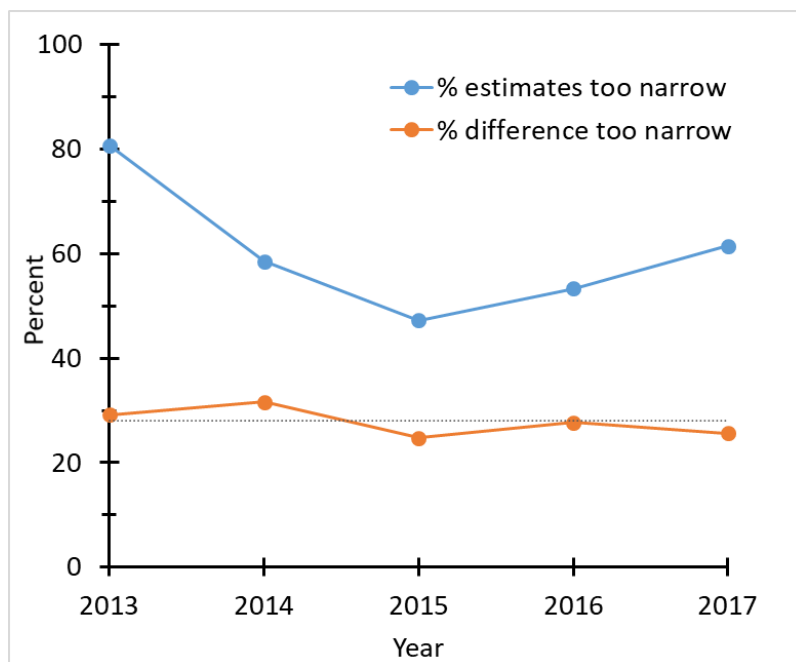
Figure 2.6. Percent of culverts that had channel width estimates by permittee that were narrower than WDFW’s bankfull width estimate, and the average percent difference between the two estimates. Percent difference calculated only for those channel width estimates that were narrower than WDFW’s estimate. WDFW estimates done by implementation monitoring field crew. Dotted line shows the weighted average of the 5 years (28% narrower).

Channel width estimates by permittees tended to be narrower than our estimates of bankfull width. On average, over the 5 years, 59% of estimates per year were narrower (Figure 2.6); the other 41% were wider than our estimates obtained through implementation monitoring. This rate changed over time. In 2013, 81% of permittees' estimates were narrower than ours, but in 2017, 62% were narrower. When permittees' channel width estimates were narrower, they were on average, over the 5 years, 28% narrower than our channel width estimate. This rate stayed roughly constant over the 5 years of monitoring.

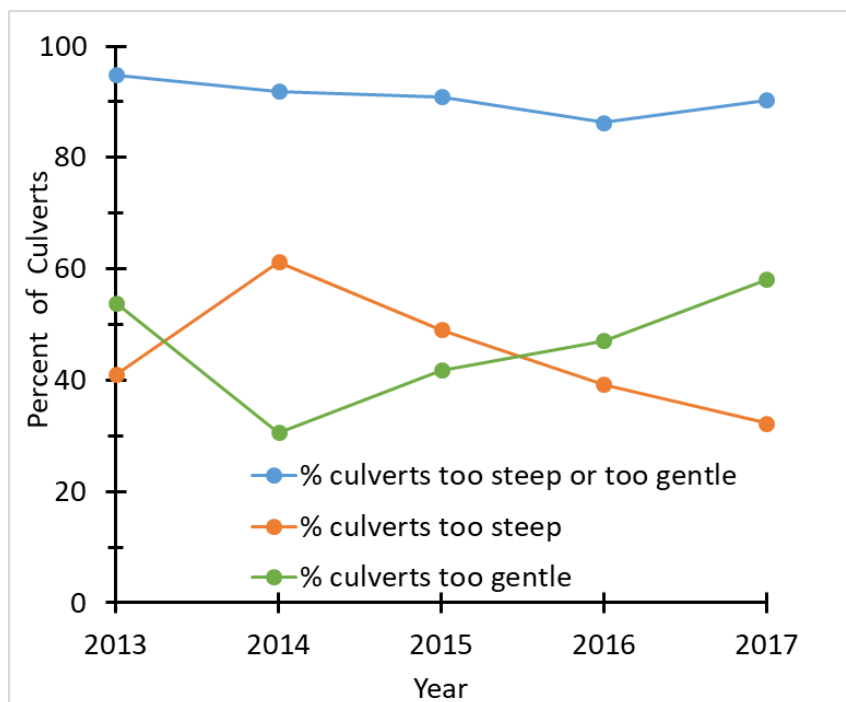
Figure 2.15. Percent of culverts each year constructed with a slope to gentle or too steep.

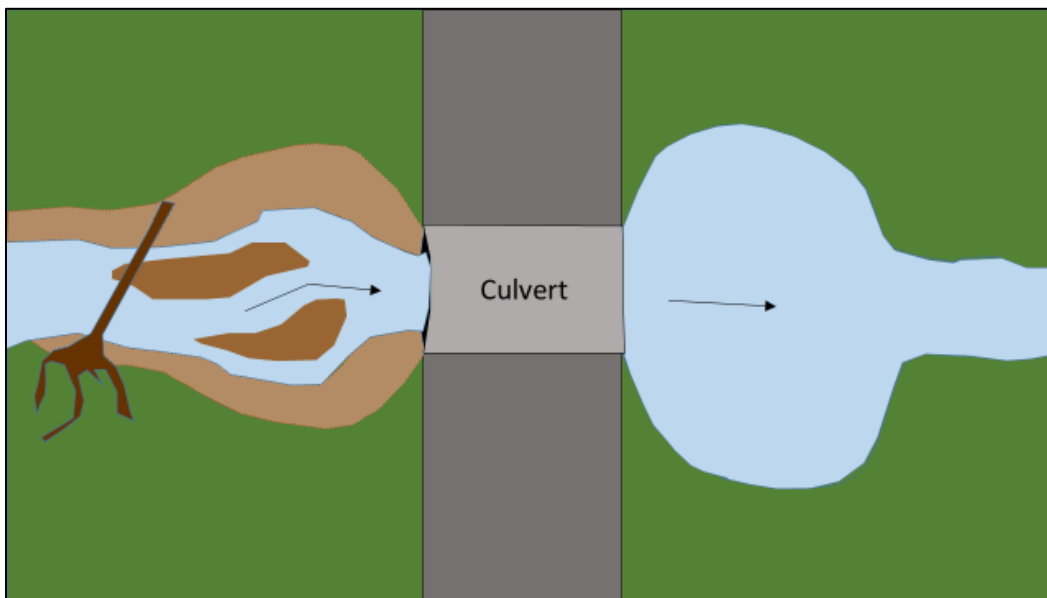
Figure 3.1. Planform view of bed and bank erosion and aggradation caused by an undersized culvert.

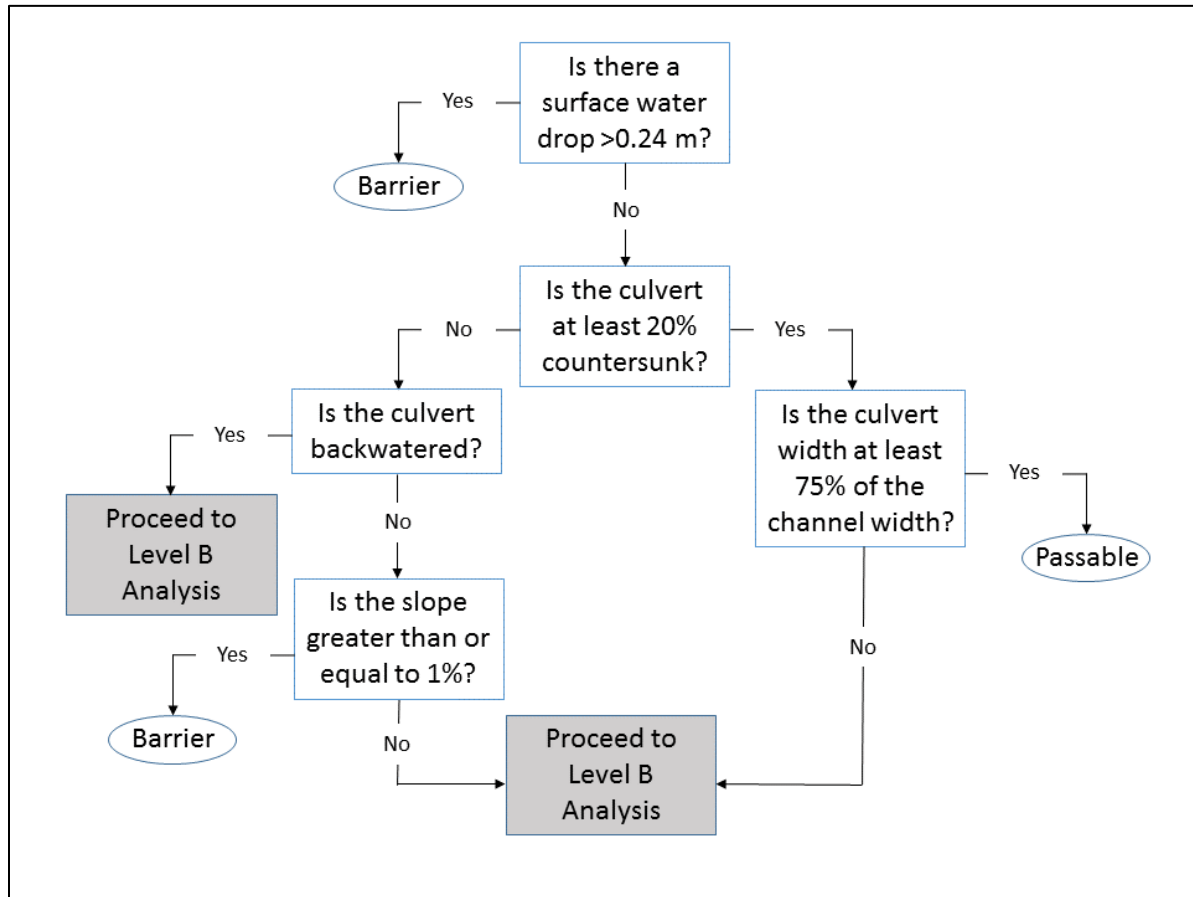
Figure 3.3. Flow chart of the Level A fish passage barrier assessment for culverts (modified from WDFW 2009).

surface flow, lack of bed material, or uncharacteristically coarse bed material. Flow velocities used in the assessment are in the current hydraulic code rules (WAC 220-660-200), and were based on the professional opinion of fish biologists. Field crews conduct a Level A barrier assessment which evaluates hydraulic drop and culvert slope (Figure 3.3). The passability of most culverts is determined through the Level A assessment, however, if a determination cannot be made, then the culvert moves on to a more comprehensive Level B assessment.

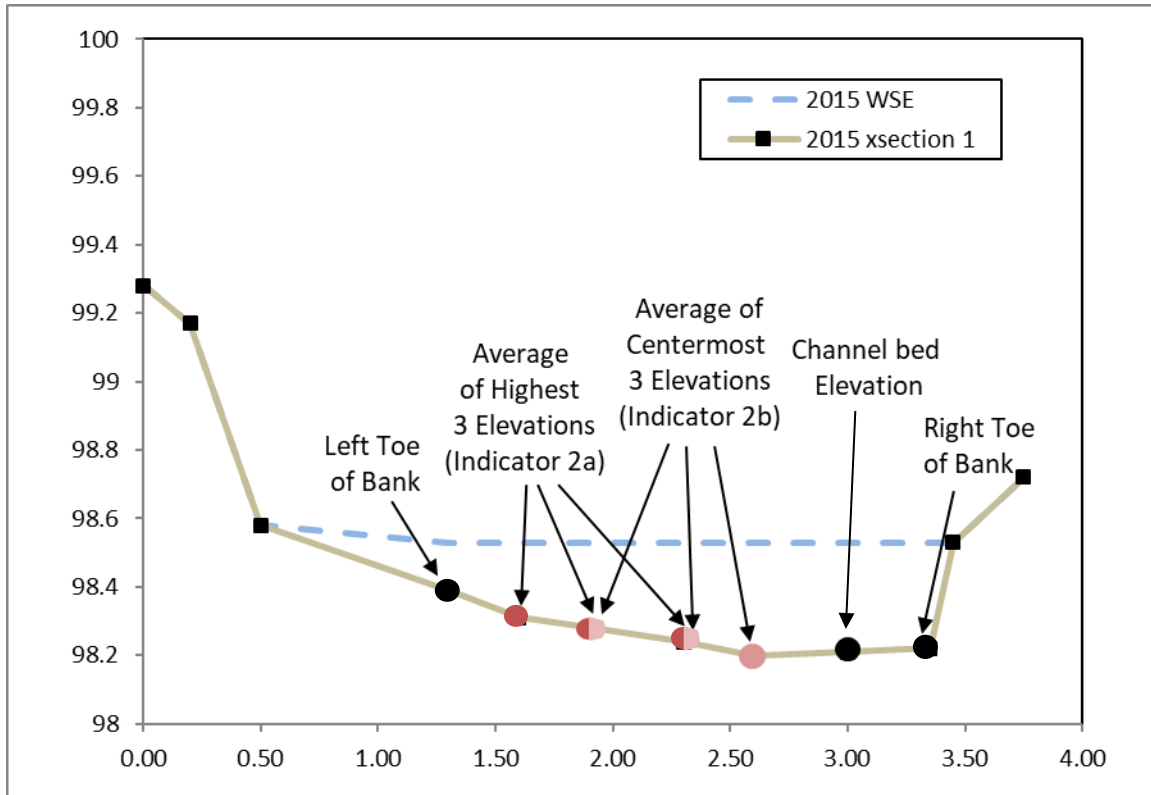
Figure 3.8. Cross-section depicting the highest mid-channel elevations, the centermost channel elevations, and the left and right toe of the banks. The tan line is the channel bed cross-section, and the blue dashed line is the water surface elevation. The elevations are based on an assumed coordinate system with a 100.00 meter benchmark. For indicator 2a the average of the centermost 3 elevations is subtracted from the average of the left and right bank toes. For indicator 2b, the 3 highest elevations are subtracted from the mean elevations of the channel bed including the bank toes.

where \bar{E}_{bar} is the mean elevation of a mid-channel bar where the bar is an elevated region of deposited sediment described by three highest, adjacent elevation measurements.

\bar{E}_{bed} is the cross-sectional average of the mean elevations of the channel bed as measured from the right to left toe of bank, not including the elevations used to measure the bar. \bar{E}_{bar} is subtracted from the \bar{E}_{bed} at each of the upstream cross-sections, and then the mean differences are averaged. The later year is compared to the earlier year. If the elevation change is increasing between years, it indicates that later year bed elevations are higher than the mid-channel bar elevations. If it is decreasing, the mid-channel bar is increasing relative to the channel bed indicating a potential problem. C_{2b} determines the threshold for change of concern.

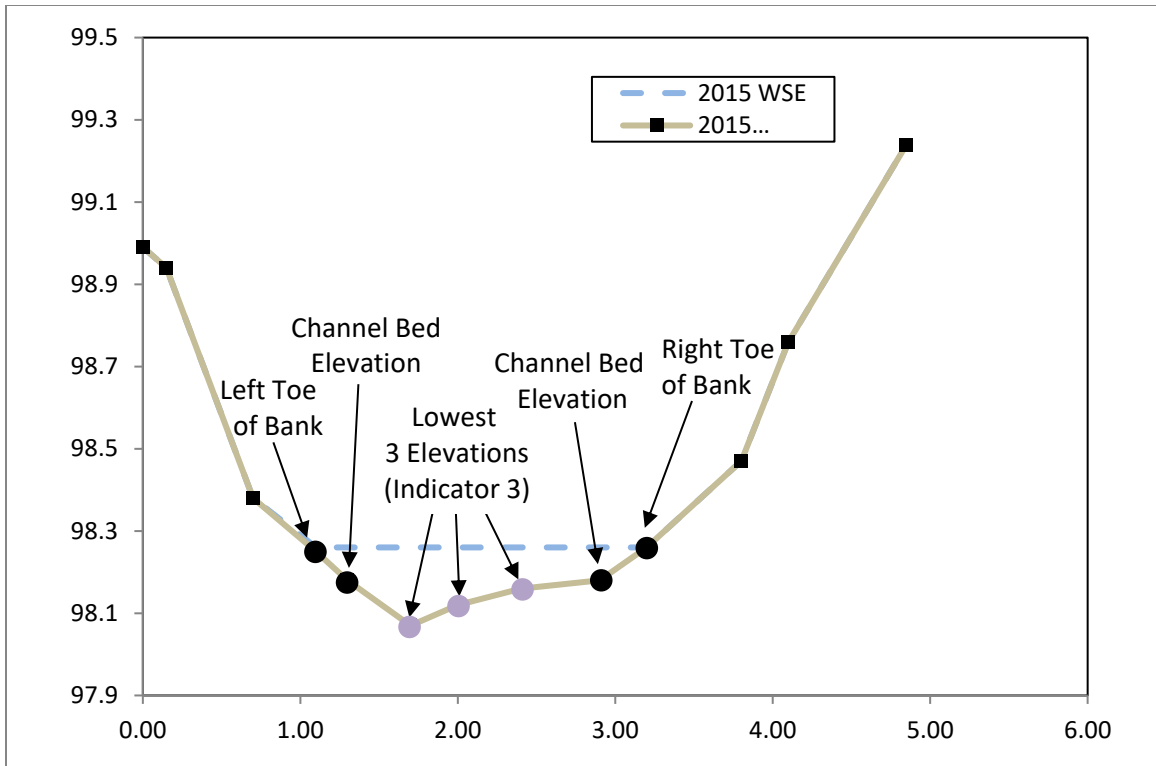
Figure 3.9. Cross-section depicting the lowest mid-channel elevations, channel bed elevations, and the left and right toe of the banks. The tan line is the channel bed cross-section, and the blue dashed line is the water surface elevation. The elevations are based on an assumed coordinate system with a 100.00 meter benchmark. For indicator 3, the 3 lowest elevations are subtracted from the mean elevations of the channel bed including the bank toes.

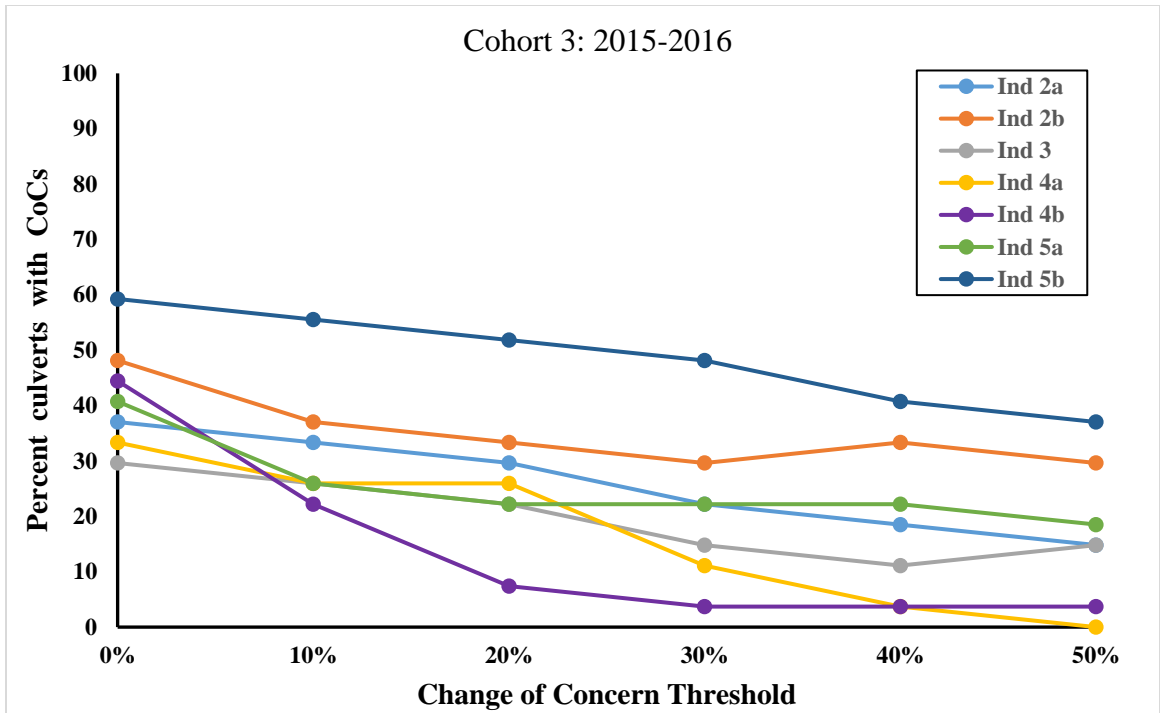
Figure 3.12. Cohort 3 data (Years 1 and 2) showing the percentage of culverts considered to have a change of concern (CoC) based on the percent difference of each indicator between the two years (n=27).

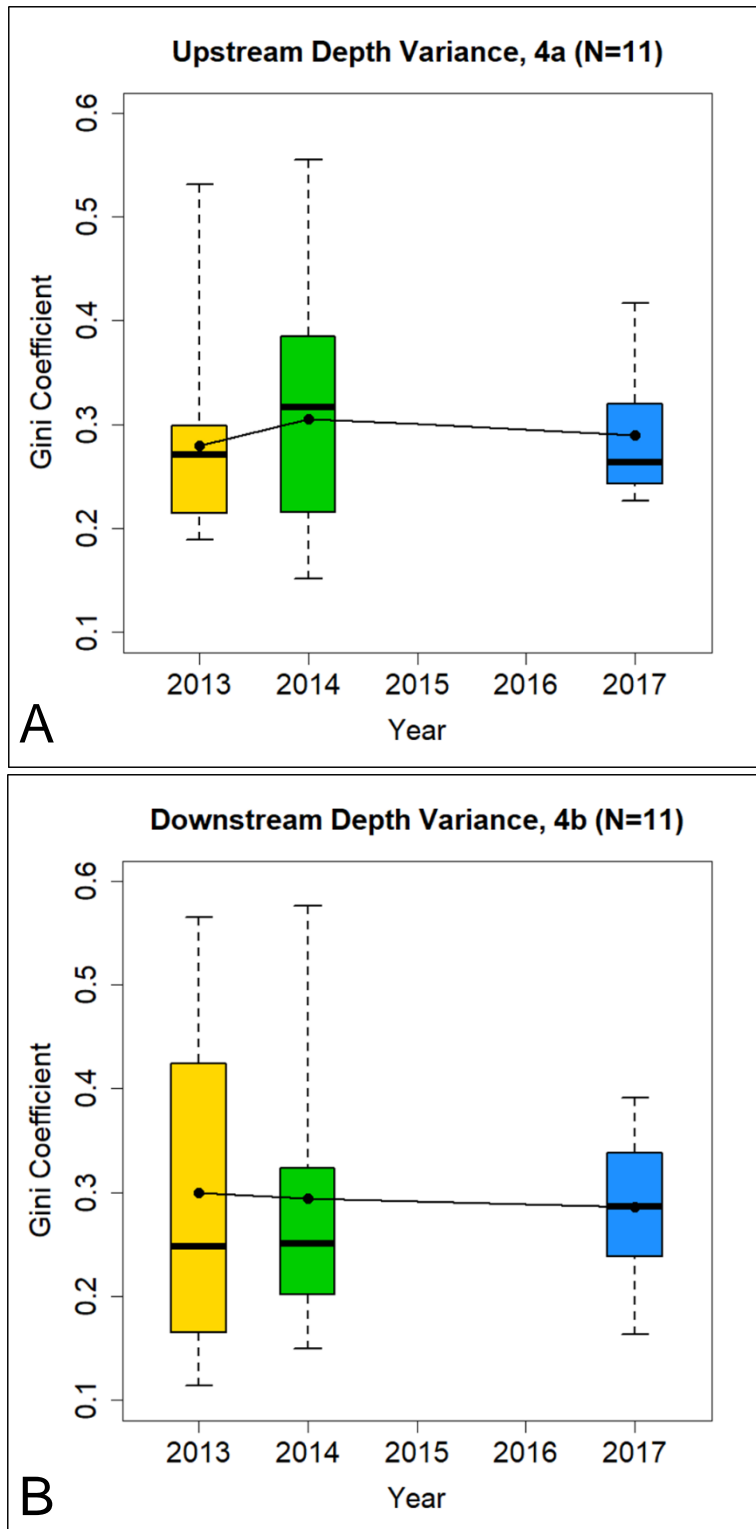
Figure 3.14. Cohort 1 data for A) upstream and B) downstream depth variance as characterized by the Gini Coefficient. An increase in the Gini Coefficient represents an increase in channel cross-section variance and complexity. Downstream of culvert, an increase in the Gini Coefficient may also indicate deepening of the channel. Thick black line within box is median, ends of box are inter-quartile range, ends of whiskers are full range of data, small black dot is the mean.

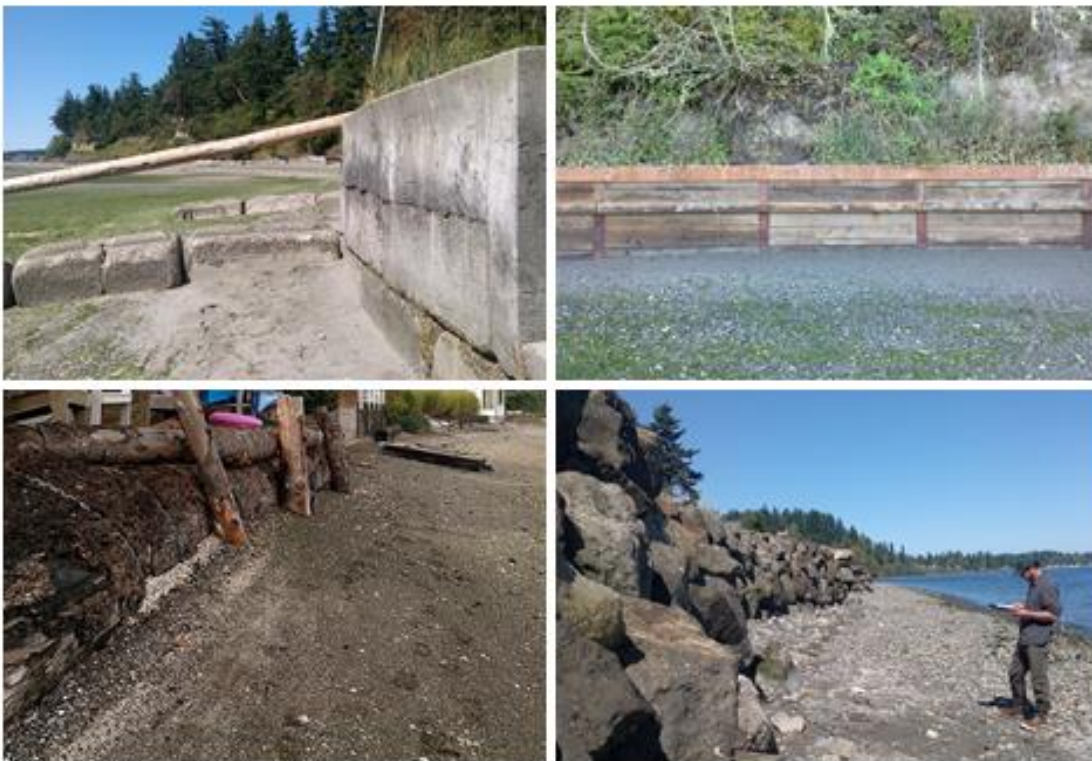
Figure 4.1. Images of various hard armor designs. Top left: concrete wall with ecology block groins; top right: vertical wood wall; bottom left: anchored log and vertical wood piles; bottom right: rock revetment

There are many project types, armor designs (Figure 4.1) and permit classes (e.g., emergency permits) of shoreline armor in Puget Sound. For our review, we focused efforts on single-family residences constructing three project types: 1) new structures, on previously unarmored shoreline; 2) structure extensions, either in length or waterward additions to previously armored shoreline; and 3) replacement of previously armored shoreline. We concentrated only on standard HPA permits, eliminating review of special permits for emergency projects. Finally, we only surveyed completed projects.

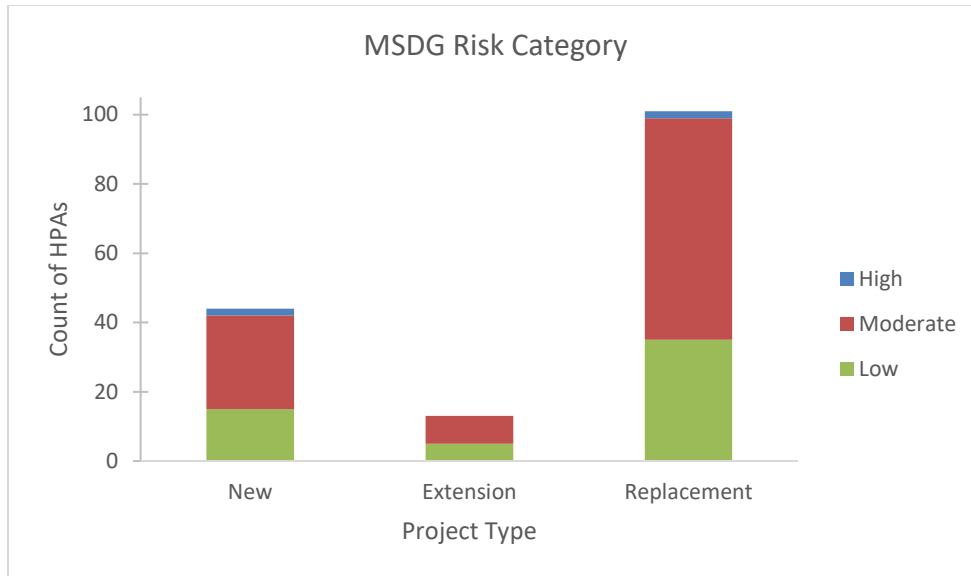
Figure 4.8. Count of HPA projects reviewed for MSDG risk category designation by HPA project type.

We completed MSDG risk assessments on a total of 85, 44 and 29 permits in monitoring years 2014, 2015, and 2016, respectively. Across all surveys years, the majority of projects (63%, 100 of 158) were determined as moderate risk sites, followed by 54 (34%) projects determined as low risk, and only 4 (3%) determined as high risk (Figure 4.7, Appendix Table C-5). Among the moderate risk sites, 64% (n=64) of permits were issued for armor replacement projects, 27% (n=27) for new armor projects and the remaining 8% (n=8) for armor extension projects. Similarly among low risk sites, 65% (n=35) were issued for armor replacement projects, followed by 26% (n=14) for new armor projects, and 9% (n=5) for armor extension projects (Figure 4.8, Appendix, Table C-5).

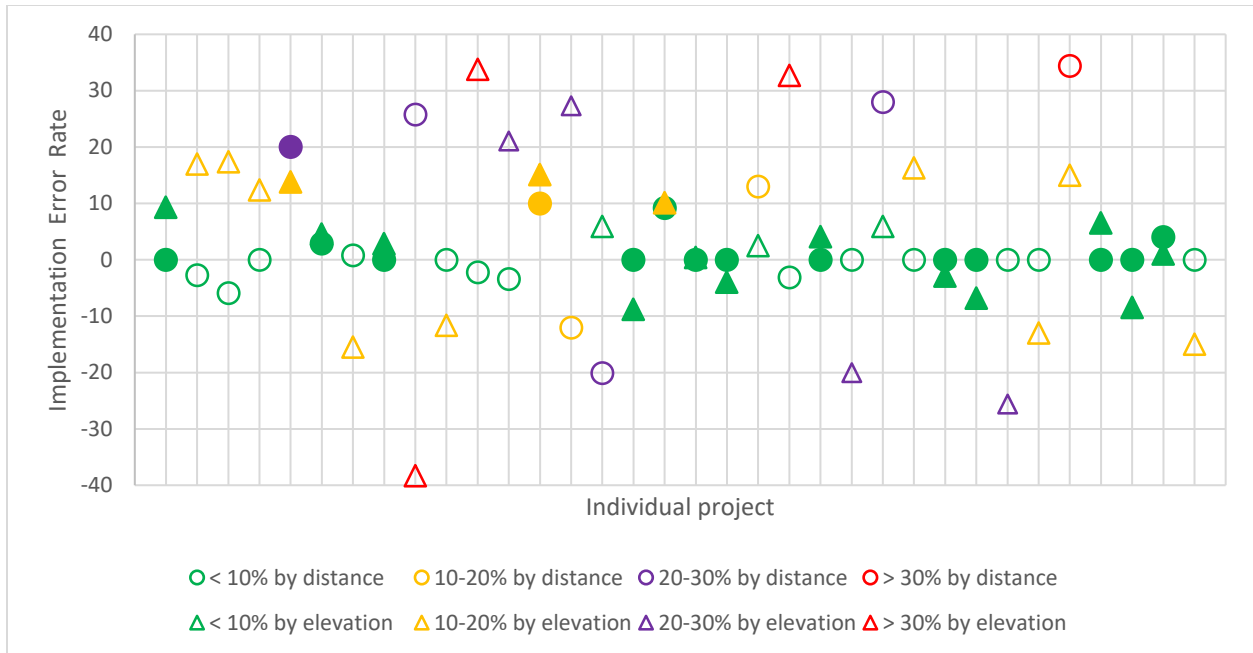
Figure C-1. A comparison of permitted structure location provided as known elevation and horizontal distance for shoreline armor in 2014, 2015 and 2016. Each vertical line represents an individual project (n=34) with implementation errors for location by both elevation (triangle) and by distance (circle), where filled shapes represent implementation errors within 10% of each other.

Of the 34 projects for which armor location was specified by both known elevation and relative distance, we found that IEs for these two permit specifications were within 10% of each other for only nine projects (Appendix, Figure C-1). In other words, for most projects, there was little agreement between locations using the two measures. Of seven projects where elevation measures in field determined that the structure was constructed waterward of the permitted location by a IE of >10%, relative distance indicated that five projects had a waterward IE of 0%, one had a waterward IE of 0-10%, and one was landward with an IE of 20-30%. Conversely, of two projects where relative distance measures in field identified that the structure was constructed waterward of permitted location by an IE of >10%, elevation measures identified that both were landward with IEs of 0-10% and 10-20% (Appendix, Figure C-1).
