State of Washington
DEPARTMENT OF FISH AND WILDLIFE

SUBJECT: Washington Department of Fish and Wildlife Shoreline Exemption L10SX040, Tokul Hatchery Emergency Repairs and Mitigation

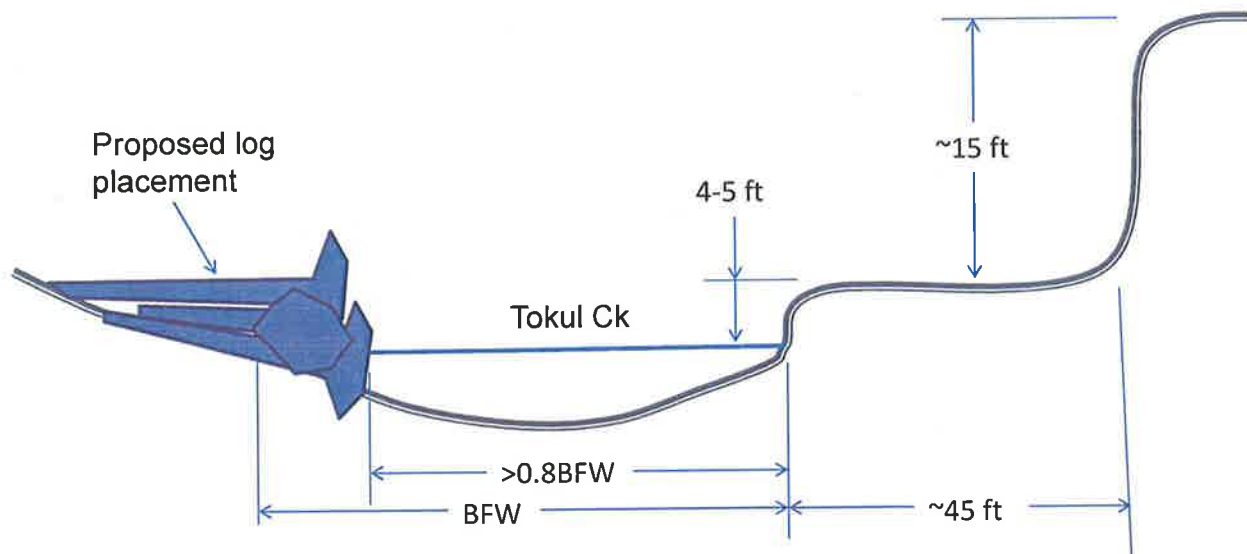
Figure 1: Cross section of Tokul Ck at the location of the proposed log jam. Not to scale.

2. Rather than the steep high bank common in the upstream reach, there is a 15 foot high terrace behind a 45 ft wide floodplain. Please see Figure 1. Should there be any left bank erosion, it would move into the low bank flood plain area and not at the toe of a steep slope. In the unlikely event that substantial lateral erosion occurred and it did reach the toe of the terrace, there would not be the massive response that occurred at the DOT site.
