**STATE OF WASHINGTON  
DEPARTMENT OF FISH AND WILDLIFE  
HABITAT PROGRAM**

SUBJECT: **GUIDANCE REGARDING HYDRAULIC PROJECT APPROVAL (HPA)  
PROVISIONS FOR THE PROTECTION OF INTERTIDAL FORAGE  
FISH SPAWNING BEDS**

# Year-One Progress Report

## Implementation and Effectiveness Monitoring of Hydraulic Projects

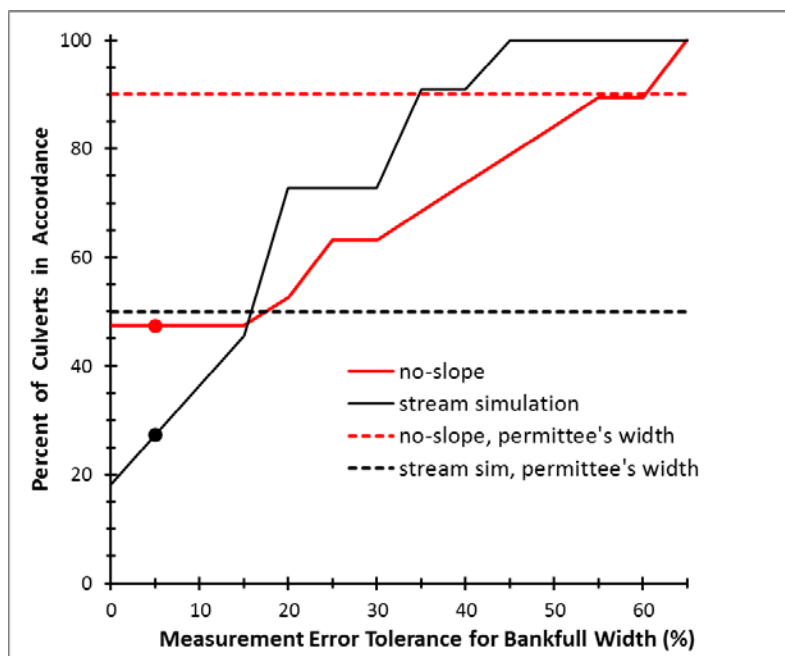
**Figure 2-1.** Sensitivity of accordance rates for no-slope and stream simulation culverts to measurement error tolerance for bankfull width. Dots are accordance rates for culvert width at stream bed for 2013 calculated with 5% error tolerance for BFW measurement. Horizontal dashed lines are mean accordance rates for culvert width at stream bed calculated with the permittees' stream width measurements and a 5% error tolerance (10 no-slope and 6 stream simulation culverts).

The accordance rate for no-slope culverts was 47% (N=19) when we used our channel width measurement but 80% (N=10) when we used the permittees' channel width measurement. Our sensitivity analysis (Figure 2-1) showed that if our estimates of BFW were mistakenly 20% too wide, then the accordance rate for stream simulation culverts changes dramatically from 27% to 73%. Also, we observed that even among staff in WDFW there could be significant disagreement about estimates of mean BFW. Therefore, based on these observations and because a standard procedure for estimating mean BFW does not exist at this time, we question the reliability of accordance rates for culverts in 2013. We do not have the same concern about the calculation of compliance rates.
