SITE NUMBER: ED-121L-06
LOCAL NAME: Polecat Springs
WRIA: 20.0126D

NORTH COAST OFF CHANNEL SITE INVENTORY DATA

RIVER SYSTEM: E. F. Dickey **DATE:** 3/4/92 **OBSERVER:** Young

CHANNEL TYPE: Terrace Tributary

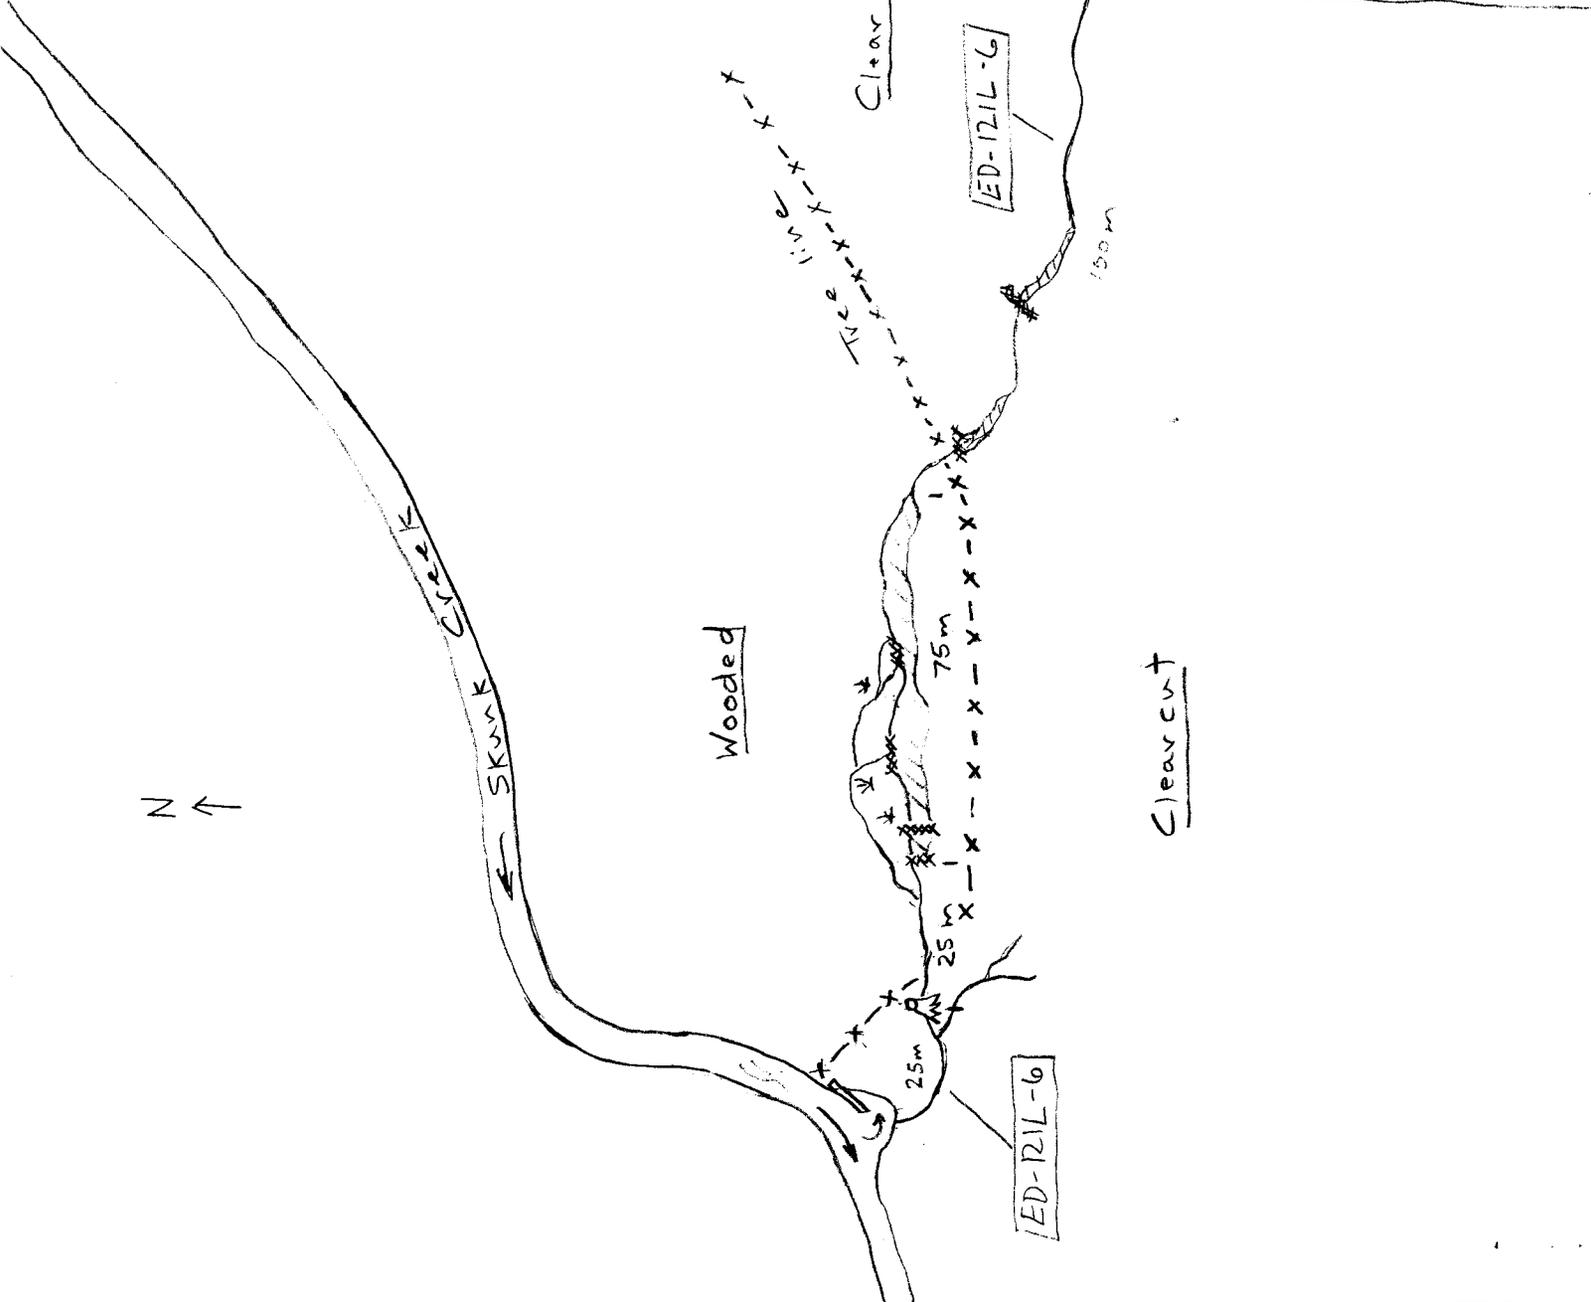
Channel ED-121L-6

COMMENTS & RECOMMENDATIONS: Entering Skunk Creek on a flat gradient at a deep, well-protected, back eddy pool and having a flow of between 0.5 and 1.0 cfs, the mouth of ED-121L-06 is probably very attractive to juvenile coho. Fish should be able to enter this channel at all flows. About 25 m above its mouth, the very dark, tannic water in ED-121L-06 flows under a large, old growth stump that spans the channel. The flow at this point seems fairly unrestricted.

25 m further upstream is the first in a series of small to medium height beaver dams. The ponds, located just inside of the tree line of the RMZ strip, all appear rather shallow. The channel is quite braided here as water appears to regularly flow around the ends of the dams.

The remainder of ED-121L-06 (i.e. upstream of the shallow ponds and braided channel) flows across an open, gently sloping marsh amid widely scattered seven to ten year old spruce trees. The channel here has low banks but seems fairly well-defined in the lower section of this reach. Small beaver dams seem to keep a maximal water volume in the channel. As one moves upstream across the open marsh, channels become increasingly diffuse. Though not actually confirmed, it appears that at least part of this water flows out of the alluvial fan of Skunk Creek.

As with other off channel rearing areas along this reach of the left bank of Skunk Creek, fish entering and moving up into ED-121L-06 appear to have a good chance of becoming stranded. It seems the further up-stream fish are able to move the more likely that stranding will occur. Enhancements to the rearing habitat in these areas might involve maximizing the available habitat in the lower reaches of the channel and eliminating or minimizing accessibility to the middle and upper reaches.

Other options might involve manipulation of the flow patterns in this entire area to minimize stranding potential. Machine access to this site is available.
