**SITE NUMBER:** ED-129L-08

**LOCAL NAME:** Crook Cr.

**NORTH COAST OFF CHANNEL SITE INVENTORY DATA**

**TRIBUTARY TO:** West Branch of E. F. Dickey River (20.0129)

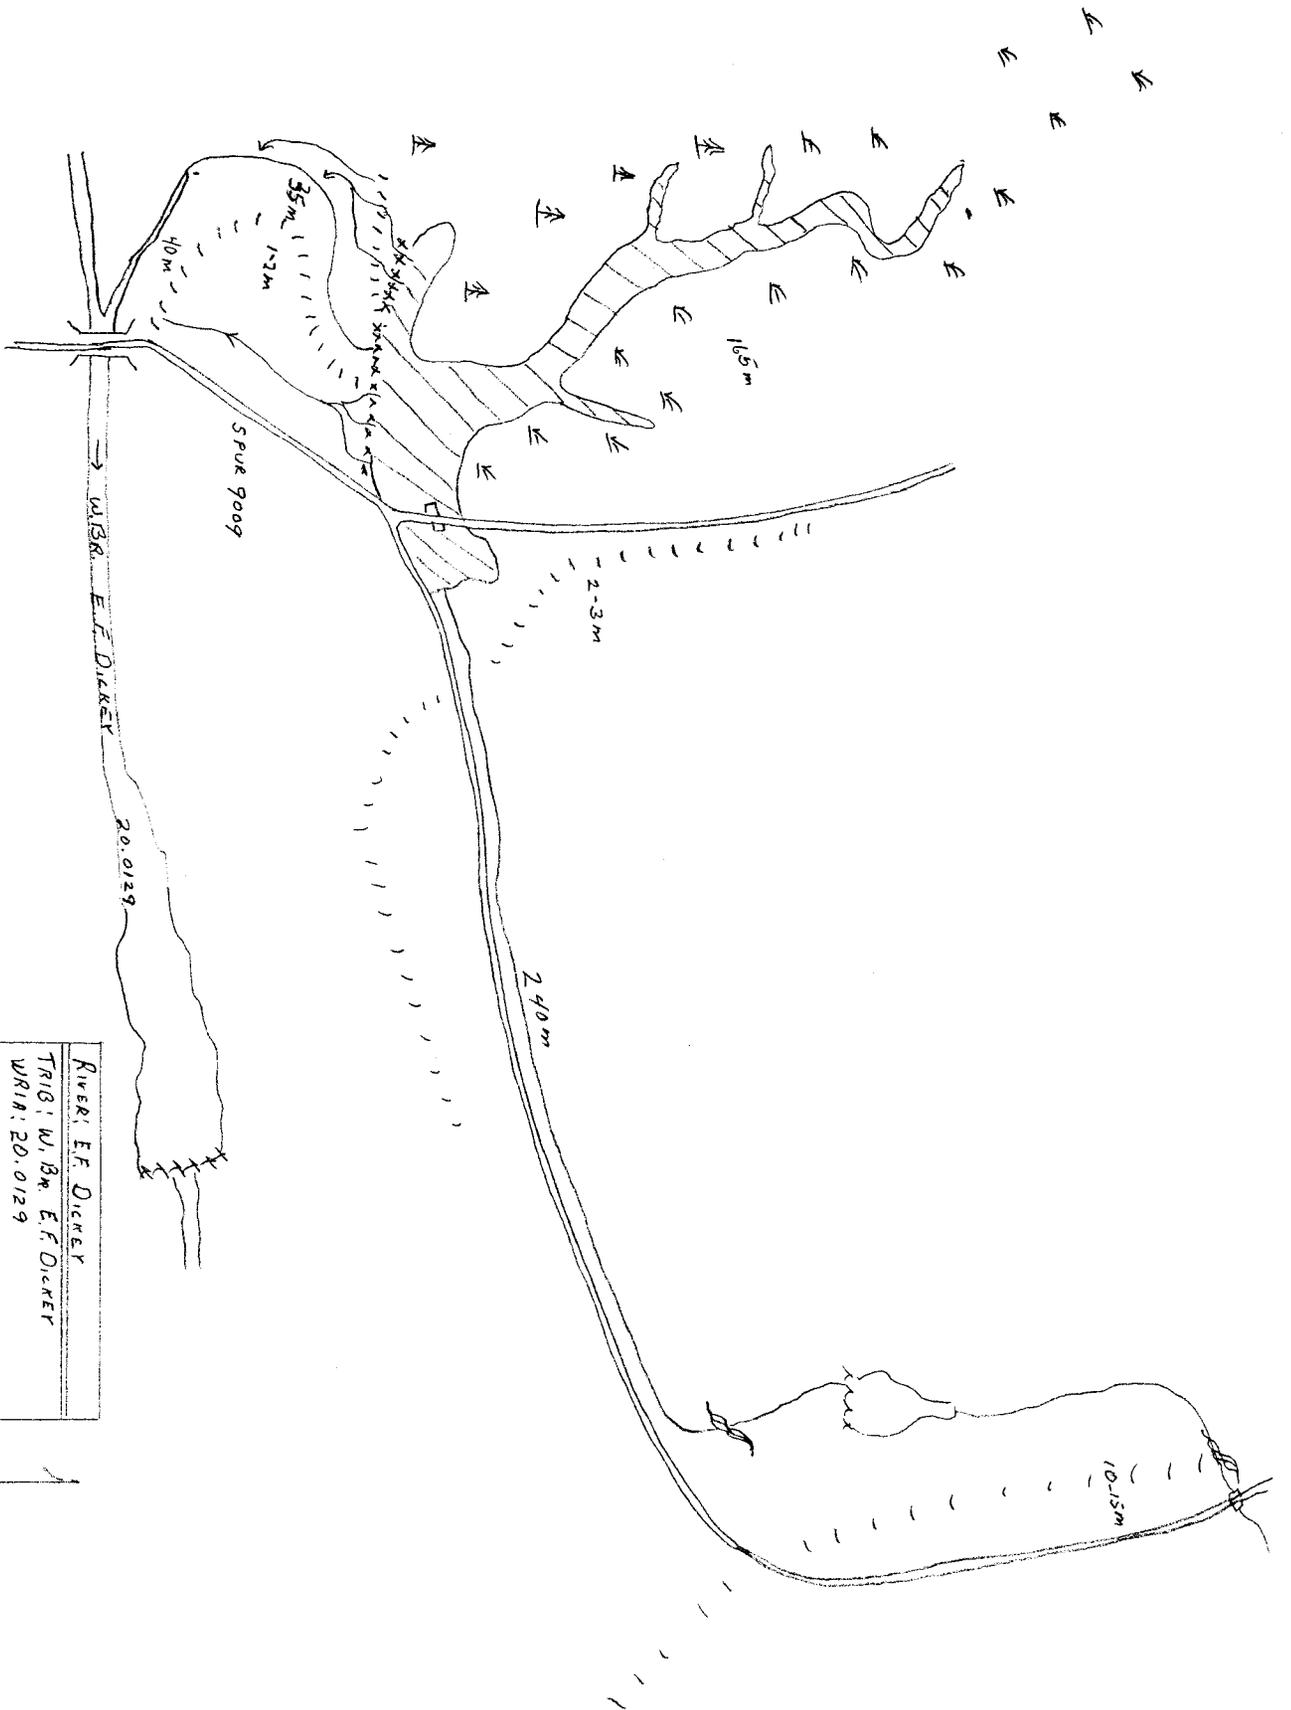
| SITE: ED-1291-8 |

**COMMENTS & RECOMMENDATIONS:** Water in ED-129L-08 originates on the valley wall, then plunges down the terrace face onto a bench. On the bench it passes through a wetland that is created in part by beaver activity.

Water then flows along the access road as it drops down to the next terrace. Here it enters a beaver pond and is joined by a trib that drains another marshy area. The channel then meanders down through another small terrace and joins 20.0129.

A set of controls can be built at the lower beaver dam to maintain the pond and perhaps provide spawning habitat.
