**SITE NUMBER:** ED-R2-01

**NORTH COAST OFF CHANNEL SITE INVENTORY DATA**

**RIVER SYSTEM:** E. F. Dickey    **DATE:** 2/7/91    **OBSERVER:** Nettnin

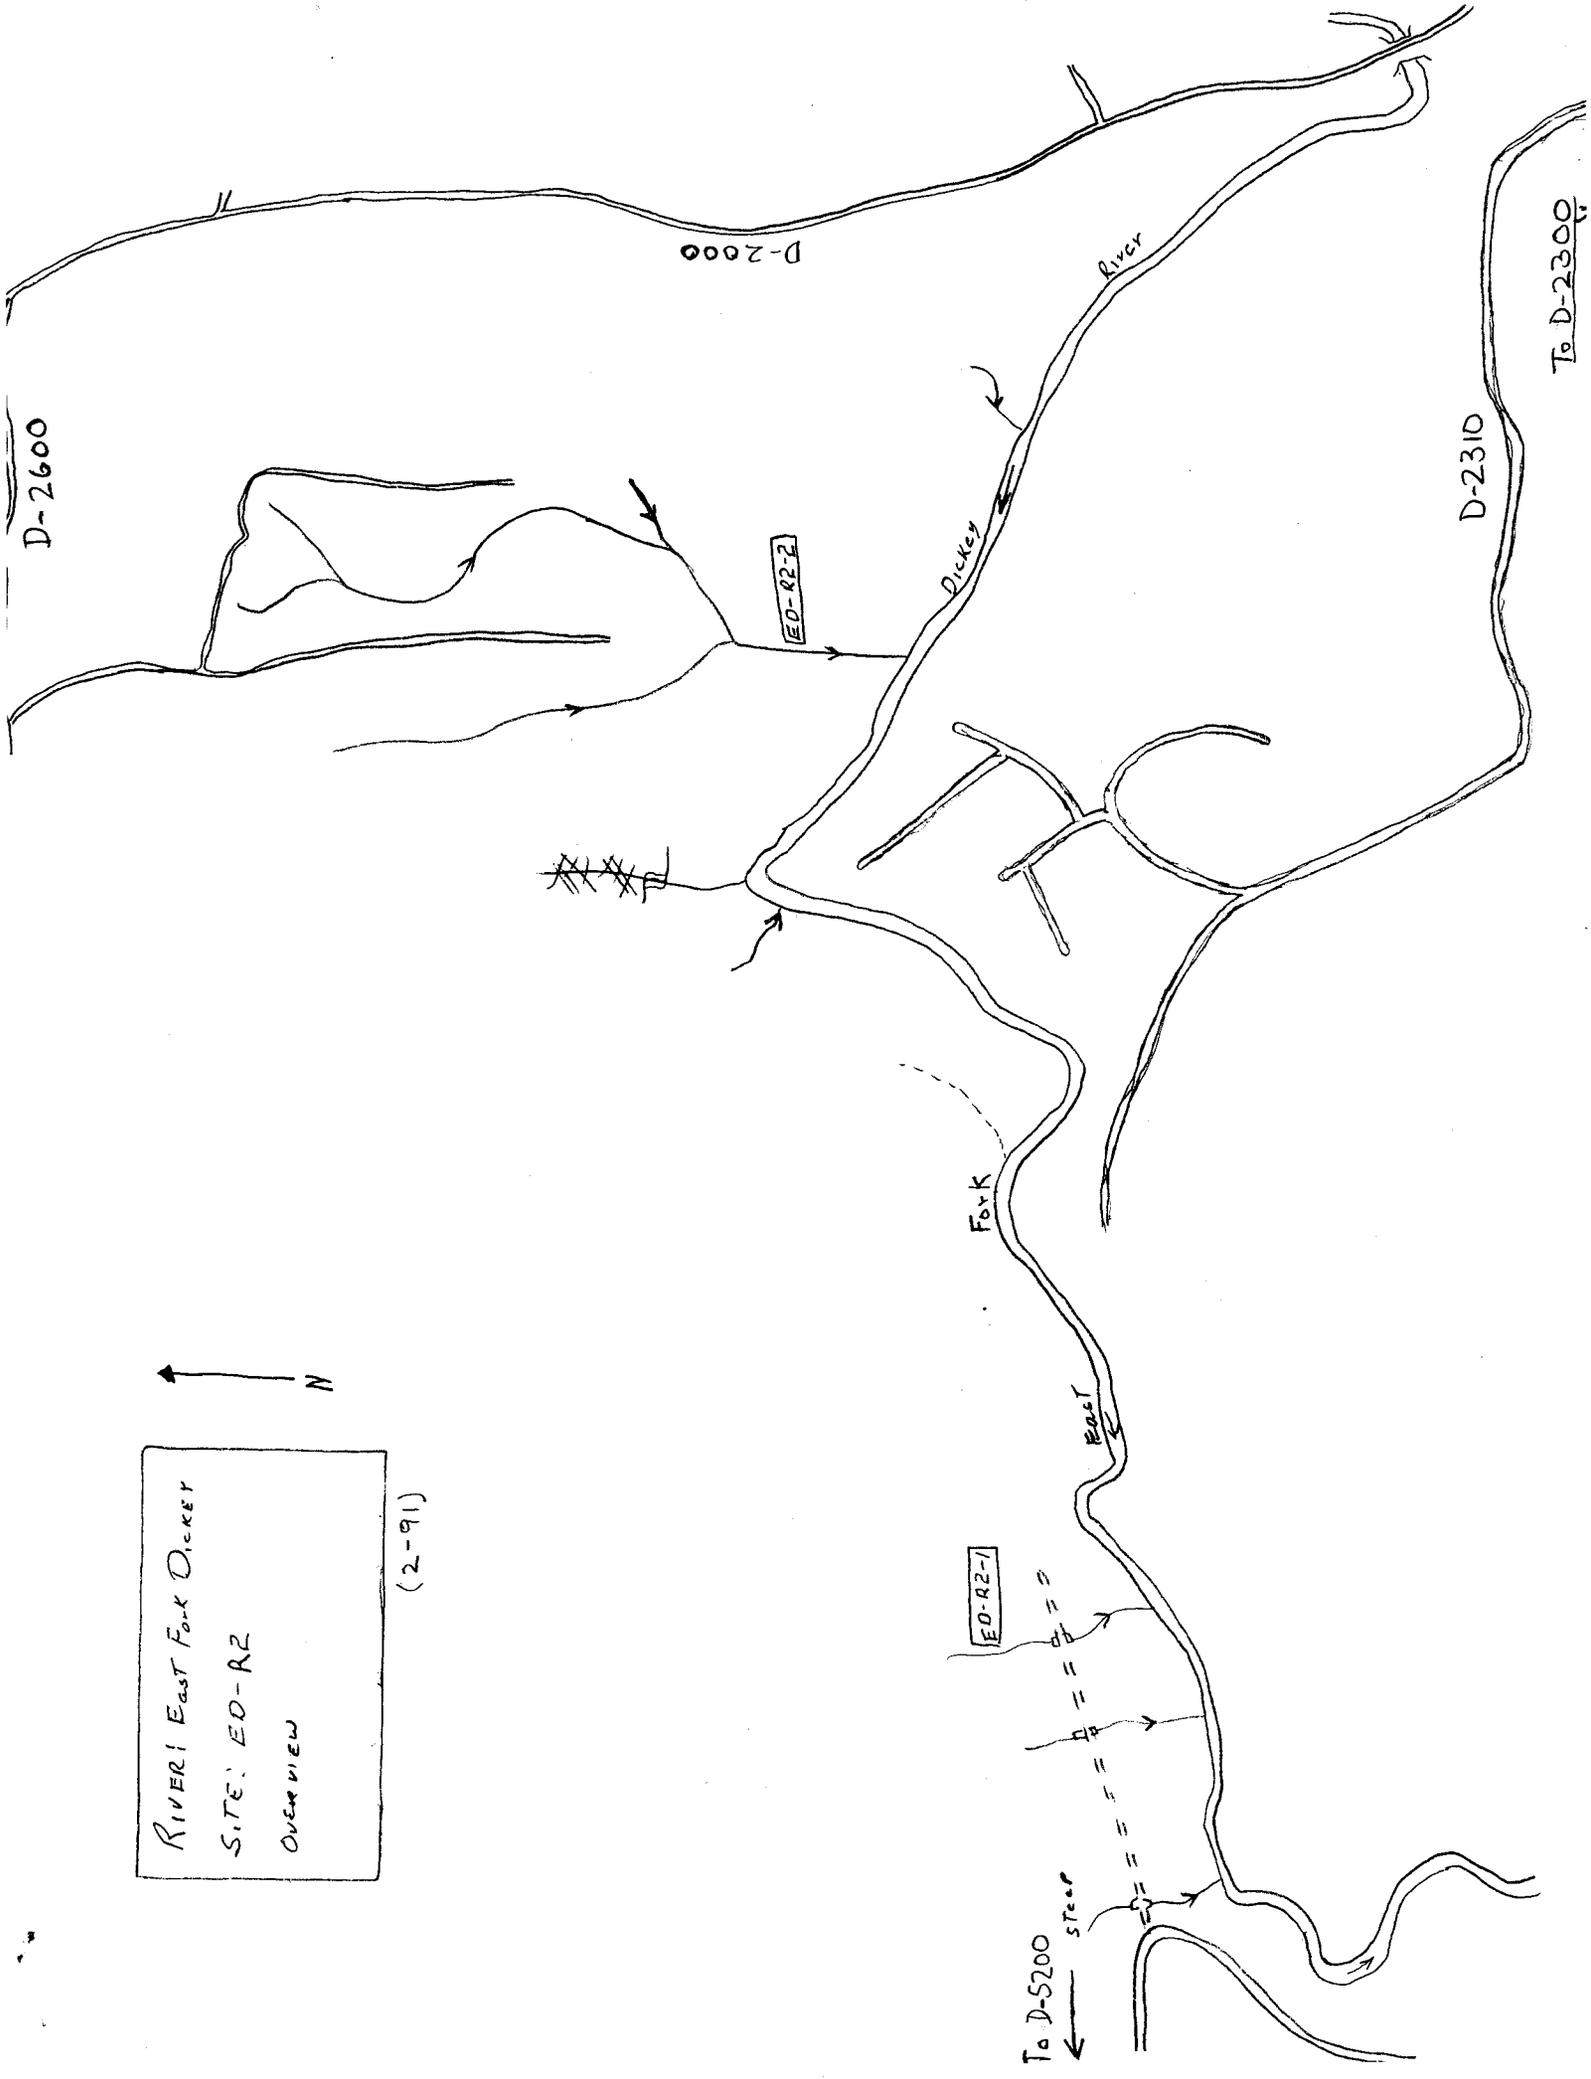
RIVER: EAST FORK DICKET  
SITE: ED-R2  
OVERVIEW

**CHANNEL TYPE:** Lower reach of a small valley wall tributary

**SITE SIZE:**    **Length-** 120 m (mouth to culvert at old grade)  
                  **Width-** Water surface = 0.5 - 1 m  
                                  Channel width = 1 - 2 m  
                  **Depth-** 2 - 8 cm

**FISH ACCESS AND CURRENT USE:** Poor entrance conditions. Erosion has caused a 1 m fall to develop at the mouth. No fish were observed.

**COMMENTS & RECOMMENDATIONS:** ED-R2-01 is a small channel that runs a straight course from the base of the terrace wall (toe the of hill) to the river. The gradient is moderate to gentle as it flows through an old conifer stand. Above the old grade (i.e. above the surveyed reach), the channel continues at a moderate gradient into a very narrow valley. ED-R2-01 has limited rearing habitat, limited flows and little or no "in-stream" cover. Habitat enhancement potential appears very limited.
