SITE NUMBER: H-428R-01 (was H-L2-08)

LOCAL NAME: Braden Pond # 1

NORTH COAST OFF CHANNEL SITE INVENTORY DATA

RIVER SYSTEM: Hoh River **DATE:** 7/2/87 **OBSERVER:** Young/Nettnin

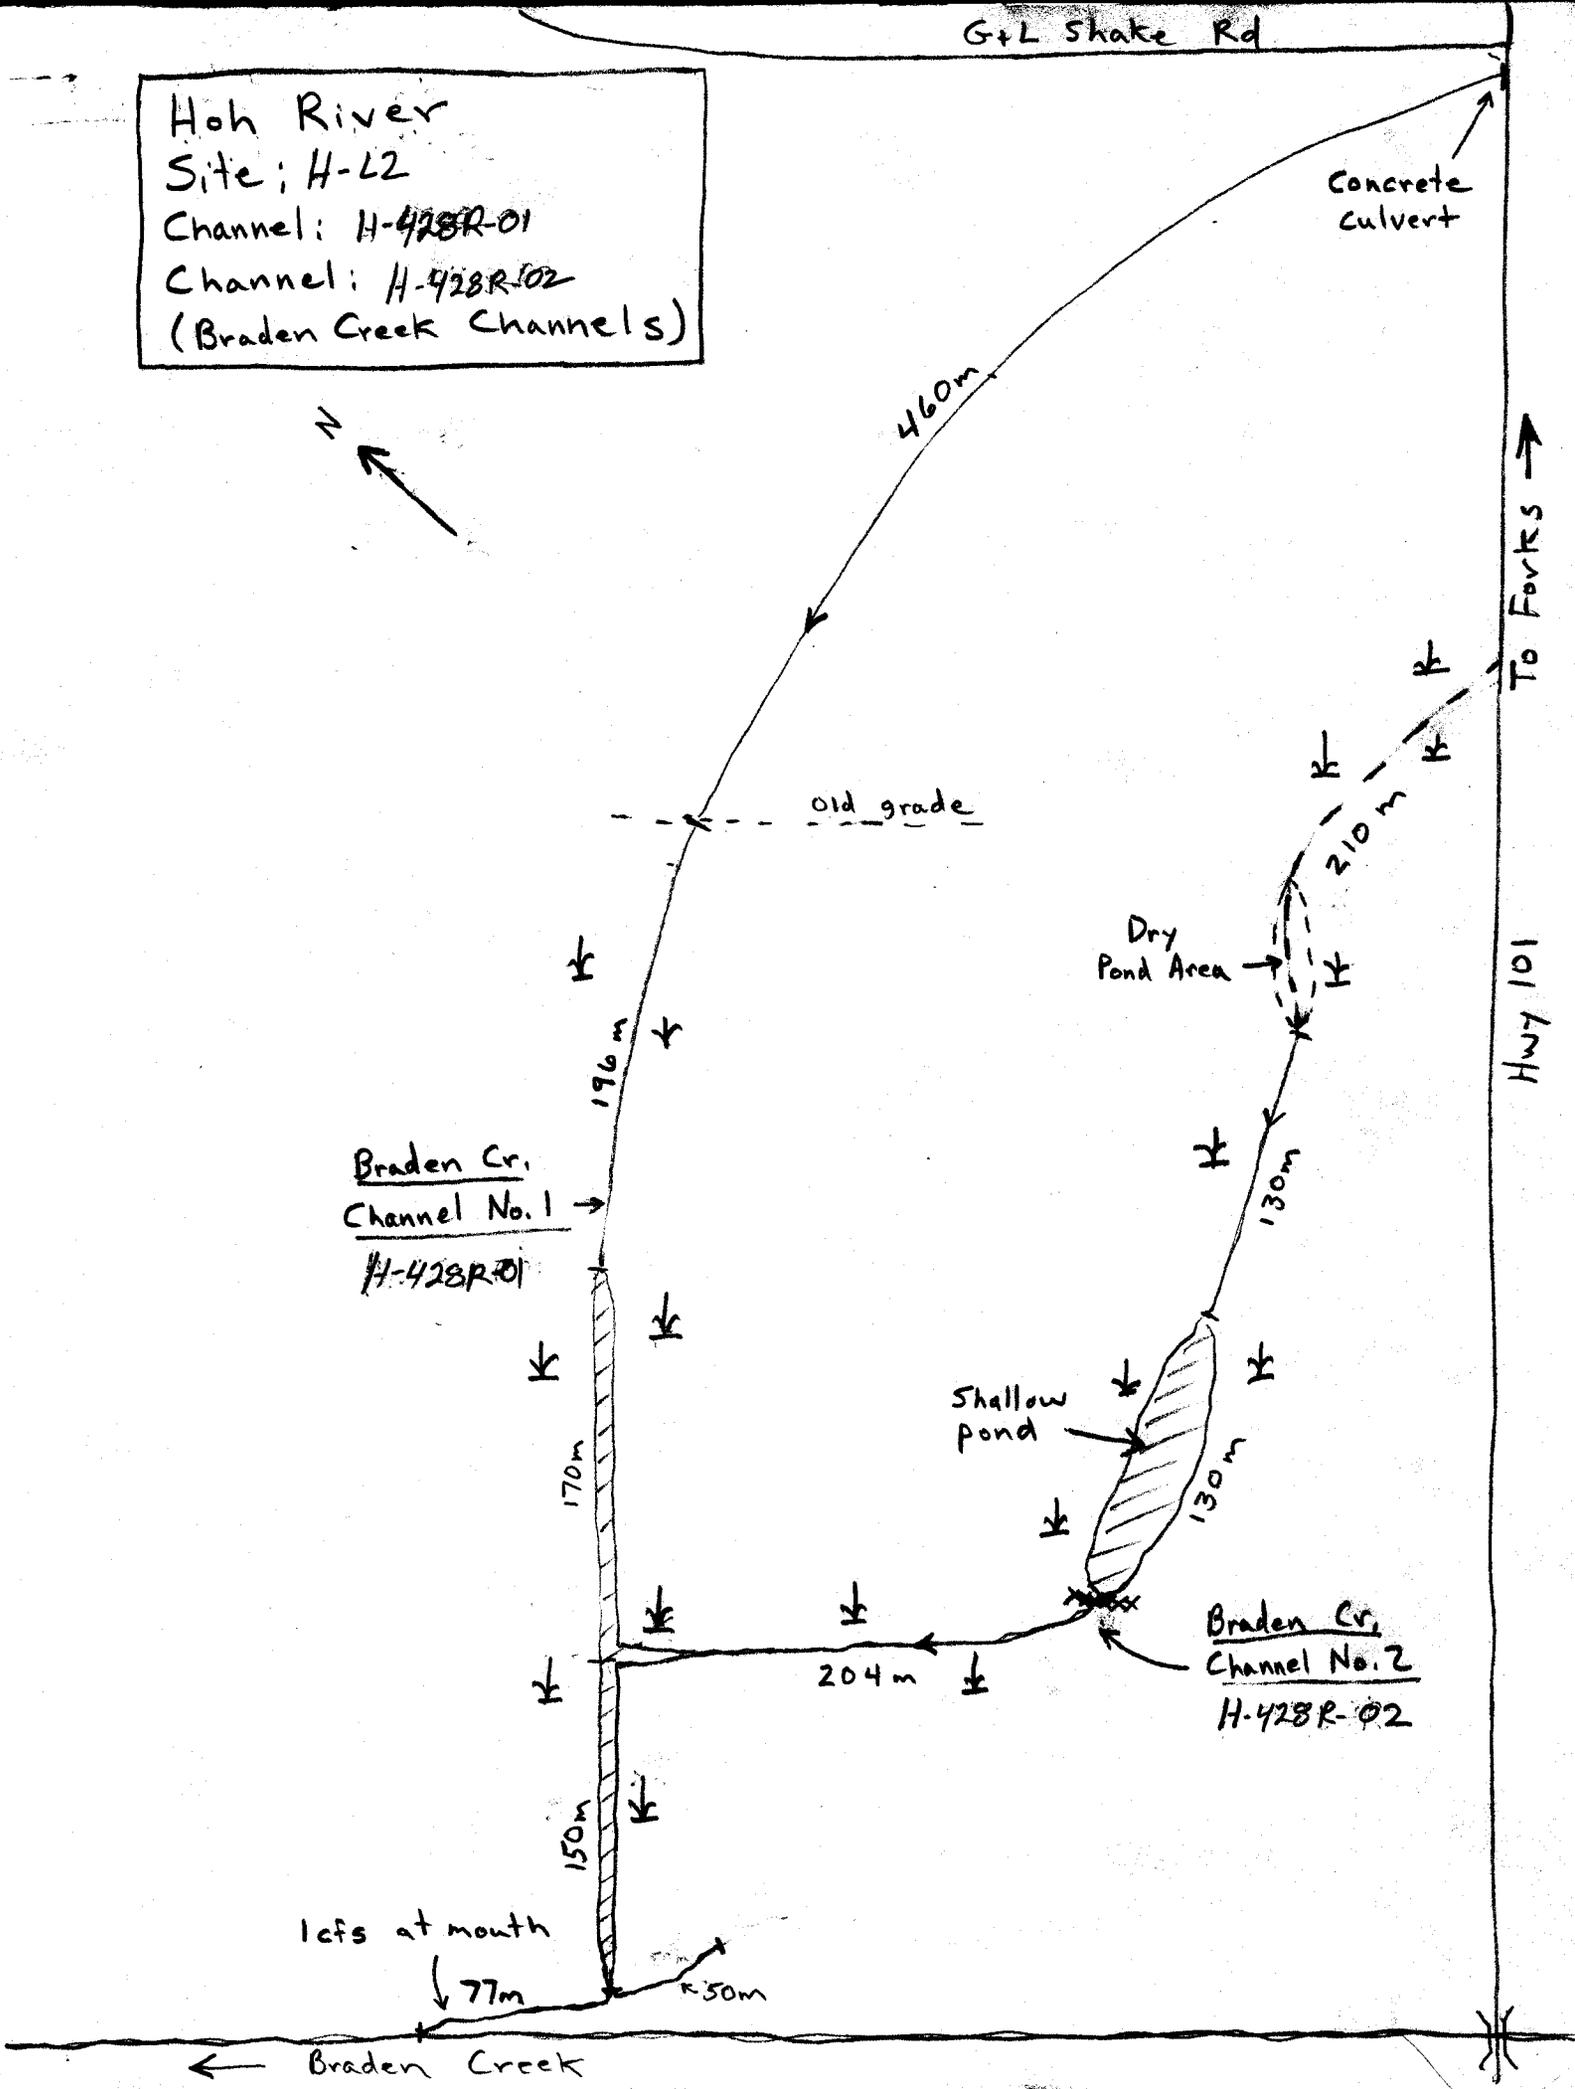
Hoh River
 Site: H-L2
 Channel: H-428R-01
 Channel: H-428R-02
 (Braden Creek Channels)

Concrete culvert

Braden Cr.
 Channel No. 1
 H-428R-01

Braden Cr.
 Channel No. 2
 H-428R-02

Shallow pond

Dry Pond Area

COMMENTS & RECOMMENDATIONS: This is a low gradient, swampy channel which is fairly shallow. The egress channel contains some debris, but is probably passable. Survey of the area above highway 101 should be conducted.
