SITE NUMBER: H-L11-02
LOCAL NAME: Unnamed
WRIA: 20.0469A

NORTH COAST OFF CHANNEL SITE INVENTORY DATA

RIVER SYSTEM: Hoh **DATE:** 2/17/88 **OBSERVER:** Nettnin

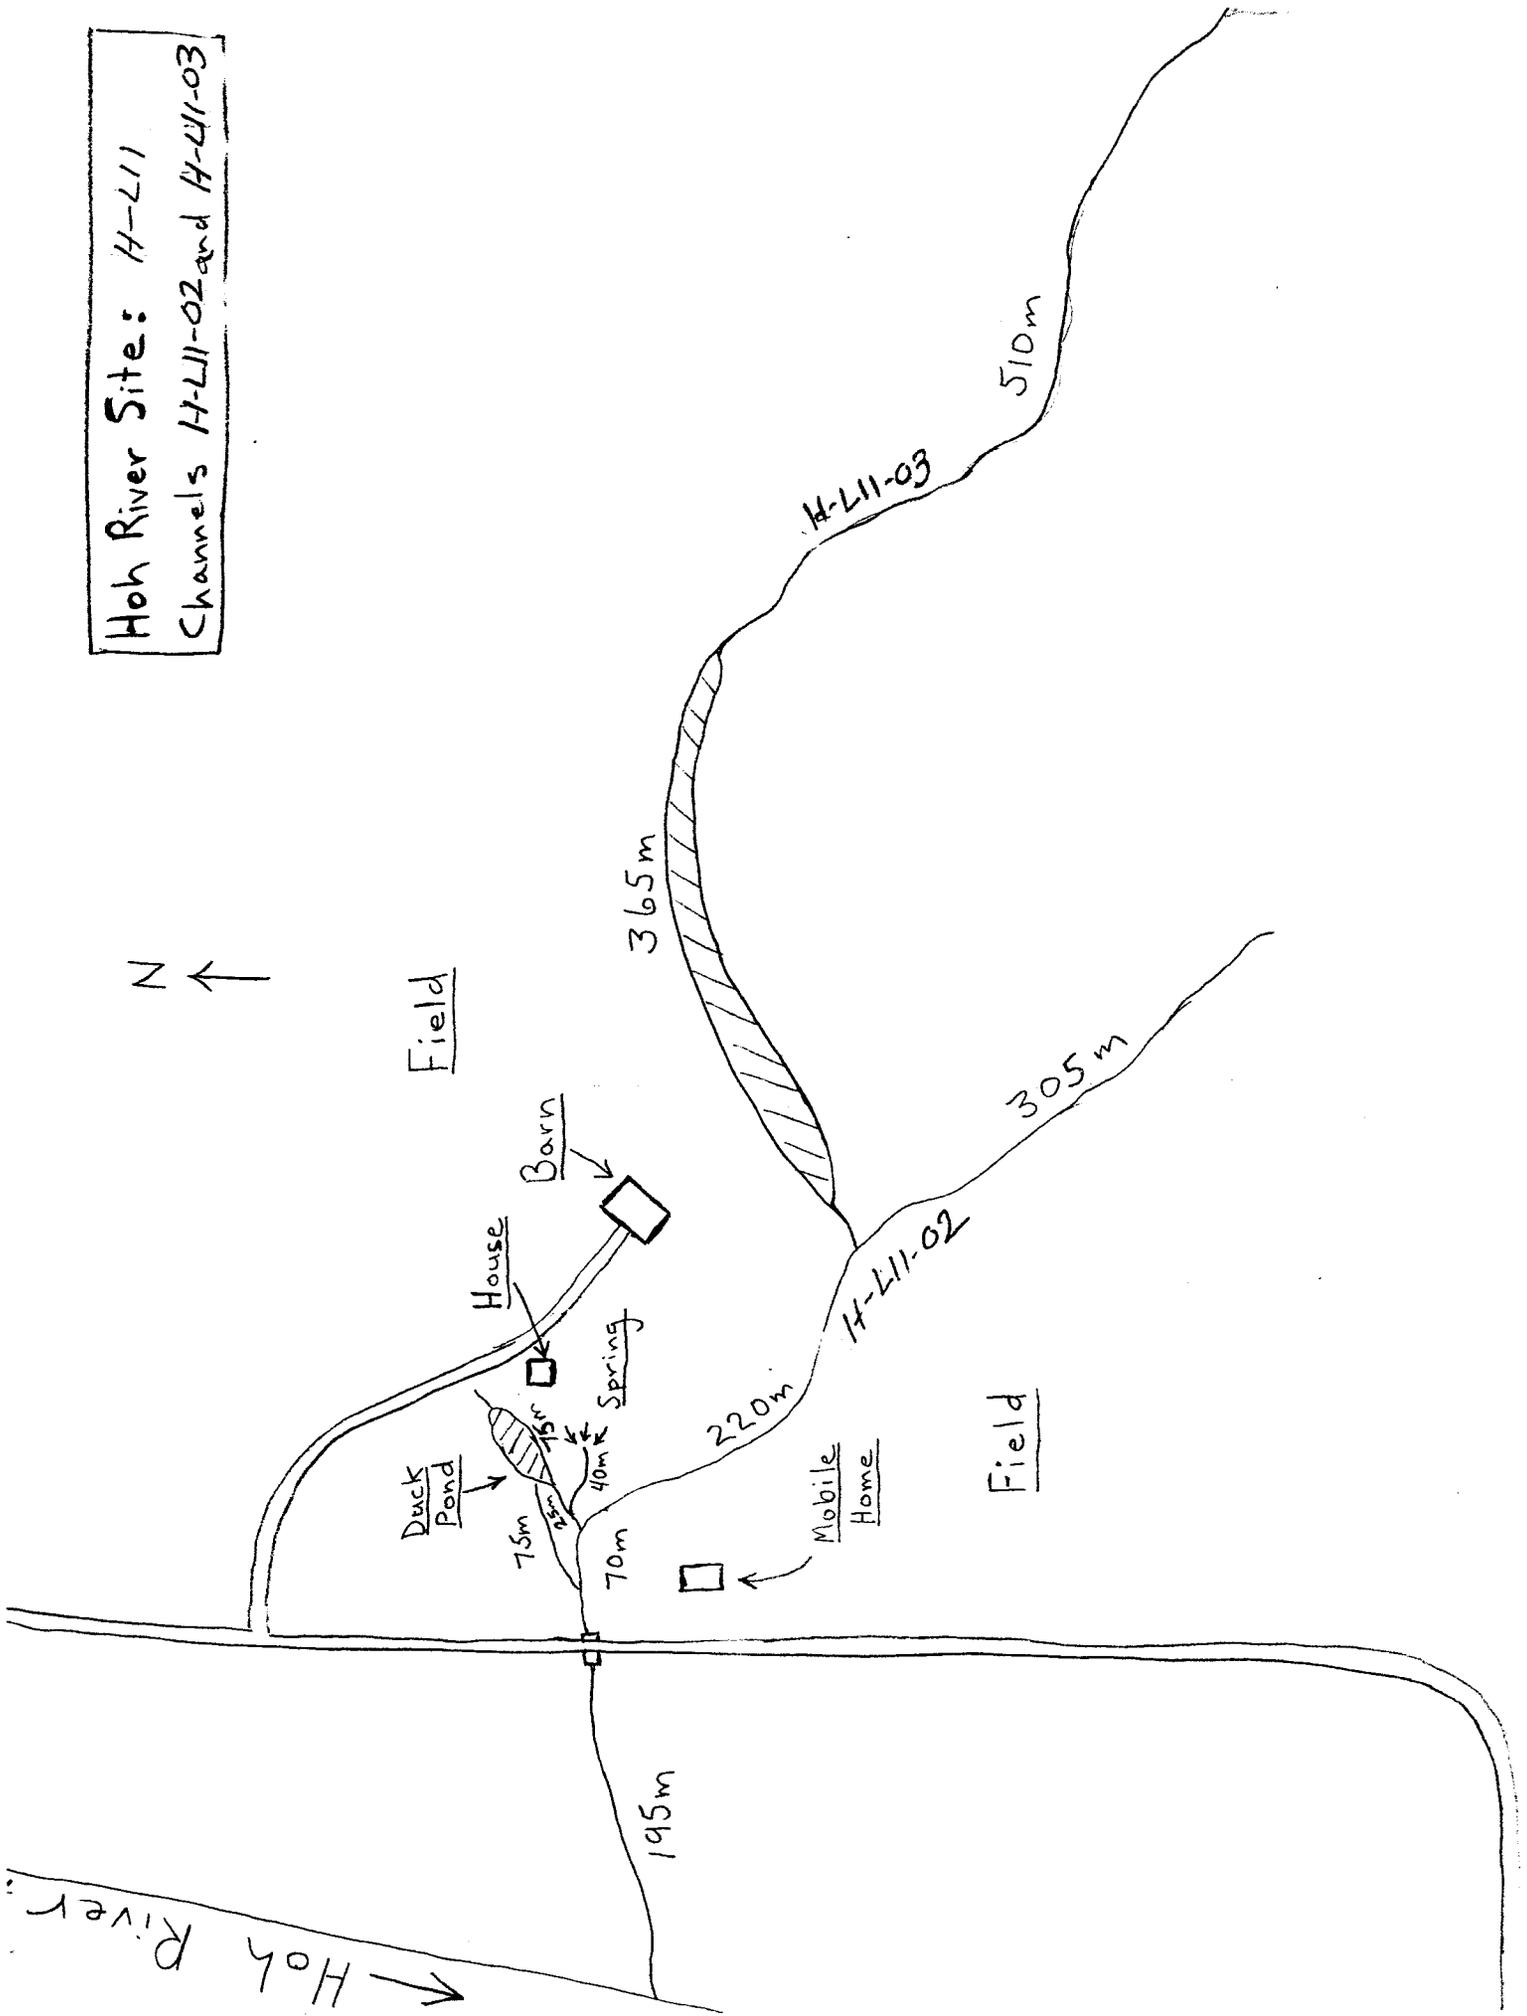
Hoh River Site: H-L11
Channels H-L11-02 and H-L11-03

COMMENTS & RECOMMENDATIONS : According to the landowner (Mrs. Fletcher) salmon used to spawn in this creek. If spawning still occurs, it is in very limited numbers. There is good gravel and no obvious reason why fish would not spawn here. A small spring fed pond is situated on the R.B. about 270 m above the mouth (see pond data supplement).
