**SITE NUMBER:** H-R8-02

**NORTH COAST OFF CHANNEL SITE INVENTORY DATA**

**RIVER SYSTEM:** Hoh River    **DATE:** 8/26/87    **OBSERVER:** Young/Nettlin

**NORTH COAST OFF CHANNEL SURVEY**  
**SUBSEQUENT SITE EVALUATION FORM**

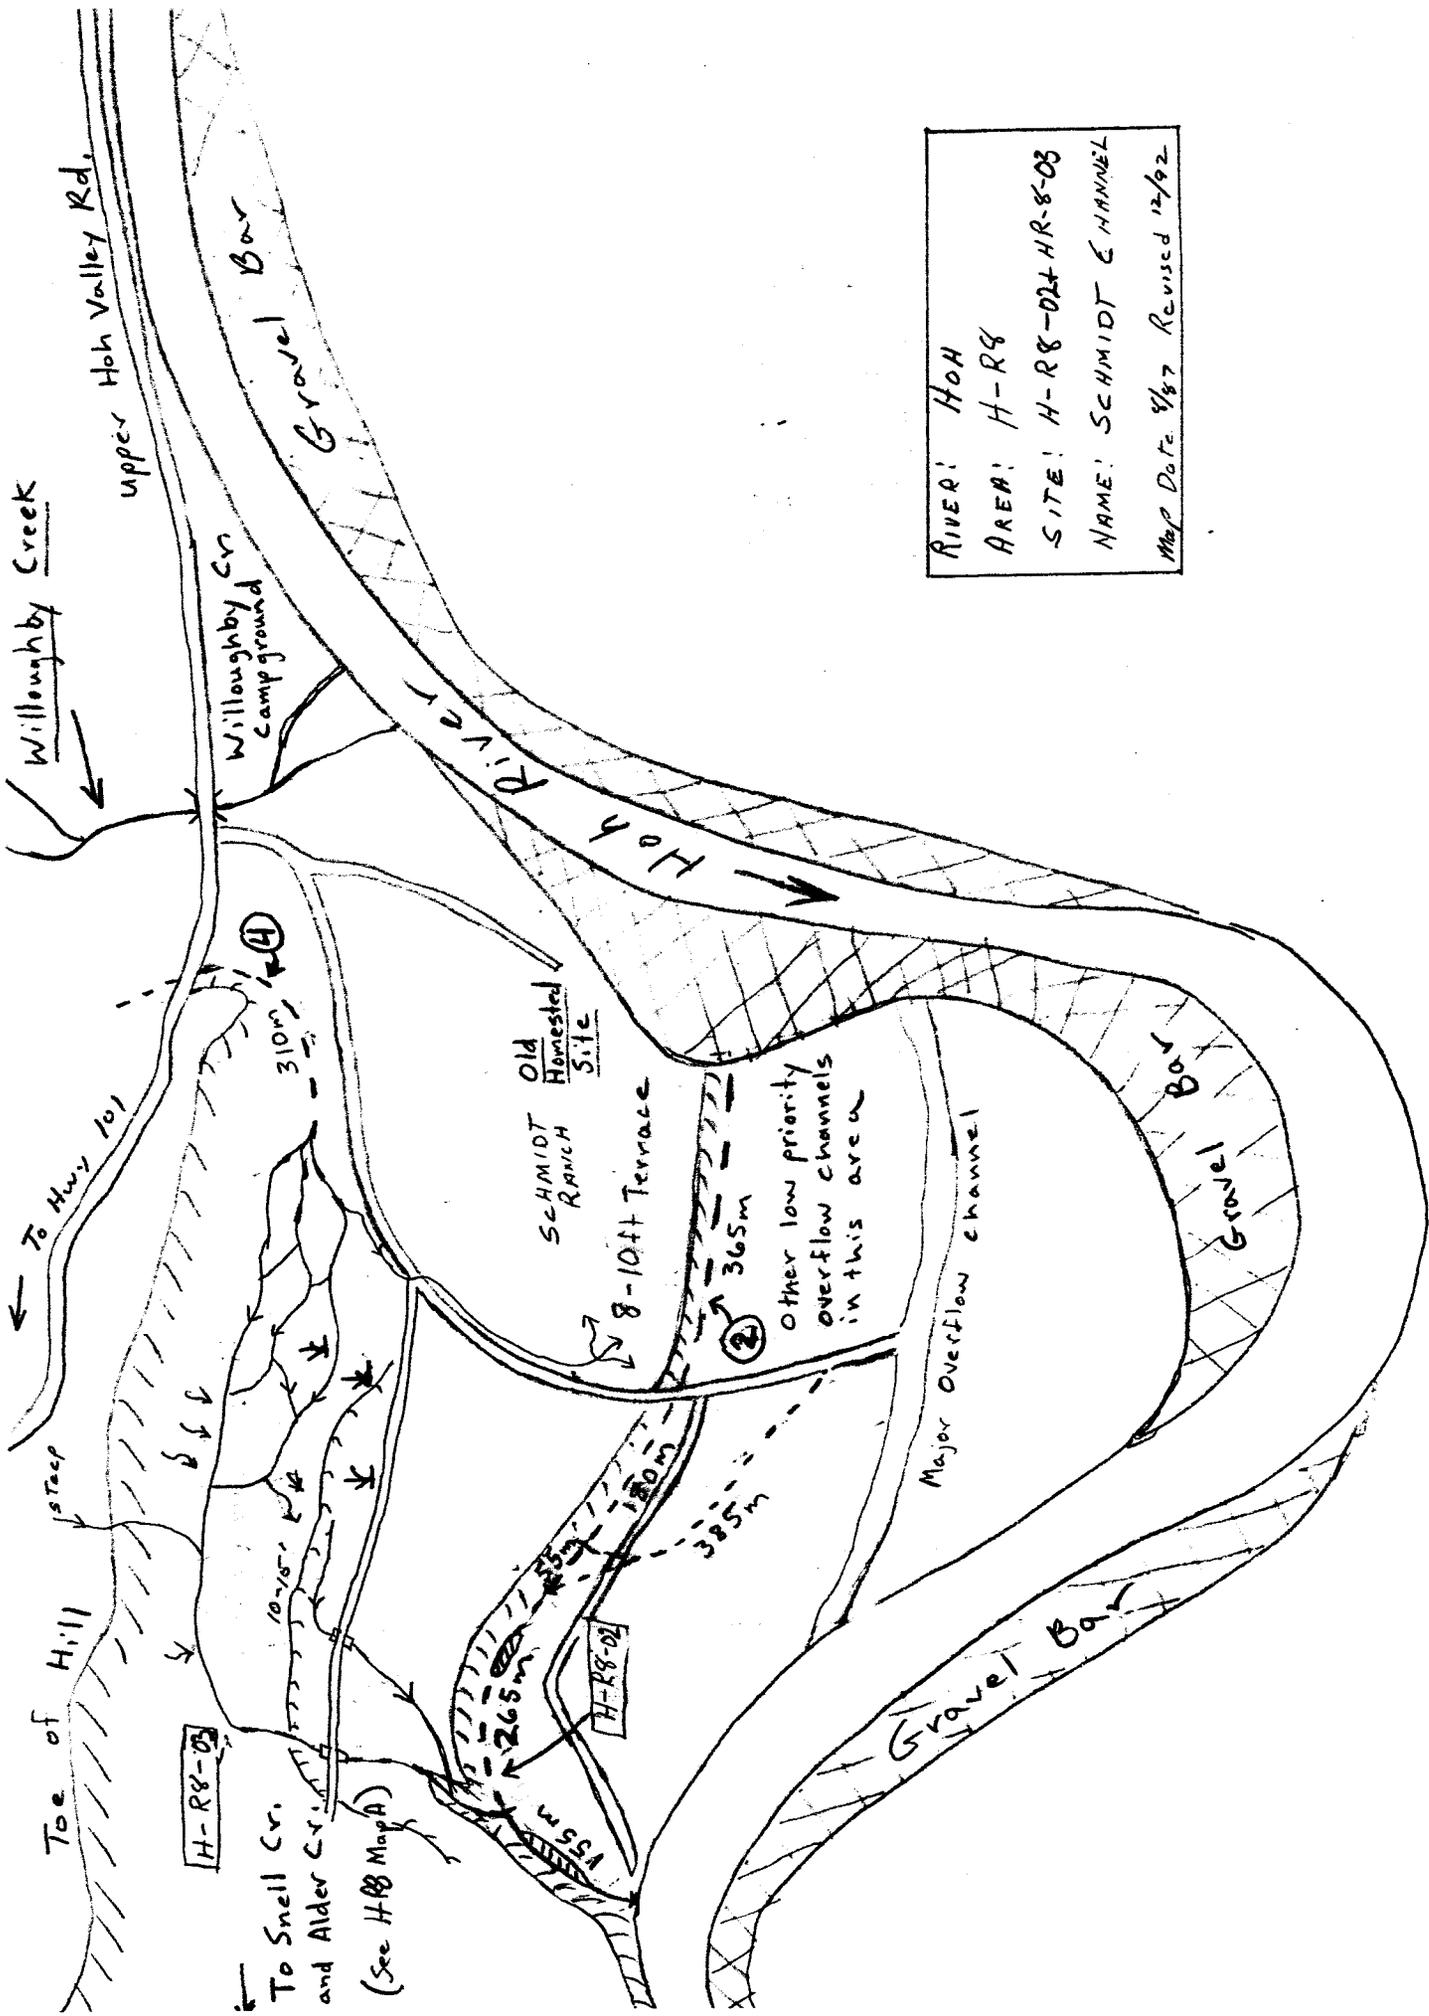
RIVER: HOH  
 AREA: H-R8  
 SITE: H-R8-01+H-R8-03  
 NAME: SCHMIDT CHANNEL  
 Map Date 8/87 Revised 12/82

**COMMENTS & RECOMMENDATIONS:** This channel appears to be located along the back edge of the active Hoh floodplain. Area north of H-R8-02 is 6 to 8 feet higher than channel and does not appear to flood. Area south of H-R8-02 appears very susceptible to flooding. A short terrace trib. which is quite steep near its mouth enters H-R8-02 about 155 m above its mouth (see H-R8-03).
