LOCAL NAME: Unnamed
SITE NUMBER: Q-R2-01
PRIORITY: Low

NORTH COAST OFF CHANNEL SITE INVENTORY DATA

RIVER SYSTEM: Quillayute DATE: 12/20/88 OBSERVER: Nettnin/Young

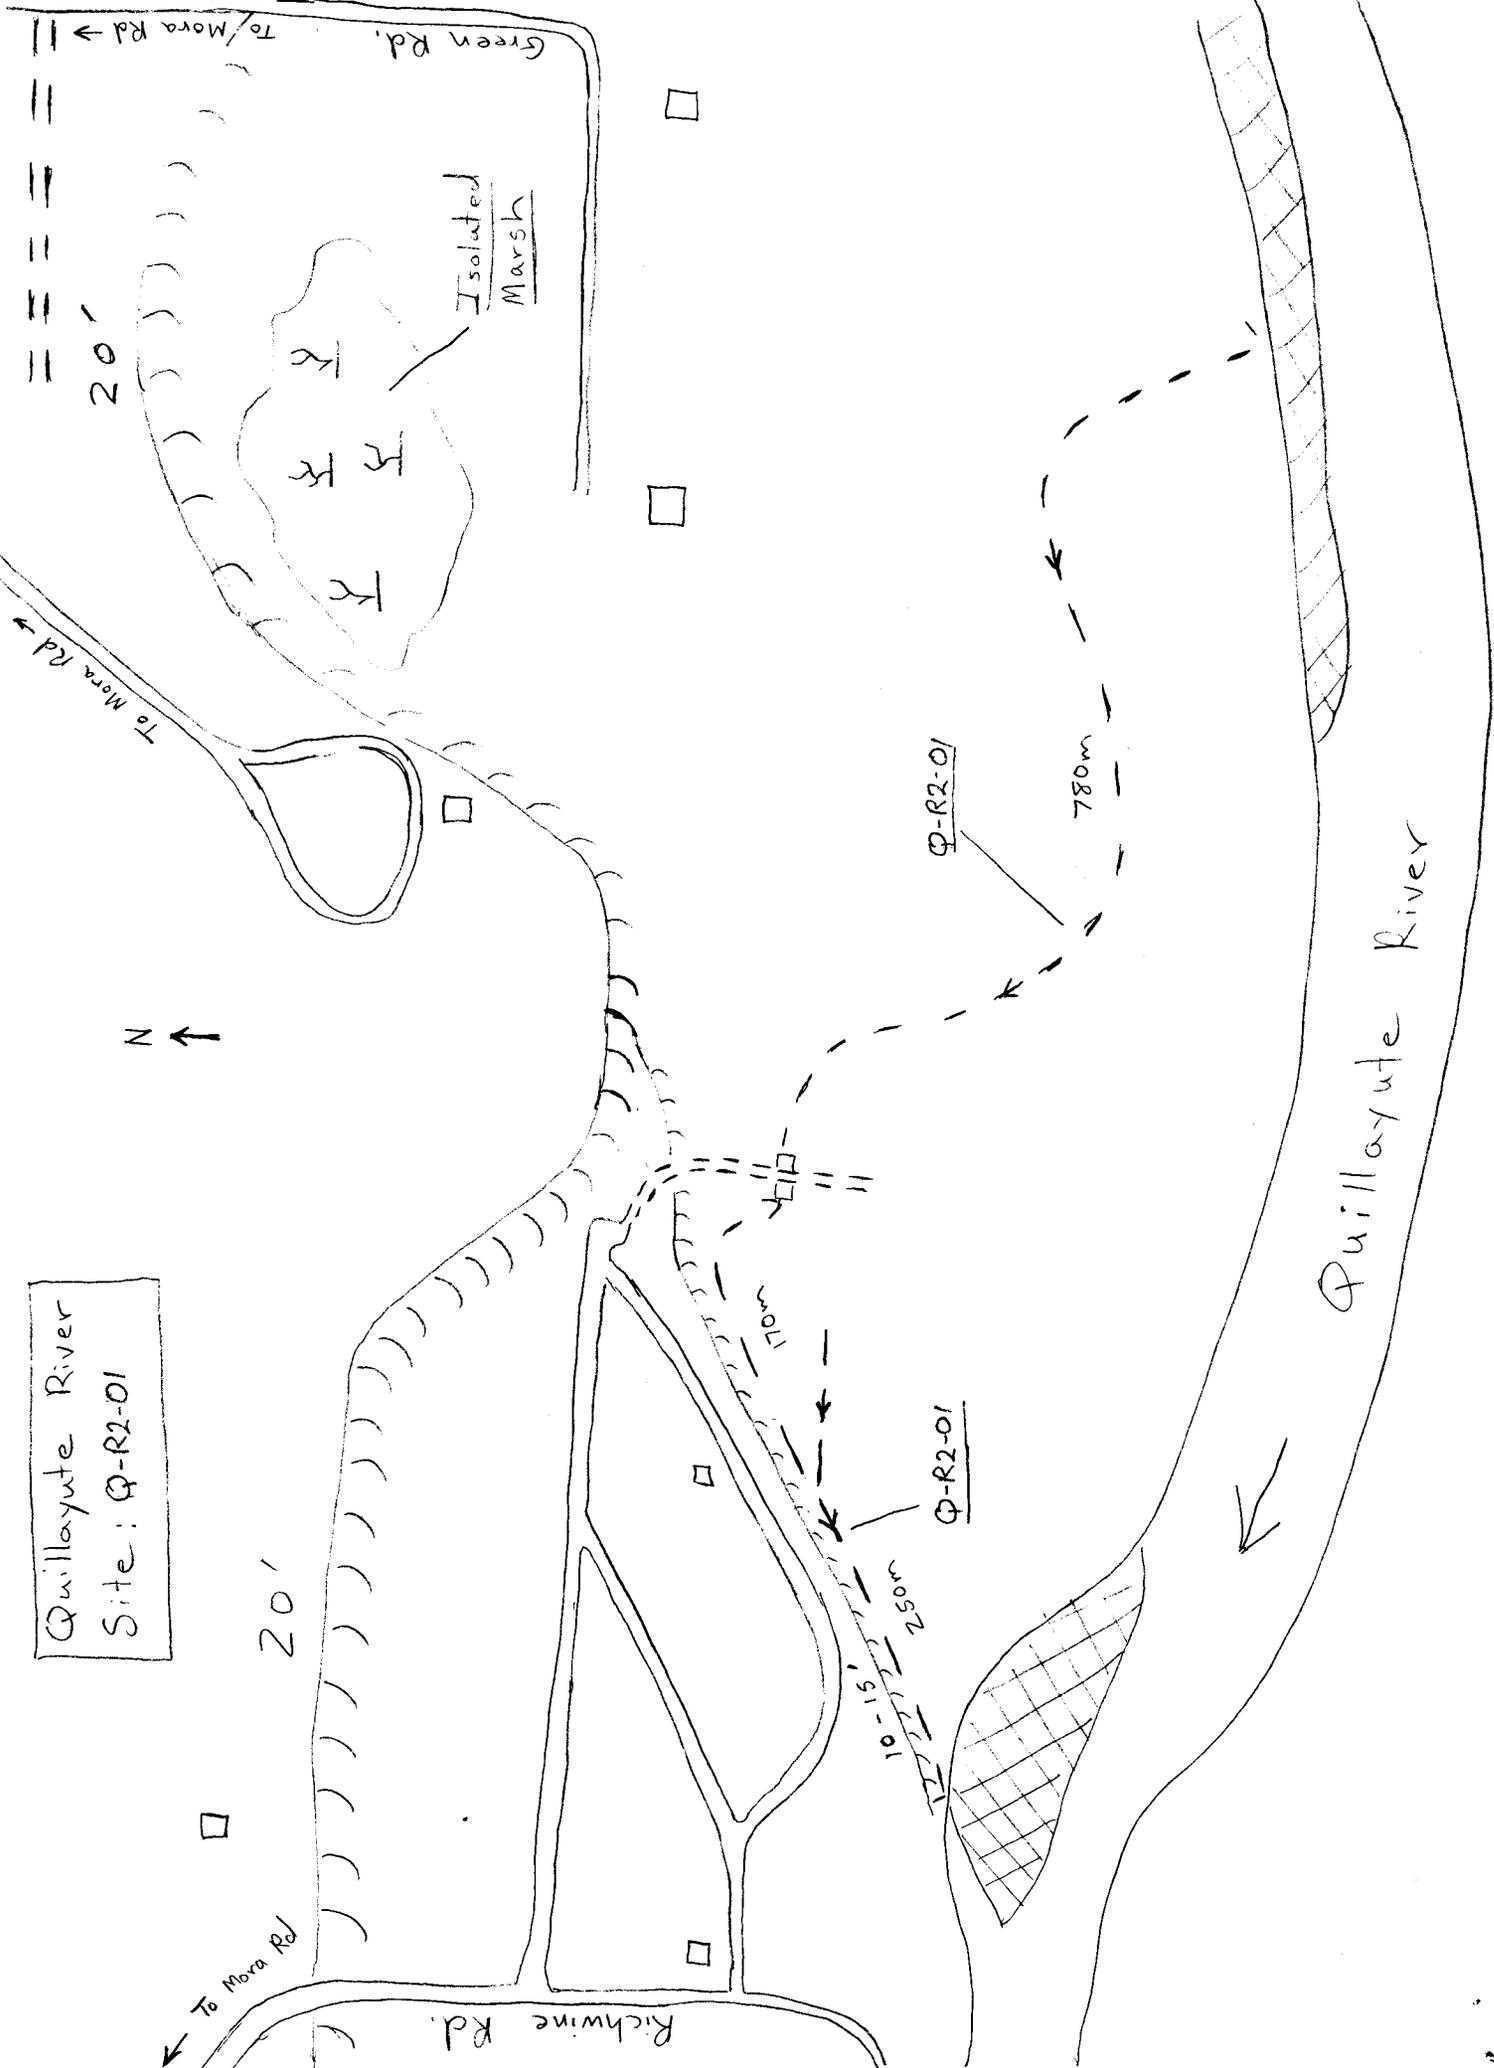
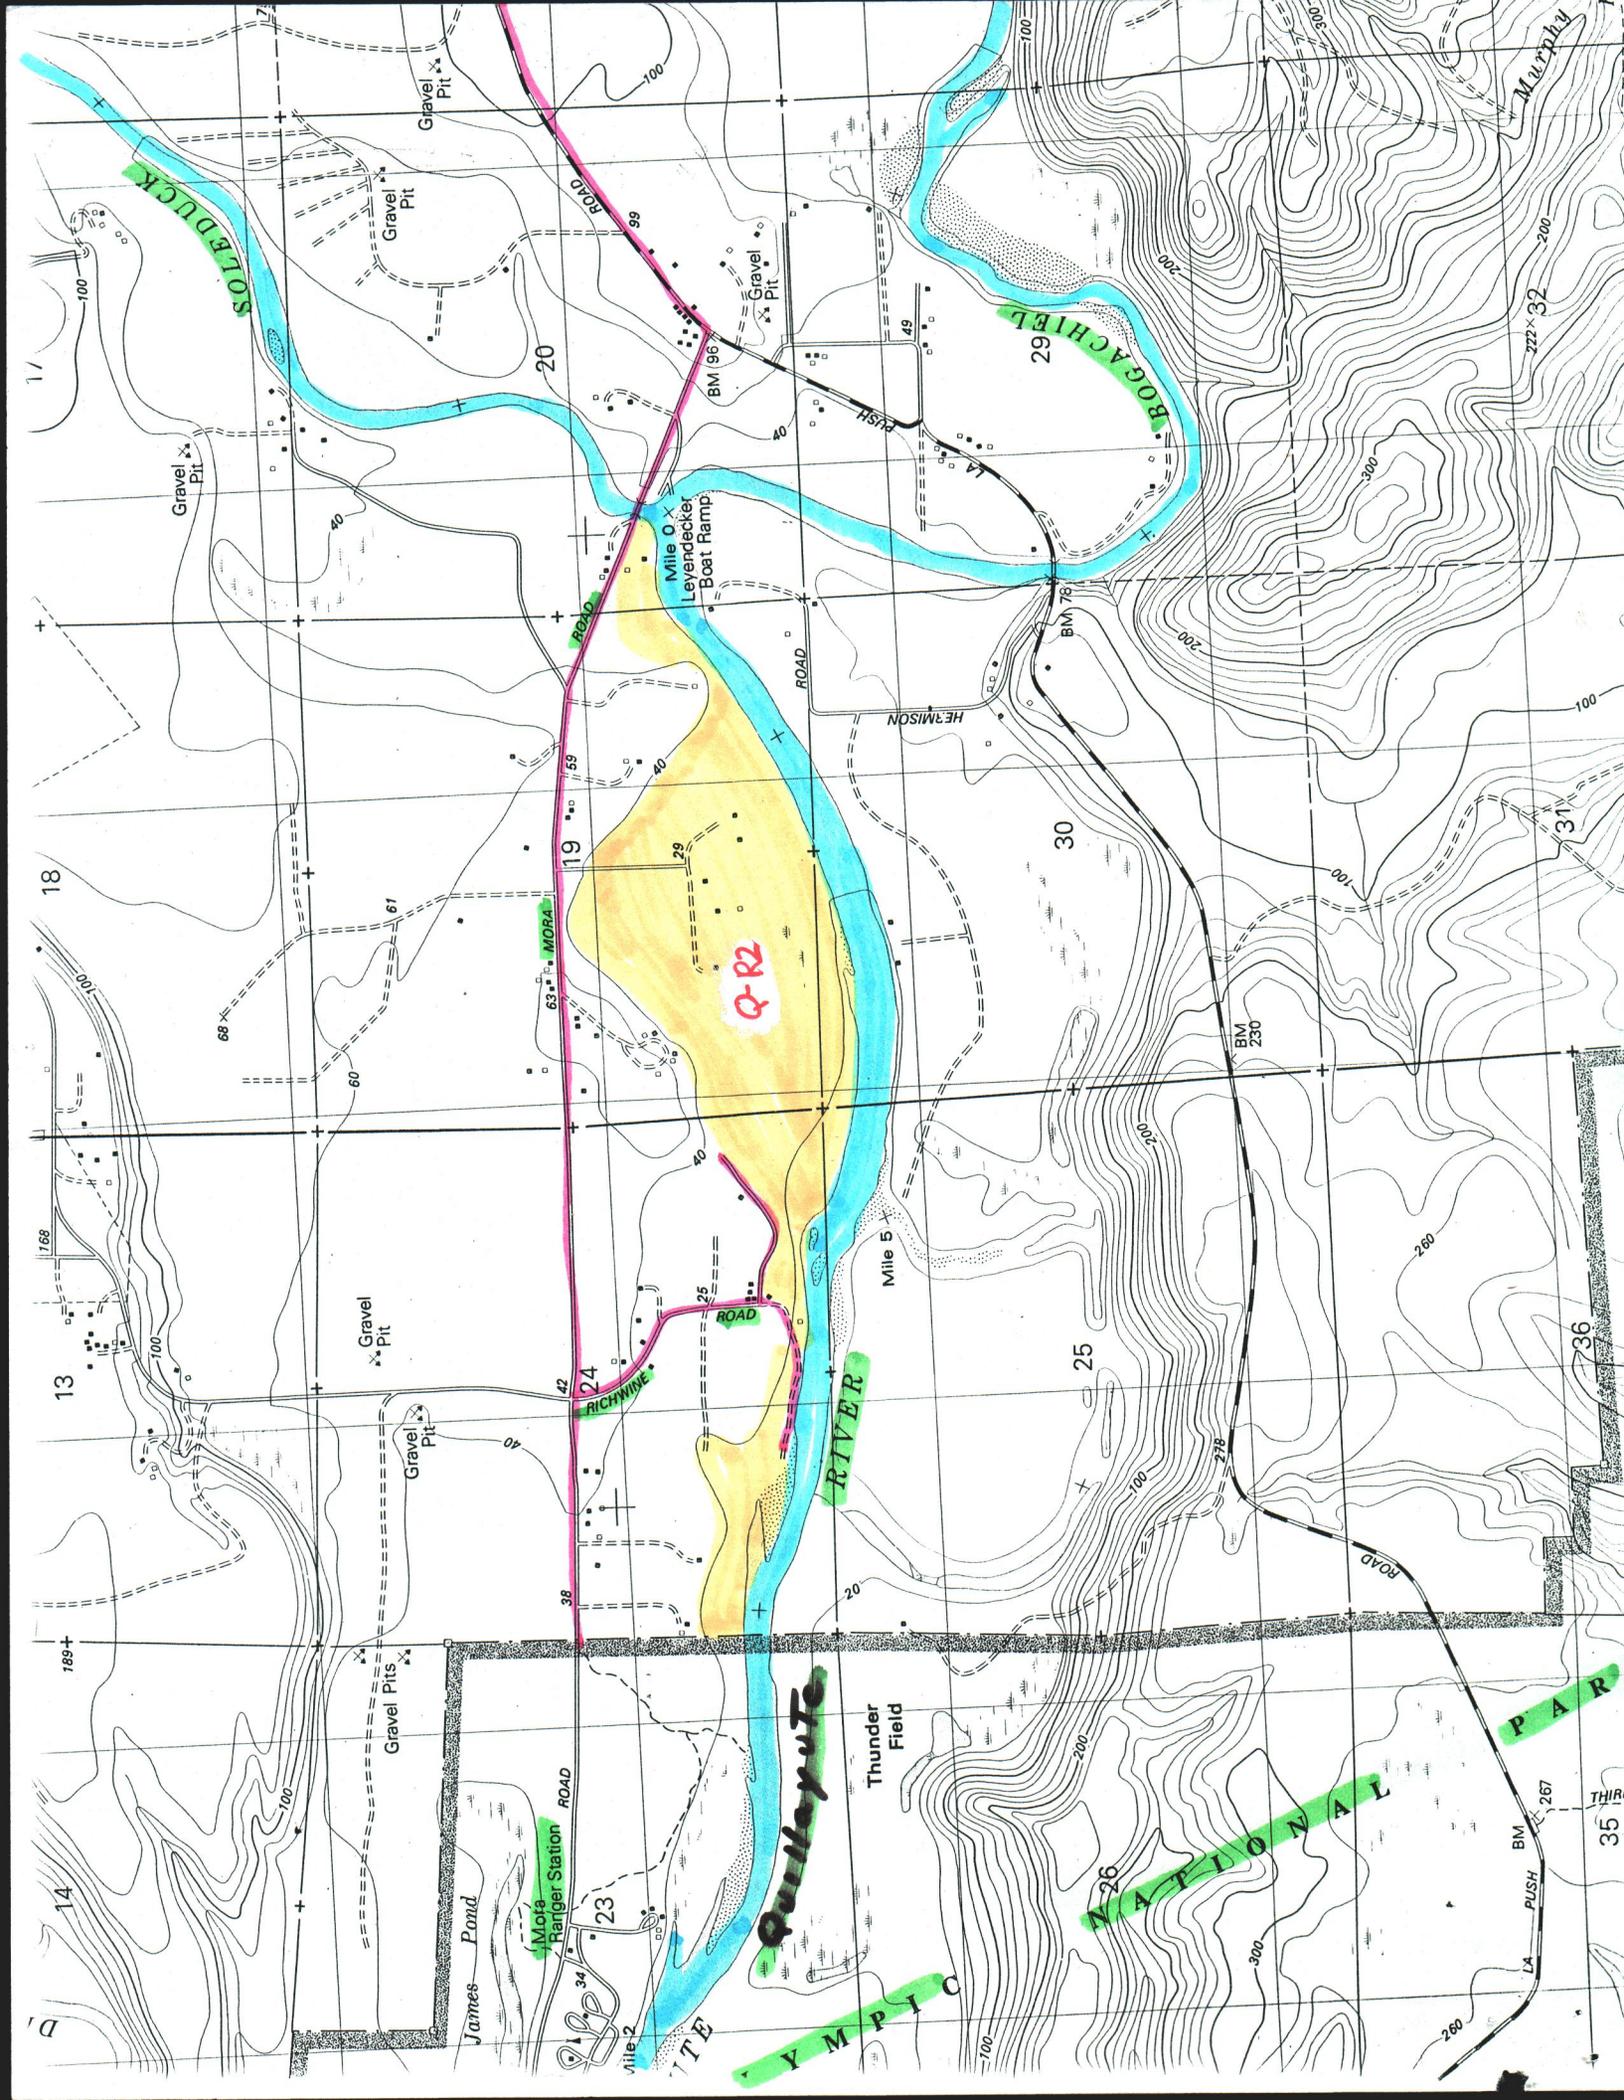
Quillayute River
Site: Q-R2-01

COMMENTS & RECOMMENDATIONS: Q-R2-01 is a well-defined, 8 to 10 ft deep channel. It does not appear water has flowed though the upper end of the channel yet this Fall. A large culvert, near the lower end, indicates Q-R2-01 is capable of carrying a large amount of water. Many isolated pools were seen in the lower 400 m of Q-R2-01. If there is no strong flow through Q-R2-01, fish may not find it. If they do enter, however, they may become stranded. Need to observe Q-R2-01 at high flows, determine if fish enter in significant numbers and if stranding is a problem. If so, may want to eliminate fish access.
